Corrosion Fractures in Wire Grips

This article describes corrosion fractures in wire grips and introduces countermeasures to this problem. It is the sixth in a bimonthly series on the theme of practical field information about telecommunication technologies. This month's contribution is from the Materials Engineering Group, Technical Assistance and Support Center, Maintenance and Service Operation Department, Network Business Headquarters.

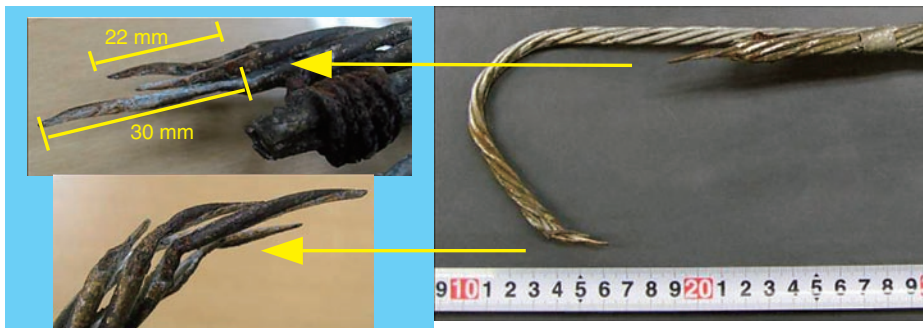
When the fractured wire grip and ground clamp were examined, it was found that the portion of the ground clamp in contact with the wire grip was heavily corroded. Moreover, the wire grip was severely wasted away in a region 20–30 mm from the fracture point (Fig. 1) indicating that the corrosion had progressed locally. Since a maximum wastage of 1.03 mm occurred in a strand with a diameter of 2.60 mm over a 21-year period from 1988, the corrosion rate was 49 μm per year. The normal corrosion rate of aluminium is 0.4–0.6 μm /year even in coastal areas [1], and since the standard thickness of the aluminium covering in the aluminium corrosion-resistant wire grip is 180 μm , a corrosion rate of 49 μm /year is extremely high. When the ground clamp was examined, red rust could be observed in the bolt section and main body. Moreover, in the section of the ground clamp in contact with the wire grip, some of the

Fig. 1. Fractured aluminium corrosion-resistant wire grip.

The results of measuring current and resistance and making observations suggest that current was flowing through the point of contact between the wire grip and ground clamp under investigation here, which caused electrolytic corrosion to occur and progress and this caused the messenger wire to fracture.

The most effective countermeasure here would have been to deal appropriately with the source generating the current, but since the source could not be isolated in this survey, countermeasures on the facility side had to be taken and countermeasures will continue to be needed in the future. If the contact resistance between a ground clamp and wire grip is sufficiently small, a potential difference does not arise and electrolytic corrosion generation can be prevented. In the survey, the resistance between ground clamp and wire grip was measured* in many locations and a measurement reading of 0 Ω was obtained in all cases. It was therefore concluded that electrolytic corrosion would not be a problem even in areas where DC was observed. However, older-type ground clamps are zinc coated to prevent corrosion of the iron materials, but if that zinc plating disappears, the aluminium portion of the aluminium corrosion-resistant wire grip can come into contact with iron, generating bimetallic corrosion. Furthermore, as the resistance at such a corrosion location is high, the corrosion will be further accelerated by electrolysis whenever DC flows. Thus, in the section between utility poles A and C where current was observed, special attention must be paid to locations with the older-type ground clamps in future facility inspec-

tions. By contrast, the latest ground clamps are manufactured by zinc alloy die-casting, which means that bimetallic corrosion will not be a problem as long as aluminium corrosion-resistant wire grips are used. In other words, replacing the older-type ground clamps with new ones could also be an effective countermeasure.

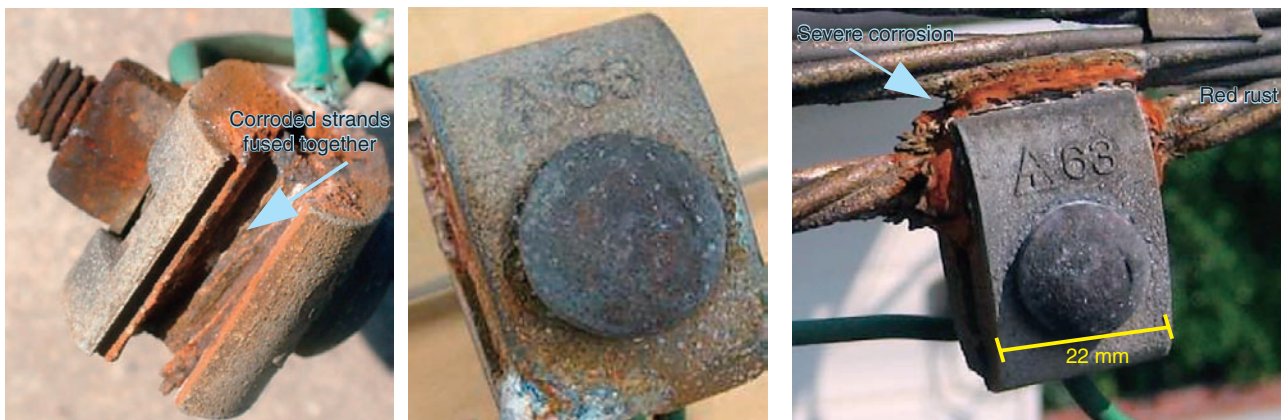
strands of the wire grip were found to have fused with the ground clamp (Fig. 2). Corrosion had also occurred on the wire grip on the other side of the utility pole at the point where the ground clamp was attached.

Fig. 2. Ground clamp (on the side opposite the fractured wire grip).

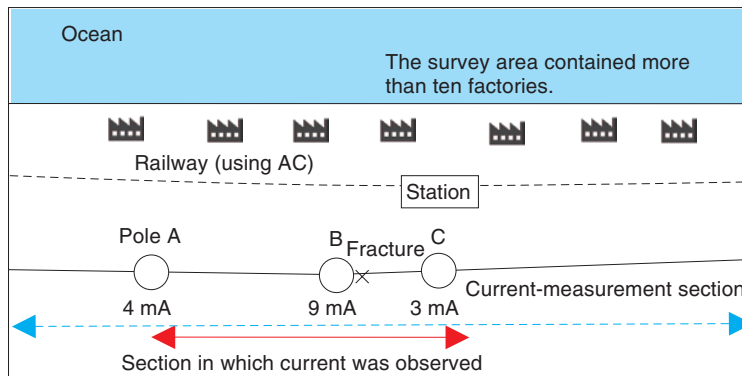
Measurement results are shown in **Figs. 3** and **4**. No AC was observed at any location, but DC was observed in the section from utility pole A to utility pole C (about 2 km). At the fracture accident location, a DC value of 9 mA was measured at 10:00 AM and 10 mA was measured at 4:00 PM. The direction of current flow changed for the two measurement times at the same measurement location. Furthermore, in the surveyed range, no corrosion was observed in messenger wires, wire grips, or metallic components even in those segments in which DC was measured.

Fig. 3. Facility configuration and measurement results.

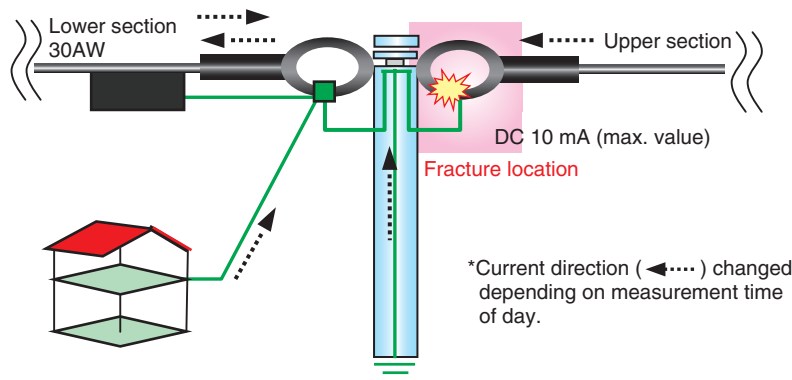
Fig. 4. Current-measurement results at utility pole B.

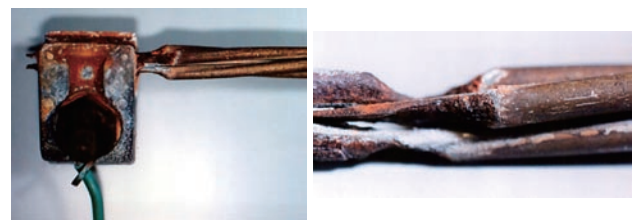
Electrolytic corrosion can occur in messenger wires in the same way as in wire grips. This section presents a case study of a corrosion-related fracture at the location where a ground clamp was attached to an aluminium corrosion-resistant (AW) messenger wire. The accident occurred about 1500 m from the ocean in a river delta in a residential area dotted with small iron works and other small factories. The fractured wire was of the 30AW type deployed in 1980. The corrosion in this fractured wire is shown in **Fig. 5**. A sudden wasting away of messenger wire not seen in crevice-type corrosion was observed at the boundary between the corroded and normal parts of the messenger wire. It was therefore inferred that current was flowing in this boundary region causing electrolytic corrosion to occur.

Fig. 5. Fractured AW messenger wire.

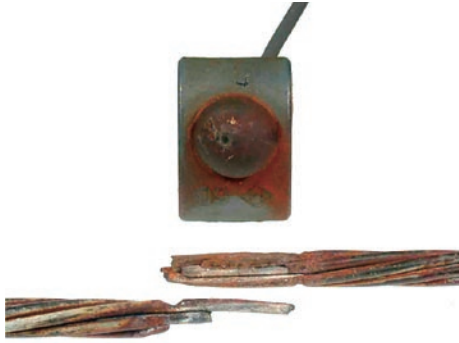
Fig. 6. Fractured SW messenger wire.

The same kind of attention must also be paid to zinc-coated steel-wire (SW) messenger wire. When the contact resistance between the messenger wire and ground clamp is high and a potential difference exists, the formation of a water film having ionic conductivity will result in the flow of current and the occurrence of an electrolytic reaction. Once the messenger wire begins to act as an anode, its wire strands can erode as a result of an electrochemical reaction. Furthermore, in coastal areas, sea-salt particles can penetrate the water film, which makes it easy for an ionic conductive water film to form. An example of electrolytic corrosion in an SW messenger wire is shown in **Fig. 6**.

The countermeasures described above can also be effective when attaching ground clamps to SW messenger wire. Moreover, since surface resistance is high in the phase preceding the appearance of red rust on the messenger wire; that is, when the zinc coating corrodes and white rust begins to appear, this white rust must be removed. The SW messenger wire is more susceptible to corrosion than AW messenger wire, so special attention must be paid when ground clamps are attached to existing SW messenger wires.
