Case Studies of Faults and Countermeasures in a Passive Optical Network System

Abstract

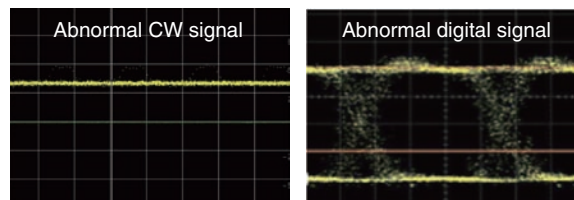
An investigation of this disconnected ONU revealed that when power was applied to it, it generated a steady output of a continuous wave (CW) signal at a wavelength of 1.31 μm with a power level of +2 dBm. It was inferred that this CW signal affected the other ONUs administered by the same PON OLT interface

Fig. 2. Abnormal CW signal and abnormal digital signal waveforms output from faulty ONUs.

In another similar fault case, we also discovered abnormal optical digital signal emission from an uncontrolled ONU, which incessantly output a 1.31- μm optical digital signal. Examples of the waveforms of the abnormal CW signal and the abnormal digital signal of faulty ONUs are shown in **Fig. 2**.

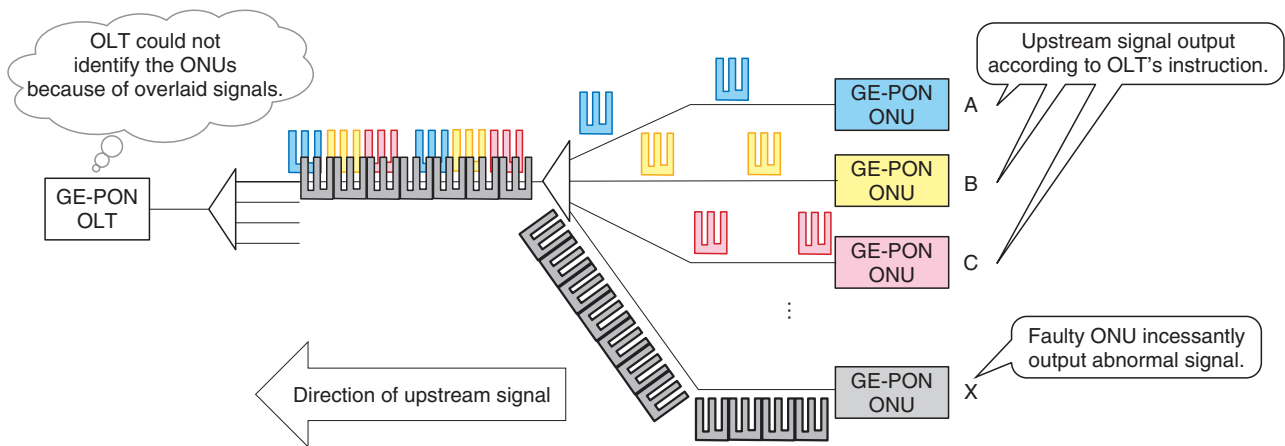
The cause of this particular fault can be explained as follows. Ignoring OLT control because of faulty operation, the faulty ONU output a continuous upstream signal (CW signal) that was overlaid on the upstream signals from other ONUs allocated by the same PON-OLT interface package (**Fig. 3**). This prevented the OLT from identifying all of the ONUs and resulted in the generation of upstream-error-rate-deterioration and service-immobilization alarms.

Fig. 3. Upstream signal from faulty ONU.

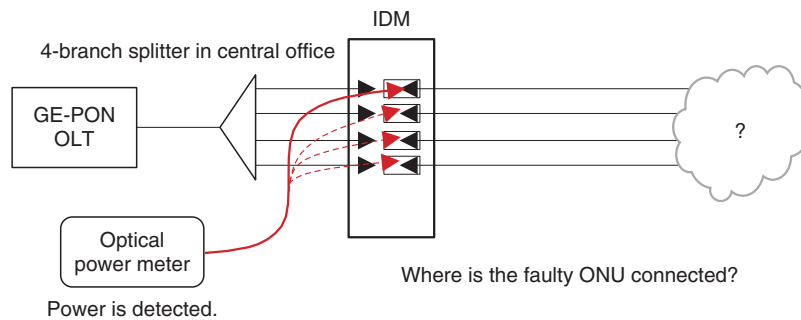
Fig. 4. Troubleshooting procedure at an IDM in the central office.

tion and service-immobilization alarms in multiple ONUs allocated by the same PON-OLT interface package suggested that the fault might have been caused by an ONU with abnormal light-wave emission. In this case, simply arranging to exchange the ONUs reported to be experiencing problems would not have resulted in their restoration and might only have prolonged the situation. To troubleshoot such a problem as quickly as possible, one must begin troubleshooting at the OLT-side 4-branch splitter in the central office. Specifically, the optical fiber connectors for the four paths at the integrated distribution module (IDM) must be physically disconnected in turn, power from the connector must be detected using a power meter, and the connector where the faulty ONU is connected must be identified (**Fig. 4**).

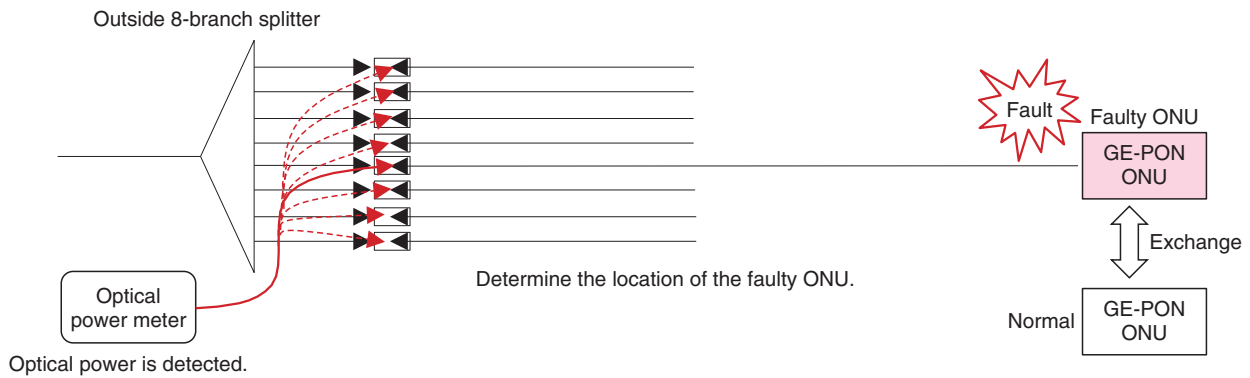
Fig. 5. Troubleshooting procedure at an outside 8-branch splitter.

from the OLT. The absence of received optical power here would therefore indicate normal ONU operation. By contrast, the presence of received optical power would indicate that the faulty ONU with abnormal signal light is connected to the optical fiber connector. Next, on the OLT-side of the outside 8-branch splitter, one must disconnect the eight optical fiber connectors in turn and identify as described above and check each connector for received optical power from that ONU using an optical power meter. Finally, once the faulty ONU has been located, it can be exchanged with a normal one to complete the repair procedure (Fig. 5).

Before an optical fiber connector at the IDM or outside 8-branch splitter is reconnected, its optical connector plug or adaptor must be cleaned.

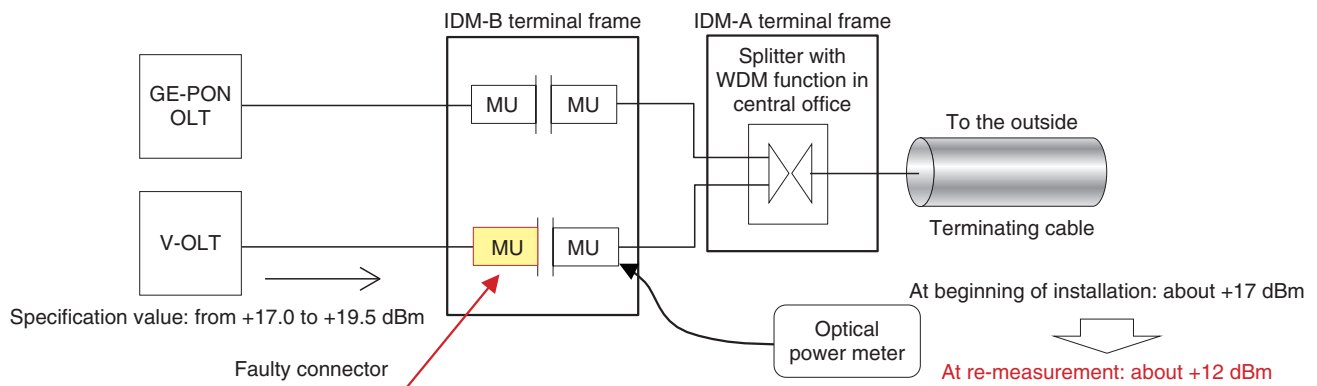
This case study involved a miniature universal coupling (MU) connector on an IDM-B used for video delivery services (FLET'S TV). At the beginning of installation of intra-office equipment (V-OLT), the received power level at the MU connector was found to be +17 dBm. After a while, when it was re-measured upon connection, it was found to be +12 dBm. The insertion loss at the MU connector increased to about 5 dB. The facility configuration in which this fault occurred is shown in Fig. 6. The insertion loss did not improve even after the optical fiber end surface of the MU connector had been carefully cleaned, so an investigation into the cause of the fault was conducted.

Fig. 6. Facility configuration for case 2.

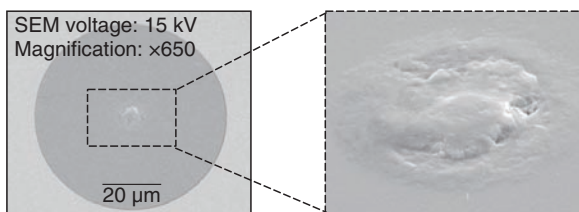
Fig. 7. Results of SEM inspection.

The investigation began with optical characteristics. The return loss at the end of the faulty connector in air was found to be abnormal at about 39 dB compared with about 14 dB for a normal connector; moreover, the loss when connected was also large at about 5 dB, as mentioned above. Next, the connector was dismantled and the connector ferrule end surface was

inspected using a scanning electron microscope (SEM). This revealed signs of fatal damage caused by silica-melting in the core section (Fig. 7).

An experiment was conducted to reproduce the fault: light from the V-OLT was injected into the connector and the tip of the MU connector was exposed to various types of contamination from oily hands, clothes (work shirts), dust, etc. It was found that fatal damage caused by silica-melting occurred in the core section and that the loss increased in the case of all of these types of contamination, but that the signs of damage observed for contamination by oily hands and clothes most closely resembled the characteristics seen in this case study. It was therefore inferred that the high optical power of the V-OLT equipment was converted into heat by the contamination on the optical fiber end surface of the connector and that this led to the silica-melting in the core section.

It is important to eliminate contamination from a connector end surface by using a cleaner. Specifical-

ly, it is essential to clean an optical connector plug and adaptor using specialized cleaners before connecting them (**Fig. 8**).
