Practical Field Information about Telecommunication Technologies

Case Studies of Using the Gigabitcompatible Protocol Checker as a Troubleshooting Tool for Home IP Systems

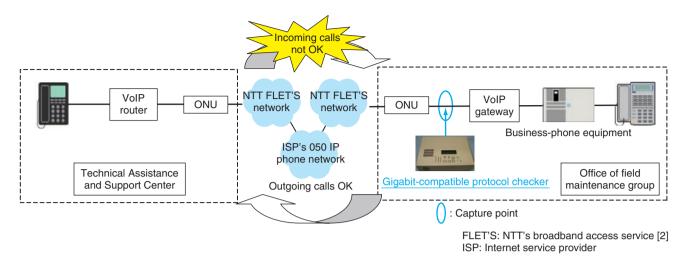
Fig. 2. Customer's home configuration and measurement system.

To troubleshoot this problem, we duplicated the customer's system configuration in the office of a field maintenance group and conducted a test to inspect calls made from the Technical Assistance and Support Center to that office. In this test, we inserted the gigabit-compatible protocol checker between the optical network unit (ONU) and the VoIP gateway in the customer's premises to analyze call conditions at the time of the fault (incoming calls not OK) and we investigated any differences in the session initiation protocol (SIP) sequence for two cases: (1) when the VoIP gateway was model A and (2) when it was model B. The test setup is shown in **Fig. 2**.
