Case Study of Noise Faults Originating in Metallic Leased Lines and Countermeasure

In this article, we introduce failure cases and a failure countermeasure for metallic leased lines. This is the fifteenth in a bimonthly series on the theme of practical field information on telecommunication technologies. This month's contribution is from the Network Service Engineering Group, Technical Assistance and Support Center, Maintenance and Service Operations Department, Network Business Headquarters, NTT EAST.

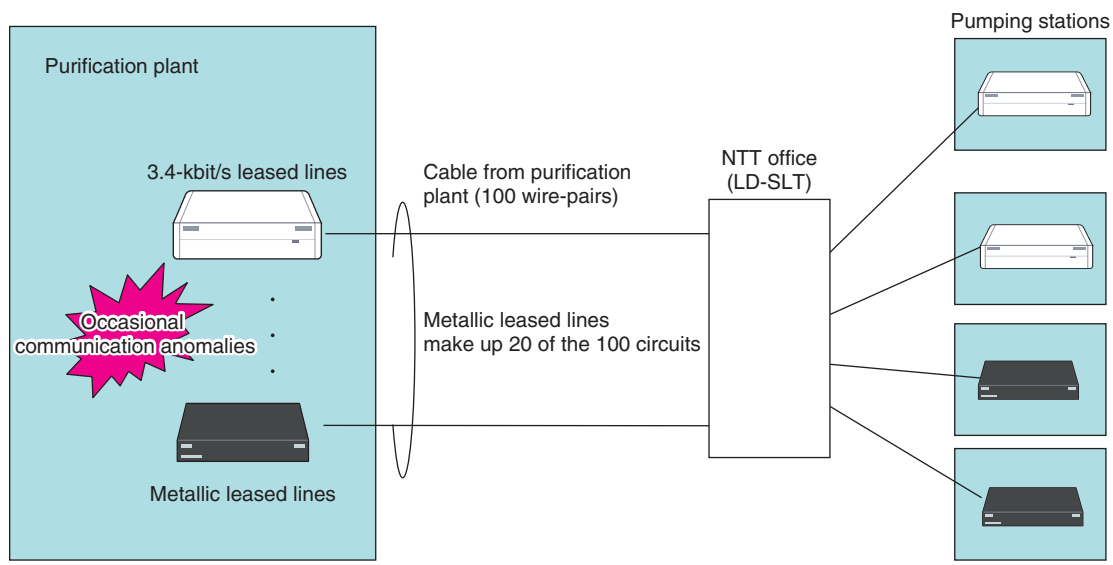
Fig. 3. Facility configuration.

A waterworks bureau that manages communications between a purification plant and multiple pumping stations using analog leased lines (3.4-kbit/s leased lines and metallic leased lines) reported that communication anomalies were occurring from time to time in terminals on the purification-plant side. In order to switch the leased lines generating the communication anomalies to other core wires in the same cable, the fault-repair department conducted a free-wire test, but the appearance of line-testing anomalies (induced voltage detected from nearby core-free wires) indicated that many core wires could not be used. The facility configuration is shown in Fig. 3.

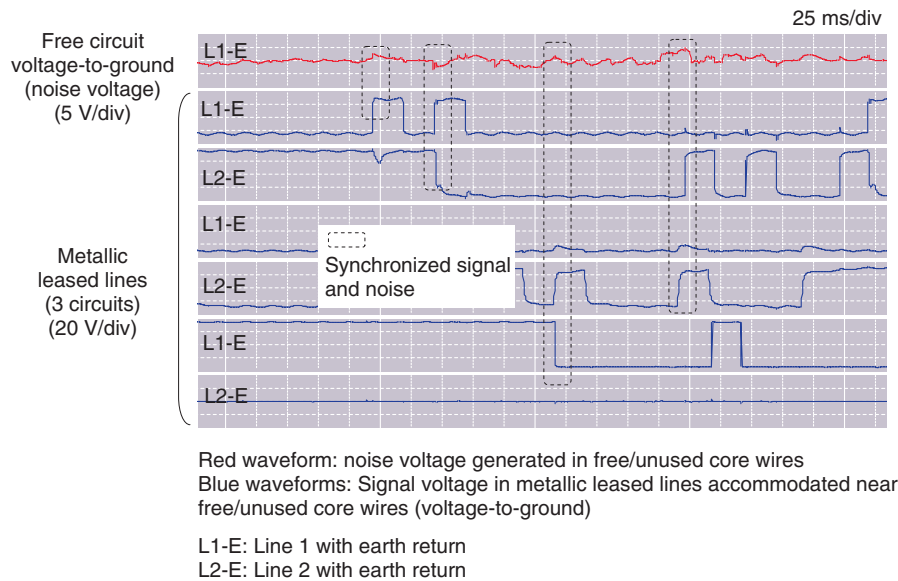
Fig. 4. Noise in metallic leased lines and free core wires.

earth-return system. Therefore, voltage-to-ground measurements of metallic leased lines and free core wires were performed within that cable to see whether noise from metallic leased lines was being mixed into other circuits. The measurement results are shown in Fig. 4.

These results revealed that noise constantly fluctuating in the peak-to-peak voltage range up to 10 V_{pp} was being mixed into free core wires. This noise was thought to be causing the line-testing anomalies discovered by the fault-repair department. It was therefore inferred that noise was being induced from the 20 metallic-leased-line circuits in the same cable. In particular, the sections in Fig. 4 marked by broken lines indicate points in these waveforms where noise was thought to be synchronized with signals in the metallic leased lines.

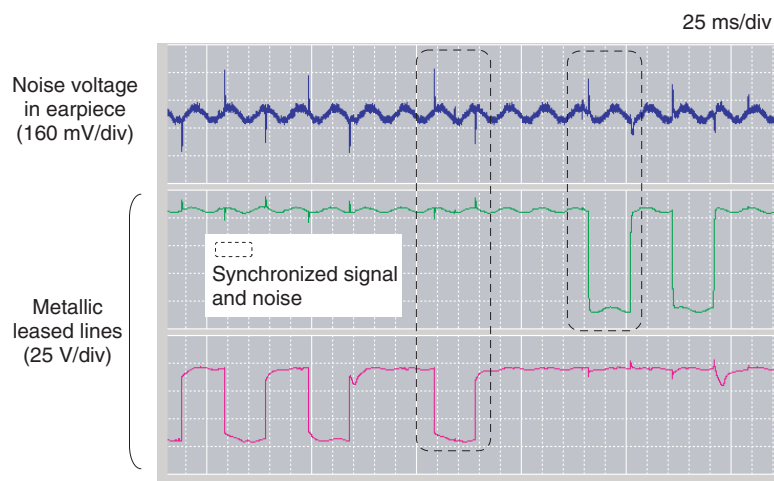
Fig. 5. Noise details.

The cause-and-effect relationship between induced noise and signals in metallic leased lines is examined in detail in Fig. 5. The green and red waveforms indicate signals in metallic leased lines, and the blue waveform indicates the line voltage in the earpiece of a telephone connected to an analog circuit within the same cable. At this time, noise (sounding like “bootz, bootz”) could be heard from the earpiece. These waveforms showed that noise in free core wires was synchronized with the rise and fall of signal voltage in metallic leased lines.

The results of the inspection described above led to the conclusion that the reported communication anomalies were caused by noise originating in metallic leased lines. This noise became mixed into other circuits within the same cable, resulting in communication anomalies in the 3.4-kbit/s leased lines and metallic leased lines and in line-testing anomalies in free circuits.

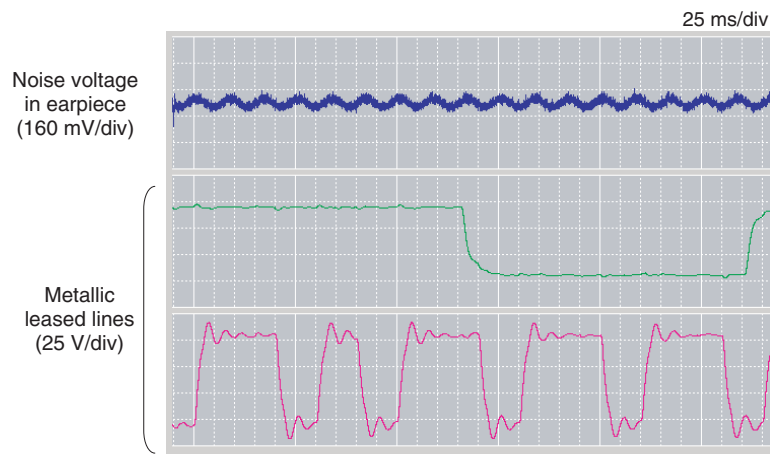
Fig. 7. Measurement results after application of countermeasure.

The signal waveforms after this countermeasure was applied to the metallic leased lines and the results of measuring noise at the telephone earpiece on an analog circuit are shown in **Fig. 7**. The rise and fall of signals in the metallic leased lines have been smoothed out, thereby eliminating sharp changes in those signals. As a result, no noise was observed mixing into the analog circuits.
