Failure Cases in Optical Access Facilities (Fiber Breakage in Optical Cabinets) and Countermeasures

The Technical Assistance and Support Center undertakes detailed analyses of actual failures and proposes countermeasures to failures that occur in optical distribution facilities. This article reports two actual failure cases involving optical fiber breakage that occurred in an optical cabinet installed in multi-dwelling unit buildings and proposes countermeasures to prevent such failures in the future. This is the sixteenth in a bimonthly series on the theme of practical field information on telecommunication technologies. This month's contribution is from the Access Engineering Group, Technical Assistance and Support Center, Maintenance and Service Operations Department, Network Business Headquarters, NTT EAST.

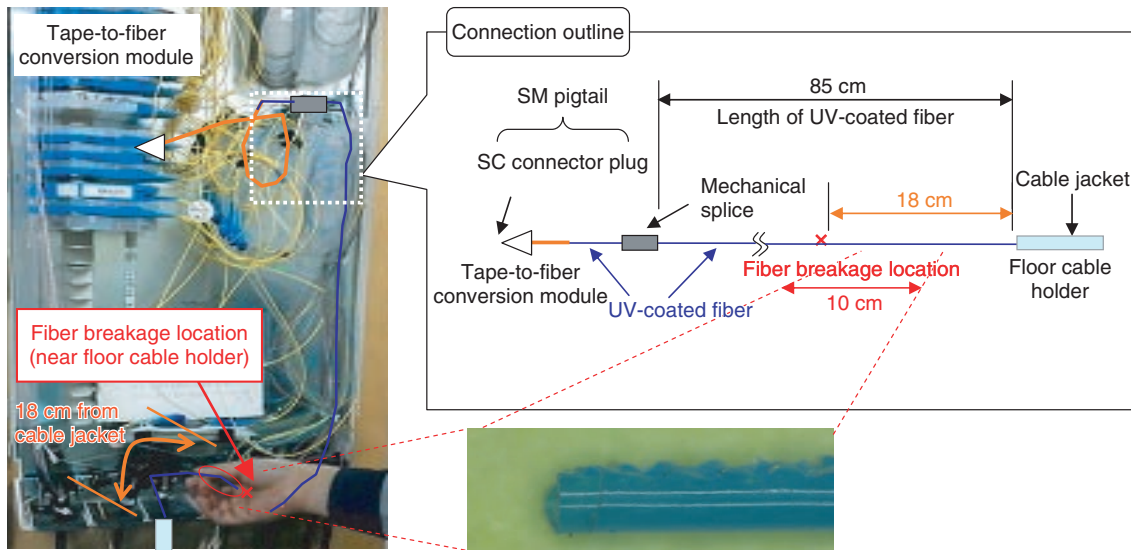
Fig. 9. Fiber breakage location in a PT cabinet (M type) and optical cabinet configuration.

A fiber breakage of an optical fiber occurred near a floor cable holder in a PT cabinet, as shown in Fig. 9.

The fiber breakage occurred 18 cm away from the end of the cable jacket holding a single-core floor cable. We also found many scratches on the fiber that extended about 10 cm from the fiber breakage. The length of the UV-coated fiber measured from the edge of the cable jacket is generally required to be more than 160 cm. In this case, the length was less than 85 cm. Therefore, the UV-coated fiber could not be stored inside the 40-core fiber storage unit because it was too short.

We considered the reason for the fiber breakage. The optical fiber guides failed to hold the UV-coated fiber. In addition, the UV-coated fiber was scratched when it was dragged over the floor cable with the metallic clamp.

We also considered that the scratches on the fiber would become larger over time. This would eventually lead to fiber breakage.

A countermeasure to this problem is to ensure that the UV-coated fiber is passed appropriately through

use the correct placement methods in the optical cabinets.

For these reasons, the length of fiber that is needed should be roughly estimated before the actual wiring of the UV-coated fiber is done. In addition, it is recommended that the extra length of the UV-coated fiber be adjusted in order to prevent sagging of the optical fiber in the 40-core fiber storage unit (Fig. 11).

the optical-fiber guides. It is also essential to have a sufficient length of the UV-coated fiber wires and to

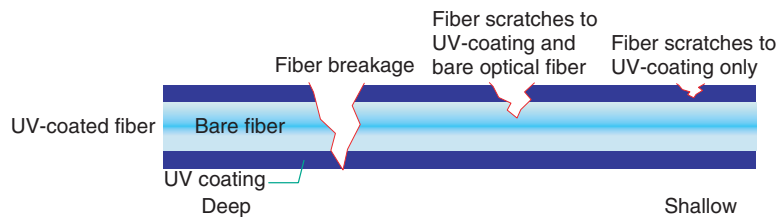
Fig. 10. Appearance of fiber scratches on optical fiber.

(Fig. 10). We measured the extent of the damage of the fiber scratches on a three-level basis (1: fiber breakage, 2: fiber scratches affecting both the UV-coating and bare optical fiber, 3: fiber scratches on the UV coating only). The results of the experiment are listed in Table 1.

The UV-coated fiber was pushed strongly against a floor cable with metallic clamps. Then, the UV-coated fiber was dragged over the floor cable with metallic clamps so that the UV-coated fiber moved about 10 cm in the axial direction of the fiber. The result of this action was that a fiber breakage (fault 1) occurred 0 out of 10 times, fiber scratches to both the UV-coated fiber and the bare fiber (fault 2) occurred 2 out of 10 times, and fiber scratches to only the UV coat-

ing (fault 3) occurred 6 out of 10 times.

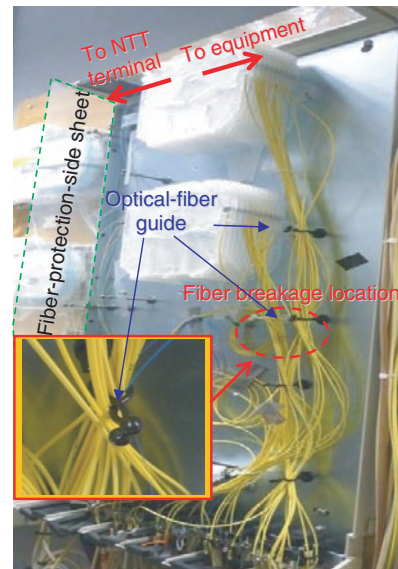
Fig. 12. Location of fiber breakage in a PD cabinet (M type).

The fiber breakage occurred after carrying out work to install the wiring in a PD cabinet. The wiring conditions and fiber breakage location in the PD cabinet are shown in Fig. 12.

The fiber breakage occurred near an optical-fiber guide. As mentioned previously, only UV-coated fiber should be held by the optical-fiber guides. In this case, both the UV-coated fibers and optical cords were being held by the optical-fiber guides.

The results of the reproductive experiments reinforced our view that there were two key reasons for fiber breakages occurring in optical cabinets. One was that a fiber breakage could occur if the UV-coated fiber was compressed when the cabinet cover was opened or closed. The second was that a fiber breakage could occur if both optical cords and the UV-coated fiber were fastened by the optical-fiber guide. Consequently, strongly bending a fiber at a sharp angle, as has been done in the past, could lead to fiber breakage in optical cabinets.

A countermeasure to this problem is to take special care when opening and closing the cabinet. In addition, it is also essential that only the UV-coated fiber, and not the optical cords, be fastened by the optical-fiber guides.
