Fault Cases and Countermeasures for Optical Fiber Cables in Optical Network Facilities

This article introduces case studies of failures that have occurred in optical fiber cables as well as some countermeasures against such failures. This is the twenty-third of a bimonthly series on the theme of practical field information on telecommunication technologies. This month's contribution is from the Access Network Engineering Group, Technical Assistance and Support Center, Maintenance and Service Operations Department, NTT EAST.

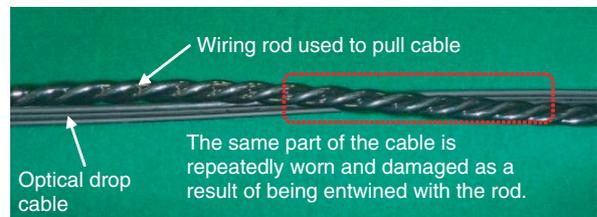
Fig. 4. Reproduction of cable damaged by entwining the rod and cable together.

cable with wiring rod, with polypropylene string, and with metallic cable, respectively, as shown in **Fig. 4**, in order to intentionally damage the cable. We then compared the resulting damage with the damage from the removed cable to see if the same kind of cable bend, jacket detachment, and optical fiber breakage occurred. Finally, we confirmed that the damage that occurred when the wiring rod was used most resembled that of the removed cable (**Fig. 5**).

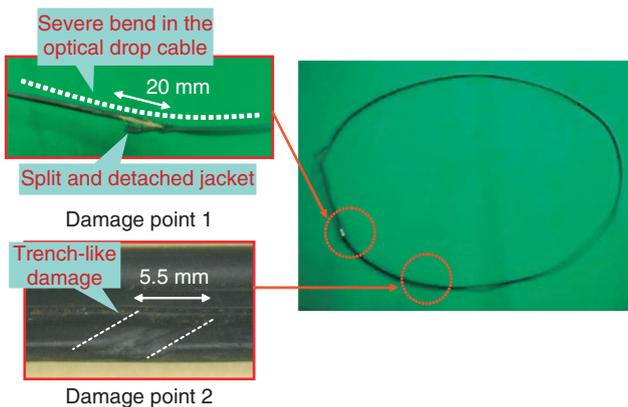
Fig. 3. External view of damaged optical drop cable.

The damaged optical drop cable that was removed from the conduit line is shown in **Fig. 3**.

The form of the damage (damage point 1) consisted of a severe bend in the cable and a split and detached cable jacket. Another point of damage consisting of a trench (damage point 2) was located 15 cm from damage point 1.

We confirmed using X-ray imaging that two optical fibers were broken at damage point 1. Moreover, we also confirmed with a video microscope that the UV (ultraviolet) coating on the broken optical fibers was

stripped, leaving the bare fibers exposed.

being entwined with the wiring rod. Therefore, we recommended two countermeasures to prevent this damage: (i) Install a new conduit line to avoid using multiple threading cables in the same conduit, and (ii) in the inevitable case that new metallic cable is installed in the conduit line containing previously installed optical drop cable (in the manner described in this report), the metallic cable must be placed very carefully. Then the installer should check whether excessive force has been applied or whether existing cables have been moved.

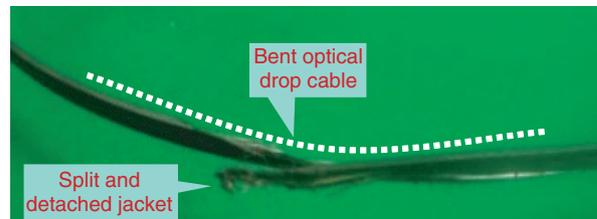
Fig. 5. Reproduced damage in optical drop cable.

In our examination, we confirmed that the optical drop cable was damaged when it was pulled after

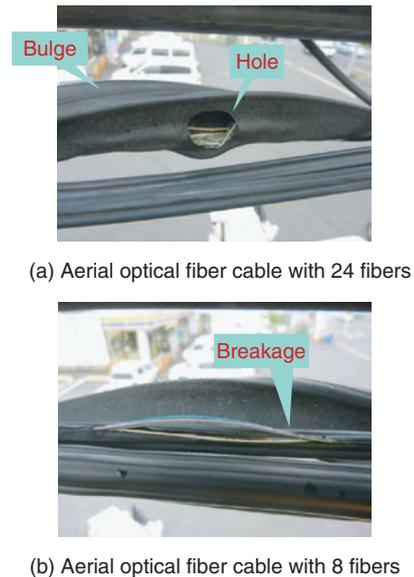
Fig. 6. External view of damaged aerial optical fiber cables.

After receiving a report of a disruption of the optical telecommunication service, maintenance personnel searched for the fault location in the aerial optical network. They found a breakage in the sheath of two optical fiber cables. Upon closer inspection, they found that one optical fiber cable had bulges and a hole in the sheath, and the other cable had breakages, as shown in Fig. 6.

We interviewed the local fire department and found that three wooden houses had been completely destroyed by fire about six years earlier in an area near the damaged optical fiber cable. The damaged cables were directly downwind of the fire when the

From the results of the above investigation, we presumed that the change in the shape of the cable sheath and the support-line surface was caused by the high surface temperature, which reached about 150°C due to the heat from the fire. Moreover, as a result of the cable surface being stretched by the force of the tension member inside the optical fiber cable, the sheath starts to tear, and after many years of exposure to weather and UV light, it degrades and eventually breaks. It is difficult to confirm the state of damage to an aerial optical fiber cable after a fire by conducting only a visual inspection from the ground. Therefore,

as a countermeasure, it is necessary to carry out inspections from close up using an aerial work platform.

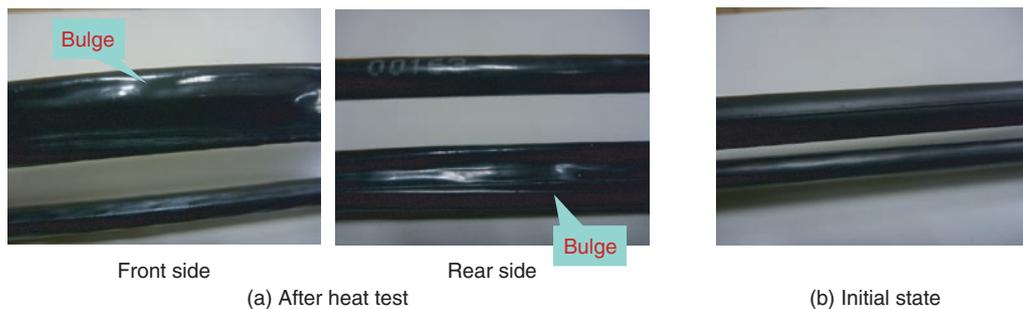
Fig. 7. Replicated damage in aerial optical fiber cable.

Fires of the type that consumed the wooden buildings typically have temperatures exceeding 1000°C (according to a fire handbook published by Kyoritsu Shuppan Co., Ltd. in 1997). The cable sheath material generally begins to deform at temperatures over 150°C. Therefore, we heated the same type of aerial optical cable in a heater in order to replicate the deformation of the optical cable by heat. When the surface temperature of the cable exceeded 150°C, the cable sheath started to soften. After 15 minutes, the cable deformed, and after 60 minutes, it started to

bulge (Fig. 7), and its shape resembled that of the piece of removed cable described in the previous section. The configuration of this type of aerial optical fiber cable with 24 fibers is shown in Fig. 8.

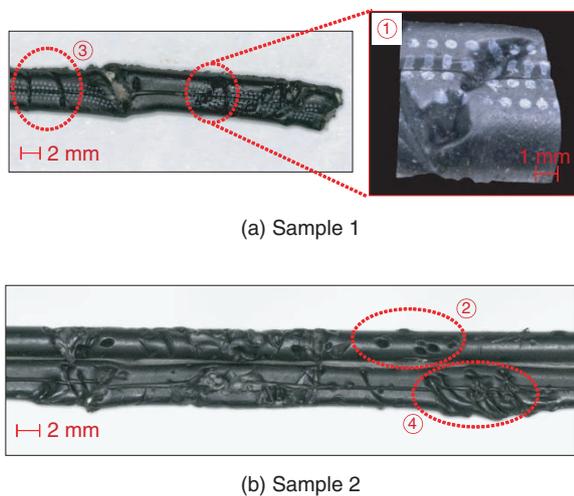
Fig. 9. Samples of damaged optical drop cables.

The first fault case involved an optical drop cable that was cut during the night. A lot of scarring was found on the sheath of the damaged cable, and the optical fibers inside the damaged cable were completely severed. These damaged optical drop cables are shown in Fig. 9. The appearance of damage on the sheath of the optical drop cable was different from the damage caused by the wildlife we had investigated in previous cases. These fault cases happened at night, but they were in areas where there were no nocturnal bird species with beaks capable of pecking through optical drop cables. The damage was also quite different from the damage caused by the incisors of rodents such as squirrels and mice. Therefore, we presumed that the damage to the cable was caused by an arboreal mammal such as a marten or civet.

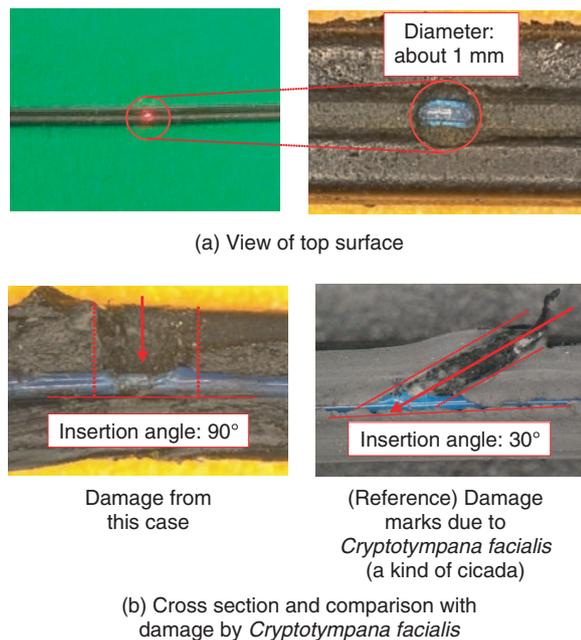
Fig. 10. Damage marks on optical drop cables.

facialis in the area where this fault occurred. The traces of damage to the optical drop cable were near the center section of the cable. The punctures had a circular hole-like shape with a diameter of 1 mm and were in the notch section of the optical drop cable (**Fig. 10**).

We examined the punctures and found that they had an insertion angle of 90°. In contrast, a typical puncture caused by the ovipositor of *Cryptotympana facialis* is characterized as a stab that occurs at an insertion angle of about 30°. This difference in the insertion angle led us to conclude that the damage was not caused by *Cryptotympana facialis*. Moreover, we confirmed that no carcasses or eggs of these insects were found in the extracted section of the optical drop cable.

We also found five semicircles 0.1 mm in diameter where the UV coating had been stripped away. The damage was similar to that caused by a bamboo powder-post beetle (*Bostrichidae*) examined in previous investigations. In particular, the width of the tip of the mandible of a bamboo powder-post beetle is about 0.1 mm, and the surface of the damaged sections is characterized by marks that appear to be less than or equal to 0.1 mm in size. Moreover, the damage marks on the optical drop cable had an insertion angle of 90°. In light of these facts, we inferred that the insect that inflicted the damage was *Bostrichidae*.
