Fault Cases in an IP Phone Circuit Accommodating a PBX via a VoIP-GW

This article introduces fault cases in an Internet protocol (IP) phone circuit accommodating a PBX (private branch exchange) via a VoIP-GW (voice over IP gateway). This is the twenty-fourth of a bimonthly series on the theme of practical field information on telecommunication technologies. This month's contribution is from the Network Interface Engineering Group, Technical Assistance and Support Center, Maintenance and Service Operations Department, Network Business Headquarters, NTT EAST.

Keywords: IP phone, PBX, VoIP-GW

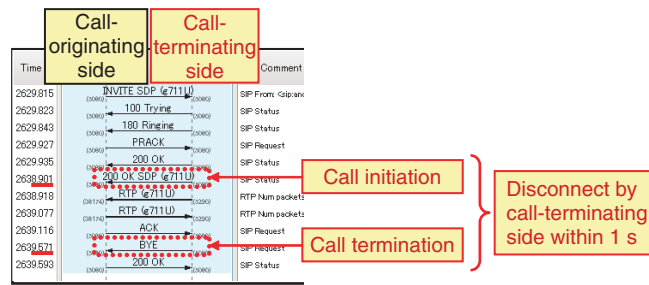
Fig. 4. Capture data (packet sequence) at time of fault occurrence.

- b) No packets that could be considered abnormal were found from the analysis of packet-capture data. However, packet sequences also revealed calls in which the time interval from call initiation to termination was less than one second, which was in agreement with the VoIP-GW call log. These results are shown in Fig. 4.
- c) At the times this fault occurred, signal monitoring between the VoIP-GW and PBX equipment revealed that the line would disconnect immediately after the PBX responded to the interrupted ringing (IR) signal sent by the VoIP-GW. The signal waveform at this time is shown in Fig. 5.

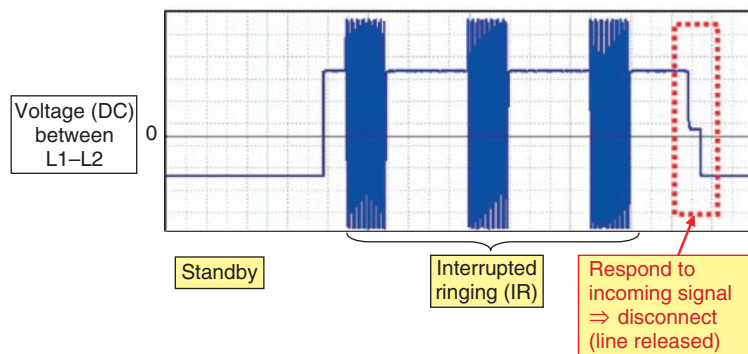
Fig. 5. Respond/disconnect waveform at time of incoming call.

Given that all incoming-call responses and disconnect operations were normal up to the analog-interface section between the VoIP-GW and PBX equipment, we surmised that a problem existed on the PBX

side. We considered, for example, that a defective hook switch on a specific extension phone to the PBX could cause the line to disconnect when responding to an incoming call.

To further troubleshoot this fault, we decided to equip the PBX with a function for saving and managing the call history, which would enable us to collect and analyze data and thereby identify the extension

phone of the PBX that was disconnecting the line when responding to an incoming call. The results of troubleshooting after implementing this countermeasure showed that the cause of this fault was an operational error by the customer of this PBX. In other words, the cause of this fault lay on the PBX side as we had surmised.

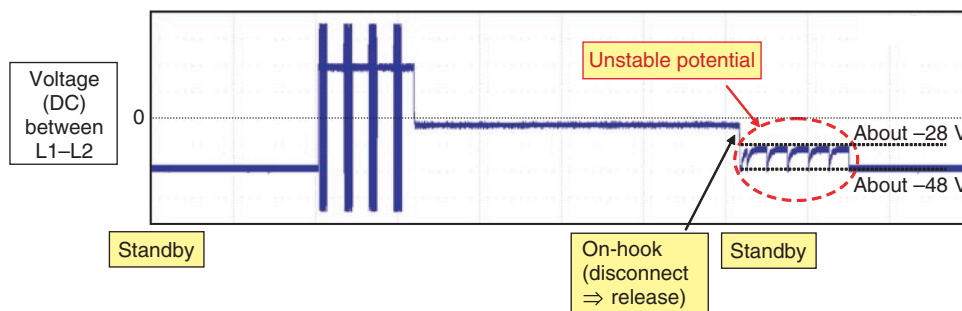
Fig. 7. Waveform depicting unstable potential (when DC resistance between L1-L2 is 0.62 MΩ).

- a) Signal monitoring in the analog-interface section revealed the following. If the value of DC (direct current) resistance between the L1-L2 lines at the time of circuit release happened to be less than 0.74 MΩ, the potential between L1-L2 would become unstable, fluctuating roughly between -48 V and -28 V directly after the on-hook operation*. The waveform at this time is shown in Fig. 7.
- b) We confirmed that no IR signal would be issued if an incoming-call polarity reversal occurred while the L1-L2 potential in the analog-interface interval was unstable. The waveform at this time is shown in Fig. 8.

Specifications of the VoIP-GW installed on the customer’s premises stipulated various electrical conditions with respect to branch connections, so we checked whether the customer’s equipment setup conformed to those conditions. One of the conditions was that the value of DC resistance between L1-L2 was to be 1 MΩ or greater, but we found from measurements that the value was only 0.6 MΩ.

The countermeasure that we implemented to keep DC resistance between L1–L2 at 1 M Ω or greater and to prevent this fault from occurring was to install a switching device instead of branch connections and to apply a switching method to be used in the PBX and IVR equipment.

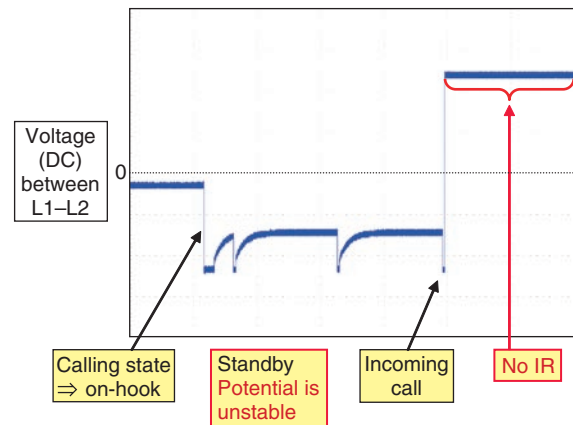
Fig. 8. Waveform at time of incoming call with no ringing sound.

would be unstable and that this fault would occur since the stipulated conditions for branch connections were not being observed.
