## Case Studies of Faults and Countermeasures in Access Telephone Office

This article reports on recent faults in optical access communication facilities that occurred in a telephone office. We review (1) a communication facilities problem caused by removal of a LAN (local area network) cable, (2) an accidental cable breakage that occurred while fixing cables on a distribution frame, and (3) a service interruption that occurred due to deterioration of an optical branch module used for testing optical lines. Cases (1) and (2) involved breakdowns that occurred during construction, whereas case (3) was an unforeseen breakdown related to long-term deterioration. We also present the appropriate countermeasures to these faults that were applied in order to maintain continuous operation of the communication facilities. This article is the thirtieth in a bimonthly series on practical field information on telecommunication technologies. This month's contribution is from the Access Engineering Group, Technical Assistance and Support Center, Maintenance and Service Operations Department, Network Business Headquarters, NTT EAST.

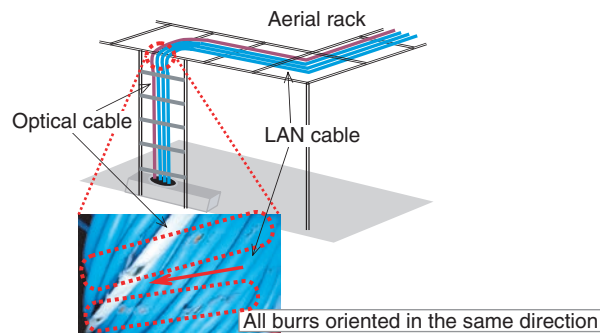
Multiple damage traces were discovered on the outer sheaths of optical cables and local area network (LAN) cables installed on an aerial rack. Although communication services had not yet been interrupted at the time of the discovery, the damage was extensive enough that the interior of the cables was exposed.

The fault location and the state of cable damage are shown in **Fig. 1**. The burred lines indicate the damage, and as shown, the burrs are all oriented in the same direction. In addition, each mark corresponds to an arc-shaped groove about equal in width to the diameter of the existing LAN cables. In light of the above, we inferred that the cause of the fault was an accident involving friction generated when removing

Fig. 1. Location of fault and cable damage.

In view of the experimental results presented above, we surmised that this fault was caused by friction generated on an optical cable or LAN cable while removing another LAN cable. We therefore considered that the use of a lubricant or anti-friction sheet at the point where the cables come in contact and gener-

ate friction would be an effective countermeasure to the friction that can accompany cable laying/removal work.

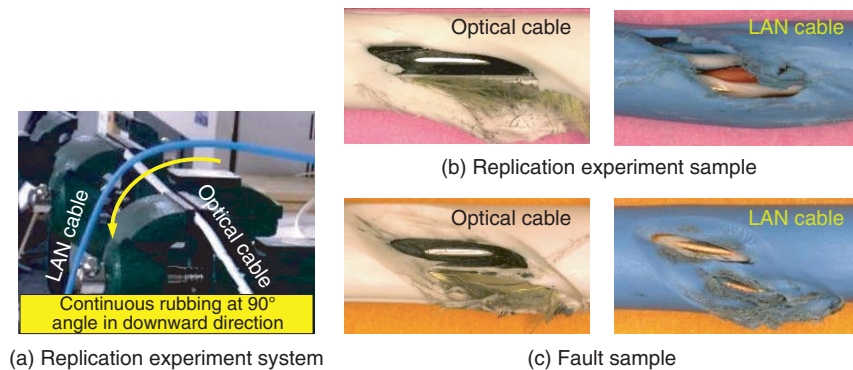
Fig. 2. Experiment to replicate cable damage.

LAN cables from the aerial rack. We therefore conducted a replication experiment in which we made two cables rub up against each other. Specifically, we prepared an optical cable and a LAN cable the same as those in use, and as shown in **Fig. 2(a)**, we pulled the LAN cable over the optical cable that was fixed in place in an attempt to simulate actual cable removal work. We found that a crack began to form on the outer sheath of the fixed cable after pulling the LAN cable about 2 m and that the tension member of the cable came to be exposed after pulling the cable 10–20 m (**Fig. 2(b)**). We confirmed that this damage was similar to that of the original fault (**Fig. 2(c)**). Similar results were obtained for a LAN cable (**Fig. 2(b)**).

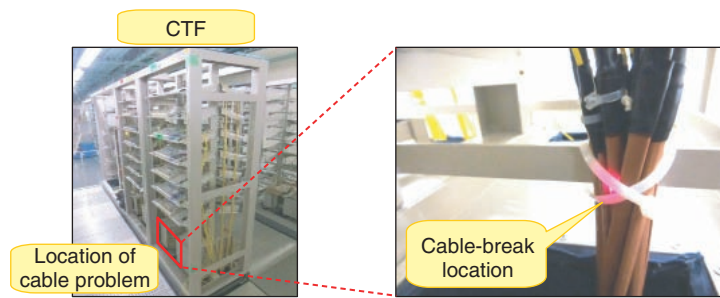
A deep cut was found in a double-core optical cable laid between a CTF and on-premise equipment near the point where the cable was bound with a binding strap to other cables at the lower end of the CTF (**Fig. 3**). No reasons as to why the cable should be damaged near the lower end of the CTF could be found, and there was no place where the fault location could have easily come into contact with the floor.

Fig. 3. Location of cable problem and image of cable damage.

applied at that time. We considered that the main cause of this accident was a working environment with tight spaces and blind spots. It is therefore important that maintenance personnel make a conscious effort to orient blade tips away from cables when using nippers. In addition, cutting the binding strap from the backside of a fixing location could also be an effective measure to prevent faults of this type.

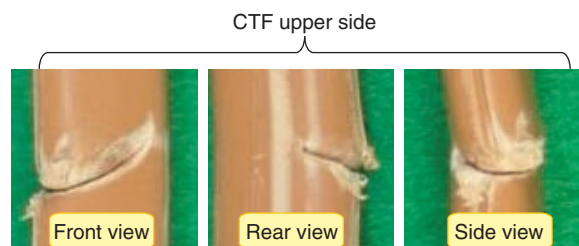
On dismantling the damaged cable and inspecting its interior, we found that constituent optical cords had been cut and that the tension-member covering

Fig. 4. Damage to outer sheath of optical cable.

was damaged (**Fig. 4**). Consequently, we suspected that the nippers and cable clippers frequently used in fixing and removing on-premise cables might be the problem, so we examined what form of damage such tools could cause. We found that the fracture caused by nippers resembled the actual fault more closely than that caused by cable clippers. The replication setup using nippers and the damage formed in this experimental reenactment are shown in **Fig. 5**. Through this experiment, we found that orienting the blade tips of the nippers toward the cables when cutting the X-shaped binding strap could damage a cable

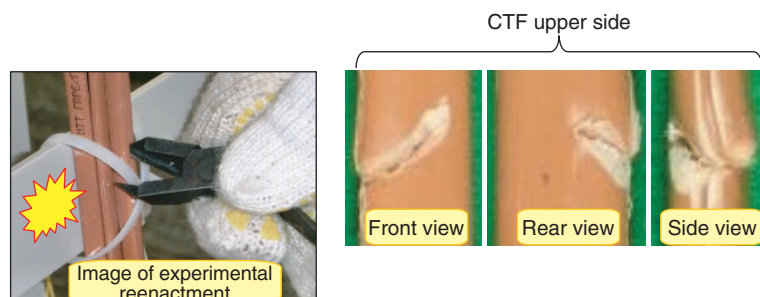
Fig. 5. Verification of reenactment results.

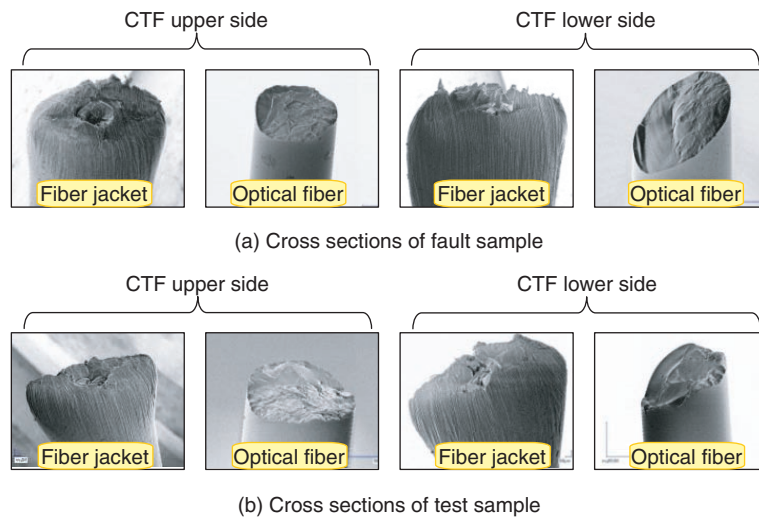
as deeply as its internal optical cords. Then, on examining the fiber cross sections at the damaged location using an electronic microscope, we found that they resembled those of the fault sample as shown in **Fig. 6**.

On the basis of our observations of the damaged cable and the results of the replication experiment, we surmised that the tips of the nippers had penetrated the cable's outer sheath when cutting the binding strap and had reached the optical-cord jacket, and that the optical fiber was sliced by the lateral pressure

Fig. 6. Comparison of fiber jacket and cross sections of optical fiber between fault sample and test sample.

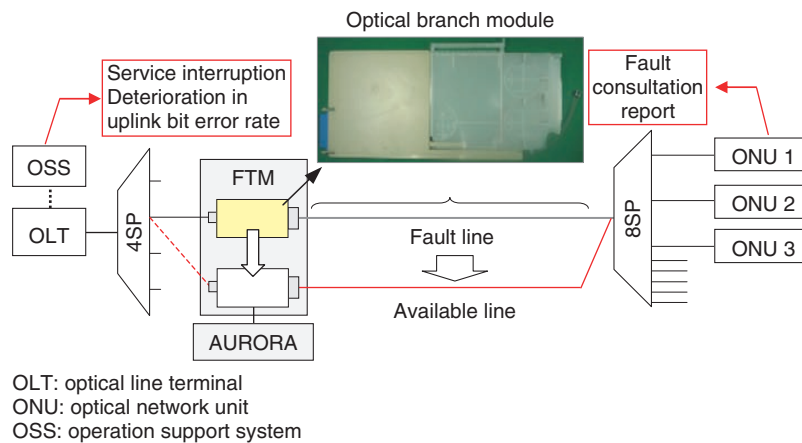
Fig. 7. Facility configuration and optical core switching.

A report of a service interruption was received from a customer using the FLET’S Hikari optical broadband service. On troubleshooting the fault, an increase in loss along the outside optical path that included an optical branch module was suspected, but the fault location could not be isolated. Although the location of the original fault had still not been clarified, it was eventually decided to switch the fault line reported as being faulty to a circuit on another optical branch module. This action effectively restored services to the customer (Fig. 7).

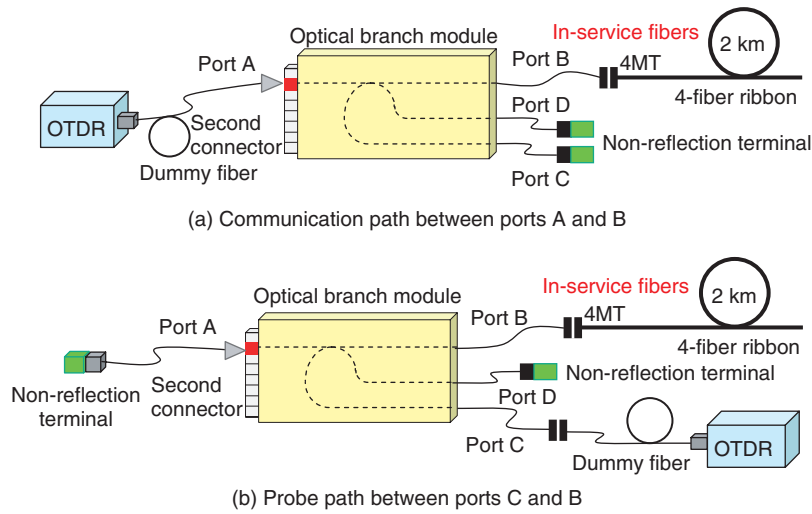
Fig. 8. Transmission loss measurement system.

Because the optical branch module targeted for inspection was accommodating other core fibers in use, we proceeded to inspect their current state in the fiber termination module (FTM) rack. First, on visually inspecting the module from the outside, we found no obvious problems in the rack or connector section. Next, we measured transmission loss between ports A-B related to the second connector cited in the fault report and also between ports C-B using an optical time-domain reflectometer (OTDR), as shown in Fig. 8. Transmission loss at the second connector of the faulty module and that of a normal

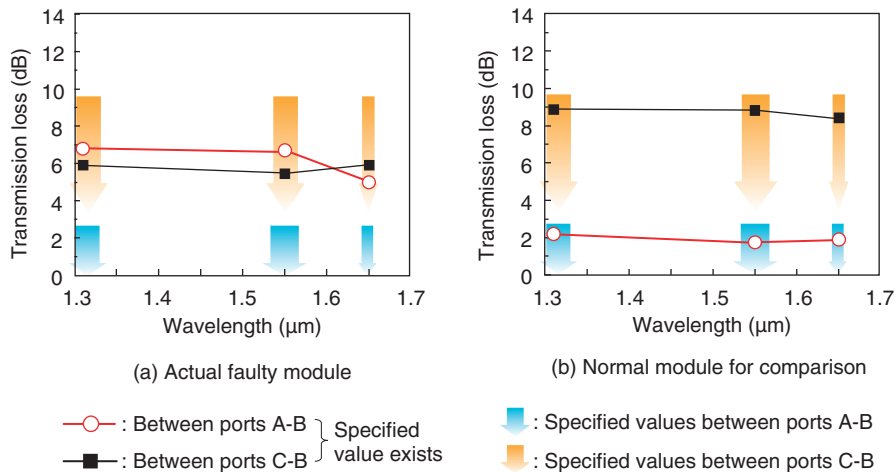
Fig. 9. Measurement results.

one as reference are shown in Fig. 9. The transmission loss of the faulty module satisfied the specified values at standard wavelengths (1.31, 1.55, and 1.65 μm) between ports C-B but greatly exceeded the specified values between ports A-B. Furthermore, in comparison with the normal product examined in Fig. 9(b), it was found that the difference in transmission loss between port-interval A-B and port-interval C-B in the faulty module was smaller.

The on-premise optical branch module uses a wavelength-independent optical coupler that has an optical transmission loss difference of about 6 dB

between port-intervals A-B and C-B, as shown in Fig. 9(b). However, this difference is only about 1 dB in the faulty module, as shown in Fig. 9(a), so we assumed that a fault exists for some reason at the second connector of the module. We were not able to isolate the fault in this optical branch module through fault maintenance work at the site during this investigation. We are therefore recommending that an OTDR test connecting a dummy fiber to port A of the optical branch module be conducted the next time a similar event occurs. In this way, we should be able to clarify the transmission loss between ports A-B from the difference in levels of backscattering light from the dummy fiber and outside path. This difference could then be used as a criterion for assessing problems in the module.
