A Case Study of a Problem that Occurred in Downstream Device of VoIP Gateway

This article describes a problem that occurred in a VoIP (voice over Internet protocol) gateway and the actions taken to rectify it. This is the thirty-first article in a bimonthly series on practical field information on telecommunication technologies. This month's contribution is from the Network Interface Engineering Group, Technical Assistance and Support Center, Maintenance and Service Operations Department, Network Business Headquarters, NTT EAST.

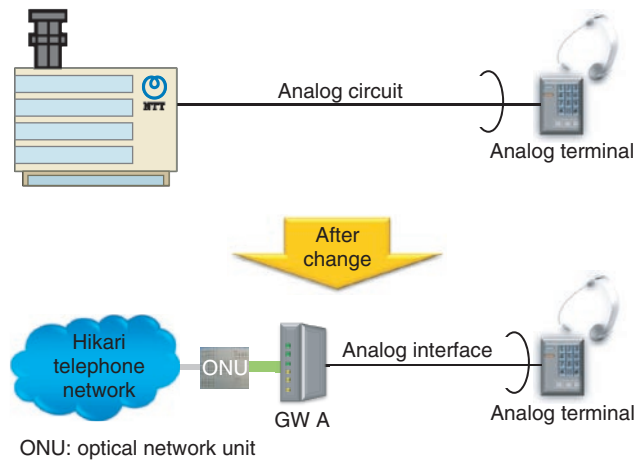
Fig. 1. Facility configuration.

phone system (Hikari telephone system) reported events in which a terminal connected to the GW could not make an outgoing call. Specifically, if an outgoing call to a telephone number that included the numbers 1, 2, 3, or 6 was attempted on the push-button panel, a busy tone would be heard after a certain amount of time after dialing, and no connection would be made. The customer informed us that they had not had any problems with their terminals before changing to the Hikari telephone system.

An attempt was made to solve this problem by replacing GW A with equipment of the same model, but the problem persisted. However, when GW A was replaced with GW B, the problem went away. We therefore performed a series of tests to determine why calls could not be made with GW A but could be made with GW B (**Fig. 1**).

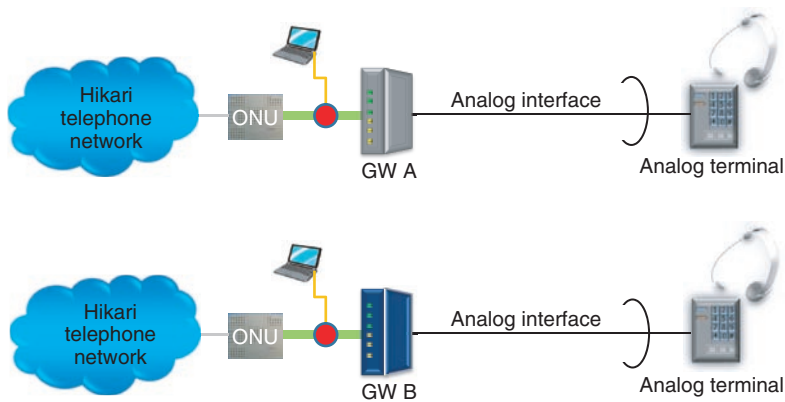
Fig. 2. Test configuration.

We conducted a call-originating experiment connecting the analog terminal to GW A and GW B (Fig. 2) and performed the following actions.

- 1) The communication logs (internal logs of GWs A and B) were collected and recorded during the experiment.
- 2) Information on the state of communication at the time of the experiment was collected through packet capture (red dot in figure denotes the capture point).

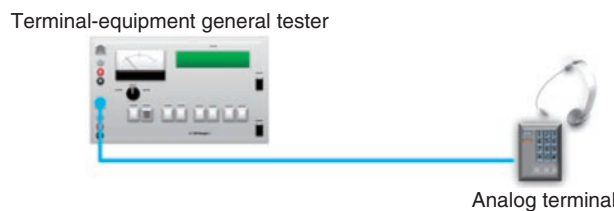
Fig. 5. Testing equipment used to conduct measurements based on Ordinance Concerning Terminal Facilities.

In this test, we conducted measurements using a terminal-equipment general tester to determine whether the terminal satisfied the following technical standards specified by the Ordinance Concerning Terminal Facilities (Fig. 5).

high-frequency level of the analog terminal—was found to be greater than 5 dB when pushing the 1, 2, 3, 5, 6, and 9 push buttons, which did not satisfy the standard value (Fig. 6).

- 2) The DC resistance value for a loop current of 20 mA in the analog terminal was found to exceed 300 Ω, which did not satisfy requirements (Fig. 7).

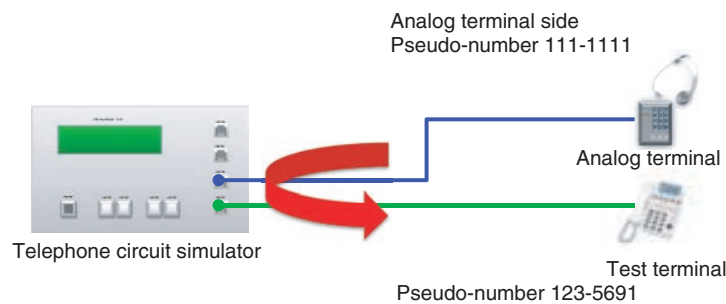
Fig. 8. Test configuration.

We changed the facilities connecting to the upstream of the analog terminal and performed a call-originating test using a telephone circuit simulator that simulated an analog circuit (Fig. 8).

Test method: Call the pseudo-number 123-5691 that combines the numbers 1, 2, 3, 5, 6, and 9 that were found to be outside the standard from the results

No events as in the case of GW A were observed when changing the facilities connecting to the upstream of the analog terminal and making a call in this test.
