Case Studies of Failures and Countermeasures in Access Network Facilities

This article describes case studies of failures and countermeasures in access network facilities. This is the thirty-third article in a bimonthly series on practical field information on telecommunication technologies. This month's contribution is from the Access Engineering Group, Technical Assistance and Support Center, Maintenance and Service Operations Department, Network Business Headquarters, NTT EAST.

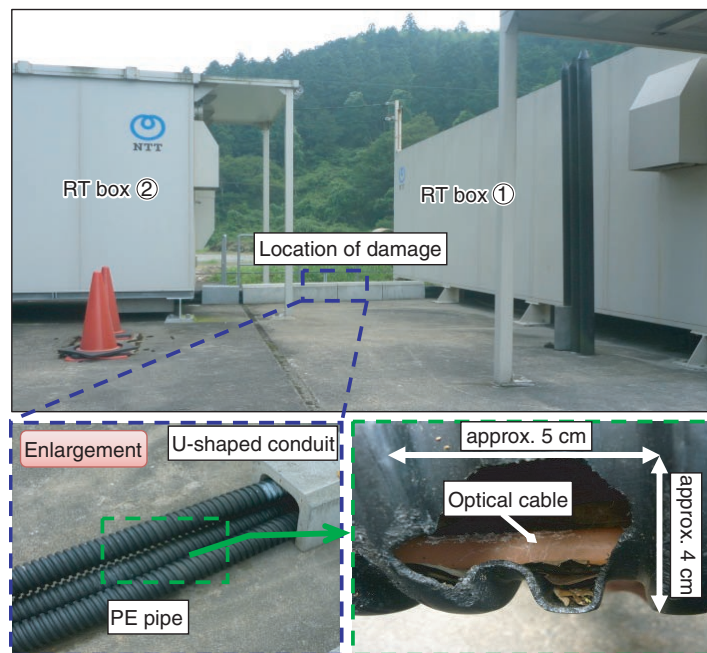
Fig. 2. Location of damage.

The optical cable between the RT boxes was drawn inside hard polyethylene (PE) pipe covered by a concrete U-shaped conduit. In this case, a 5×4 cm hole was discovered in one of three PE pipes within which tree leaves were scattered about (Fig. 2). A digital microscope was used to observe the optical cable and the PE pipe at the damaged location. This observation revealed incisor teeth marks (two upper teeth 0.7 mm in width and two lower teeth 0.6 mm in width) thought to be those of rodents. The widths of the teeth led us to infer that the damage-inflicting wildlife was a small rodent such as a house mouse (Fig. 3).

As a countermeasure to damage caused by wildlife, it is important that facilities that require protection not be exposed. In this case study, it is thought that an animal penetrated the U-shaped conduit and gnawed

on the cable in the process of building a nest inside the PE pipe. We therefore recommend that the entrance to a U-shaped conduit or any other location of penetration be sealed off and that any locations where wildlife-related damage has occurred in the past be periodically inspected.

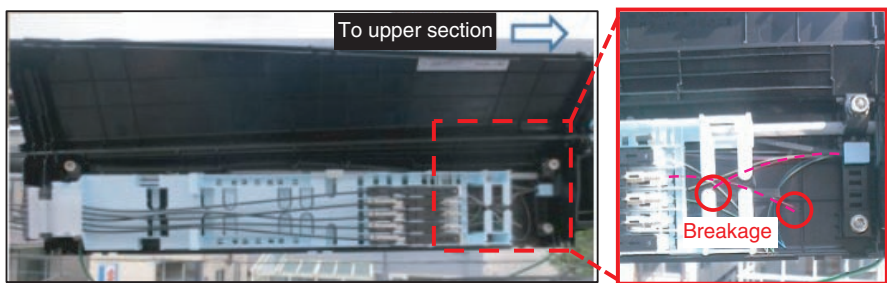
Fig. 4. Breakage locations.

Breakage of an optical fiber occurred in two optical fiber cables within an optical drop closure at the bottom of an outdoor 8-branch splitter. An inspection performed by the local maintenance department revealed that the two failures occurred at the same time according to the monitoring-system log and that core fibers suffered breakages 8–10 cm from splice-on connectors within the closure (Figs. 4 and 5).

achieved using existing work procedures, it was possible to reproduce the shape of the fractured fibers in this case study when using procedures outside of installation standards. In an optical drop closure with splice-on connectors, the excess cutoff length of fiber cores (cutting position) is predetermined, but if the cutoff position is longer than that predetermined length, it is known that the surplus length of the fiber core may protrude from the closure when being stowed and end up being crammed in by the closure lid. The fracture of a crammed-in optical fiber is diagonally shaped, and since that was similar to the received fractured sample, it was concluded that the type of fracture in this case study was caused by an external force such as cramming applied to a core fiber that had been cut off at the wrong position.

Optical fibers are vulnerable to scratches, cuts, and bends, so they should be handled with the utmost

care. We recommend that stipulated surplus lengths be observed when assembling a connector and that sufficient caution be taken to prevent fibers from getting crammed in when opening or closing the optical closure.

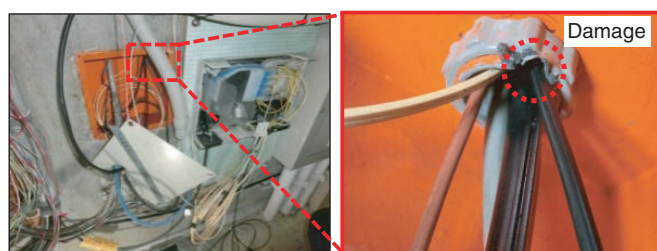
Fig. 6. On-site conditions (MDF room).

The pipe opening through which optical cables pass in the MDF room was installed in the downward direction at a height about 60 cm from the floor, and it was found that a portion of the edge of the pipe opening had been chipped away (with a width of about 10 mm), as shown in **Fig. 6**. In addition, the damaged optical cable suffered a breakage near the pipe opening. This breakage took the form of groove-shaped damage with a maximum width of 3.7 mm that occurred at an angle to the longitudinal direction of the cable.

between the edge of the pipe opening and the threading wire generated friction that eventually damaged the pipe opening.

- 2) Then, when performing threading again in a state in which an existing optical cable was stuck in place within the damaged edge of the pipe opening, the optical cable and the threading wire rubbed against each other, thereby damaging the optical cable.

It is important that care be taken so as not to damage existing facilities during work operations. For the type of failure presented in this case study, we recommend that field personnel use threading wire carefully so as not to damage pipe openings and that they

pay attention to the state of existing cable.

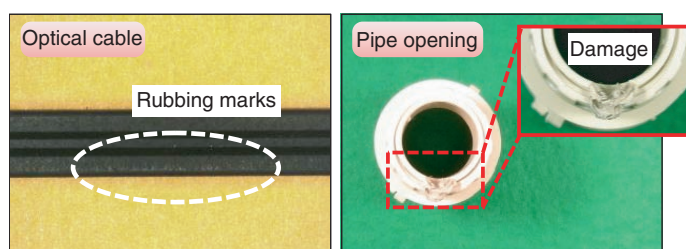
Reproducibility experiment (1)

We conducted reproducibility experiments to isolate the cause of this breakage. First, we inserted 15 m of a threading wire (6.5 mm in diameter) into a pipe in which multiple optical cables already existed and pulled it out while in contact with the pipe opening, repeating this process three times. In each case, only rubbing marks appeared on the outer sheath of the existing optical cables, but it was found that the edge of the pipe opening was damaged in the form of groove-shaped chipping similar to the damage in the on-site pipe (**Fig. 7 (1)**). We then conducted another experiment, this time by fitting existing optical cable into the groove-shaped damaged section of the pipe opening and again inserting and pulling out a threading wire three times. For two of the three times, we found that we were able to reproduce the state in which the outer sheath of the existing optical cable was scraped away to expose the optical fiber (**Fig. 7 (2)**).
