Recent Case Study of Fault in IP Phone User System

Abstract

This article describes a problem a customer was having with disconnects in inter-office calling using IP-VPN (Internet protocol virtual private network) services and how we rectified it. This is the thirty-sixth article in a series on telecommunication technologies. This month's contribution is from the Network Interface Engineering Group, Technical Assistance and Support Center, Maintenance and Service Operations Department, Network Business Headquarters, NTT EAST.

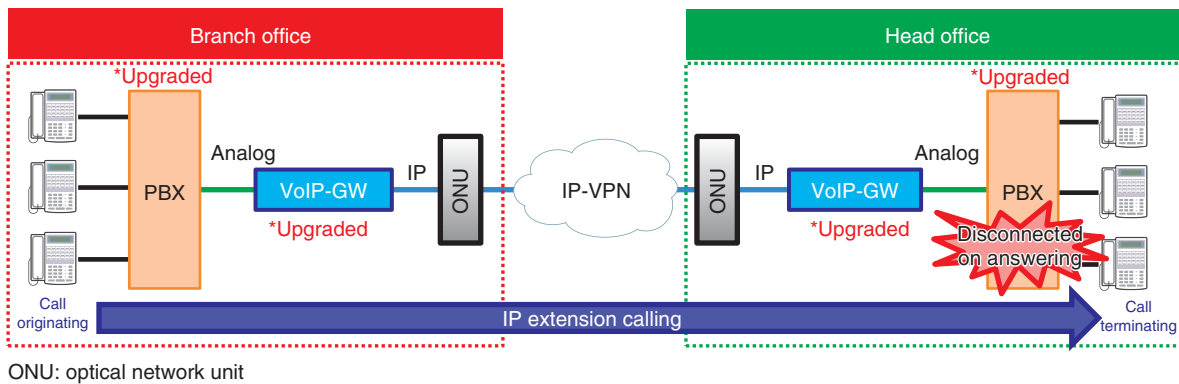
Fig. 1. Example of event occurrence.

The customer who experienced the problem has been using an IP-VPN service to make voice calls between the head office and branch offices by private branch exchange (PBX)-based IP extension calling. When both the voice-over-IP gateway (VoIP-GW) and PBX installed in the head office and branch offices were upgraded, a problem would occasionally occur in which an IP extension incoming call would disconnect on being answered, thereby terminating

the call (**Fig. 1**). This event was not restricted to specific offices—it would occur at any office that used IP extension calling. Replacing the entire VoIP-GW or PBX package substrates did not solve the problem, so the Technical Assistance and Support Center was consulted to troubleshoot the problem.

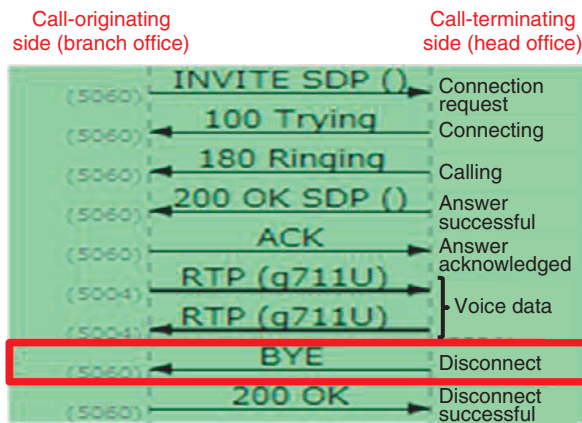
Fig. 3. Call control sequence at time of event.

The following results were obtained from this analysis. (1) Packet capture data revealed that the head-office VoIP-GW on the call-terminating side transmitted a BYE disconnect signal to the call-originating side (**Fig. 3**). (2) A *putt-putt* sound was output from the head-office VoIP-GW at the time of the disconnect, coinciding with the regeneration of voice data as indicated in packet capture data. (3) A survey of PBX logs over a period of about one month revealed that a disconnection (incomplete call) occurring within two seconds of answering an incoming call occurred 65 times on multiple phone sets. It was therefore concluded that the event was not caused by a defect in a phone set or by the intentional termination

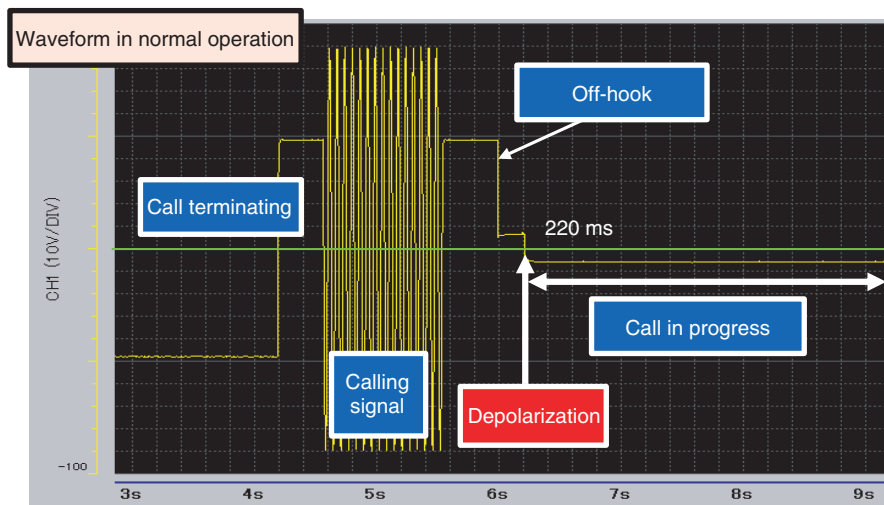
Fig. 5. Voltage between L1-L2 lines in normal connection.

Consequently, in reproducibility testing using the PBX, the technicians examined the voltage waveform between the layer 1 and 2 (L1–L2) lines during normal answering of an incoming call and the voltage waveform between the L1–L2 lines when a call was disconnected immediately after answering. First, for a normal connection, the VoIP-GW transmits a calling signal to the PBX on terminating the incoming call, and the PBX-connected phone goes off-hook. At this time, the polarity between L1–L2 is depolarized, and the call progresses (Fig. 5).

Additionally, on examining these waveforms in detail, it was apparent that the time from off-hook to depolarization was 50–575 ms when connecting normally, but 606–640 ms whenever the event occurred.

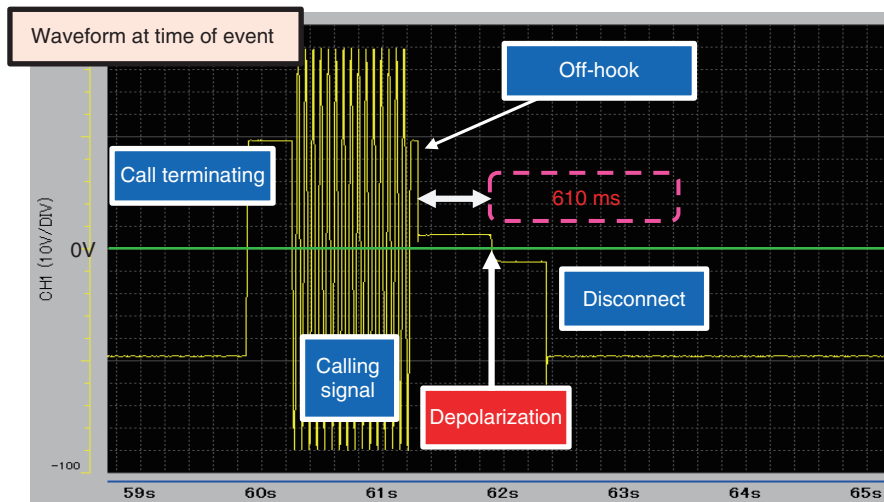
Fig. 6. Voltage between L1-L2 lines at time of event.

However, at the time of the event occurrence, the L1–L2 loop state cannot be maintained after depolarization of L1–L2 polarity when the PBX-connected phone goes off-hook, and as a result, the circuit is released (disconnected), and the call is terminated (Fig. 6).

The above reproducibility test therefore showed that this event in which an incoming call failed to connect would occur whenever the time from off-hook to depolarization was 606–640 ms. In view of this fact, the settings related to the analog connection between the VoIP-GW and PBX were examined. It was found that the period for detecting the closing of the VoIP-GW TEL port (analog telephone port) circuit due to a terminal off-hook operation was set to 640 ms as a default value in the VoIP-GW. Meanwhile, on the PBX side, the guard time setting turned out to be 600 ms as a default value. This setting serves to prevent an unstable waveform generated at

From these results, it was confirmed that changing any of the following settings in the VoIP-GW or PBX could avoid the problem of an incoming call being disconnected.

- (1) In the VoIP-GW, change the default value of the period for detecting closing of the TEL port circuit from 640 ms to 560 ms.
- (2) In the PBX, change the default value of the guard timer for preventing an unstable waveform from being falsely recognized as on-

hook from 600 ms to 650 ms.

- (3) Change the PBX on-hook signal detection method from its default value of *polarity detection* or *BT detection* to *BT detection* so that depolarization after the call is off-hook is not treated as if it were on-hook.

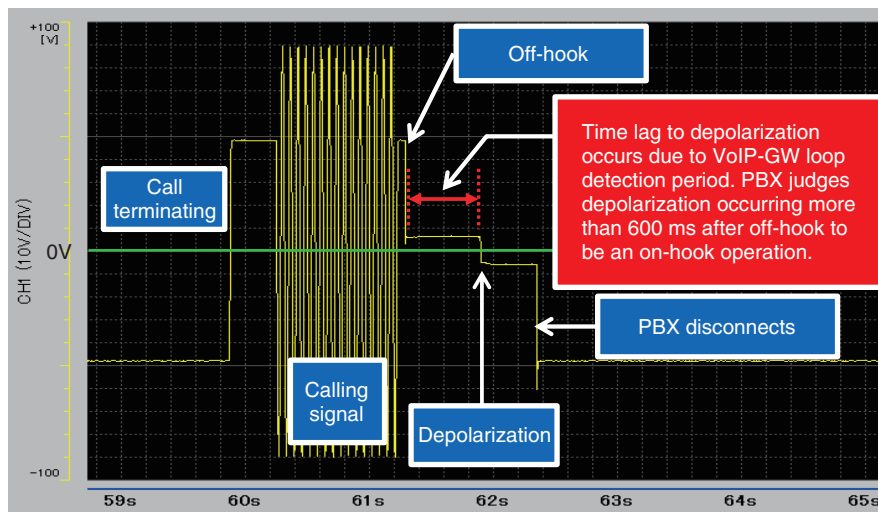
Fig. 7. Operation in customer's equipment at time of event.

The VoIP-GW used by the customer in this case study had a period of 640 ms for detecting the closing of the TEL port circuit due to a terminal off-hook operation. Thus, depending on the timing of this off-hook operation, a maximum time lag of 640 ms from VoIP-GW detection of the off-hook state to L1-L2 depolarization might occur. In the PBX, meanwhile, a time of 600–640 ms from off-hook to L1-L2 depolarization would exceed the guard timer (600 ms), which is used to prevent an unstable waveform at the

time of depolarization from being falsely recognized as an on-hook operation. In such a case, it appears that the PBX would erroneously judge that an on-hook operation had occurred and would disconnect the circuit as a result (Fig. 7).

with the customer and recommended that the setting for the PBX on-hook signal detection method be changed (item (3) above). This effectively eliminated the event in which an incoming IP extension call was disconnected upon answering.
