Fax Transmission Failure Analysis Method Requiring Multi-signal Analysis

This article describes a problem a customer had involving facsimile transmission failure and how it was resolved through analysis of multiple signals. This is the thirty-eighth article in a series on telecommunication technologies. This contribution is from the Network Interface Engineering Group, Technical Assistance and Support Center, Maintenance and Service Operations Department, Network Business Headquarters, NTT EAST.

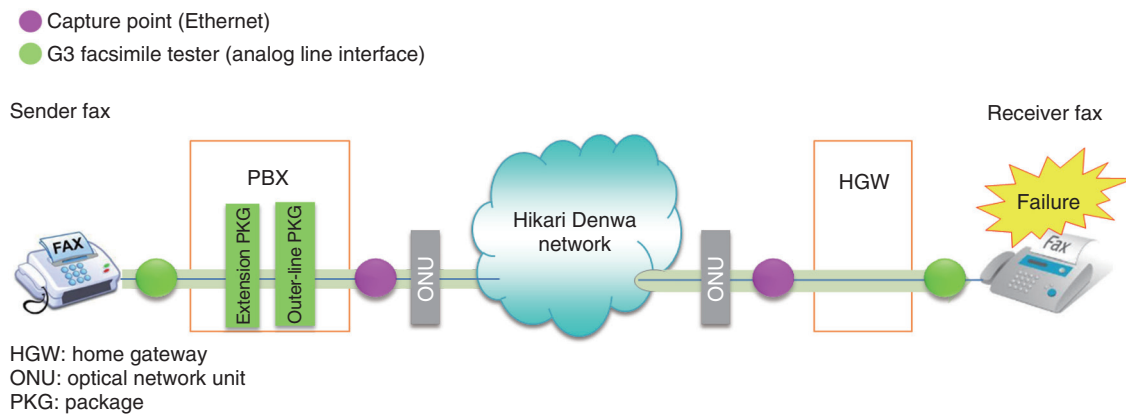
Fig. 1. Connection configuration and data-collection points.

To collect data at the time of failure occurrence, we installed packet capture equipment in the Ethernet interval and a G3 facsimile tester in the analog line interface and proceeded to collect and analyze IP packets and fax signals (**Fig. 1**).

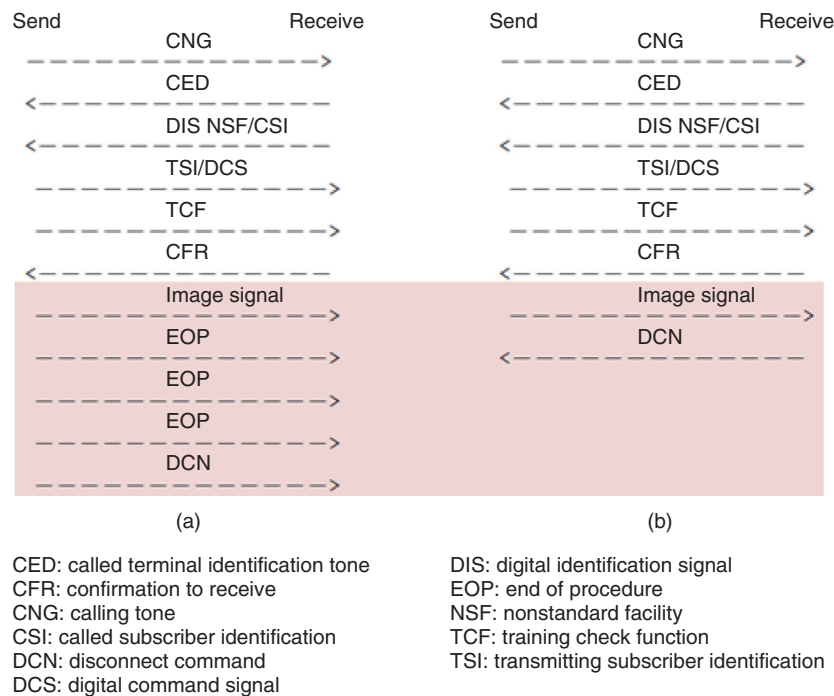
Fig. 2. (a) Sender fax communication sequence; (b) receiver fax communication sequence.

The sender fax sends an EOP (end of procedure) signal after sending the image signal. However, as no MCF (message confirmation) signal is received from the receiver fax, the sender fax sends a DCN (disconnect command) signal and disconnects the communi-

cation (Fig. 2(a)).

After receiving the image signal, the receiver fax sends a DCN signal before receiving an EOP signal from the sender side and disconnects the communication (Fig. 2(b)).

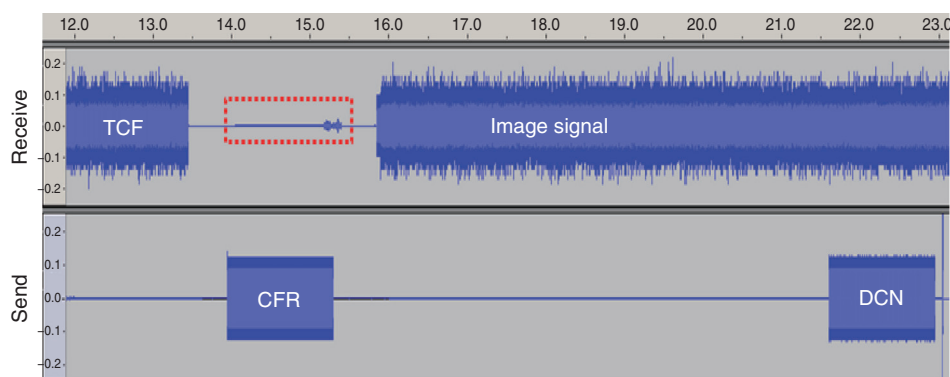
Fig. 3. Results of analyzing audio file using Audacity.

We extracted RTP packets from captured Ethernet data on the receive side at the time of failure and analyzed the audio files saved for each call made and received using Audacity^{*1} software. In our analysis, we found a particular signal that could not be recognized by the G3 facsimile tester (**Fig. 3**, red-framed box).

This signal differed from the TCF (training check function) signal and image signal transmitted by the sender fax, while it had the same signal transmit time and signal frequency as the CFR (confirmation to receive) signal transmitted by the receiver fax (**Table 1**, red-framed box).

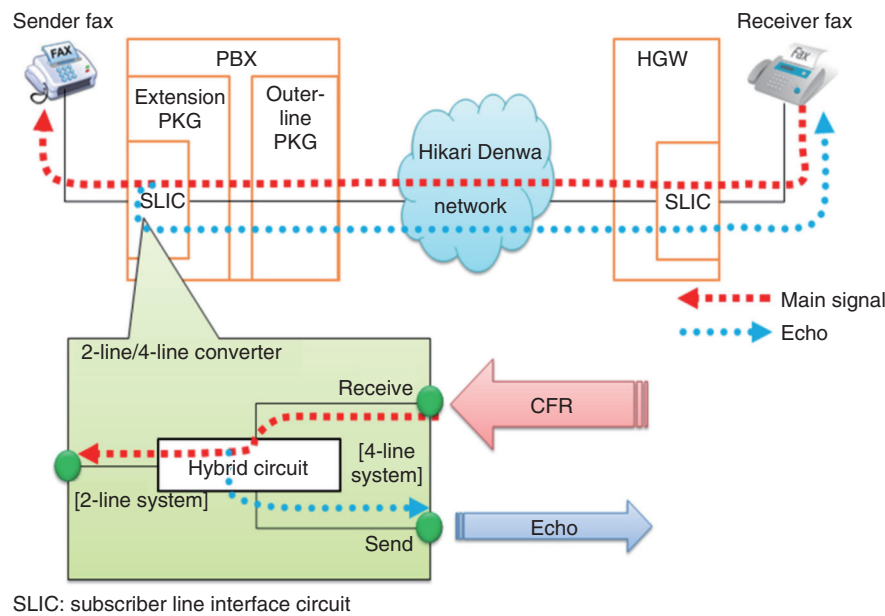
Fig. 4. Echo generation at 2-line/4-line converter.

The above results suggest that this signal was an echo^{*2} of the CFR signal transmitted by the receiver fax and that it originated in the extension package of the PBX equipment on the sender side (2-line/4-line converter), as shown in **Fig. 4**.

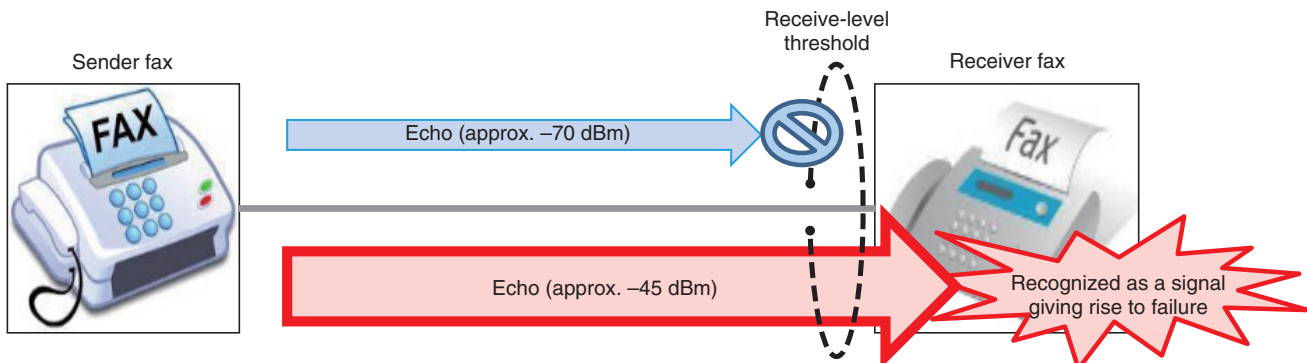
Fig. 5. Threshold of receive level.

It was thought that a CFR echo of approximately -45 dBm or greater generated in the extension package of the PBX equipment (2-line/4-line converter) would exceed the receive-level threshold of the

receiver fax. This echo would consequently be erroneously recognized as a signal from the sender fax, causing this failure to occur. The signal level of the CFR echo during normal operation was approximately -70 dBm (**Fig. 5**).

We considered that the receive-level threshold of the receiver fax could be raised so that the echo would not exceed that threshold, or that the transmit level of the receiver fax could be lowered so as to reduce the echo and prevent it from being recognized as a valid

However, because the receiver fax was a model for which the receive-level threshold could not be changed, we lowered the transmit level in 1-dB increments and found that lowering it by 2 dB was enough to prevent the reoccurrence of this event. We considered that this was because the echo would no longer exceed the receive-level threshold of the receiver fax at that transmit level, thereby preventing the echo from being mistakenly recognized as a signal from the sender fax.
