## Failure Analysis of Internet Protocol Terminal Equipment

This article describes a fault that occurred in the transmission of voice signals in a customer's Internet protocol telecommunication system and the analysis carried out to identify the problem. This is the forty-second article in a series on telecommunication technologies. This contribution is from the Network Interface Engineering Group, Technical Assistance and Support Center, Maintenance and Service Operations Department, Network Business Headquarters, NTT EAST.

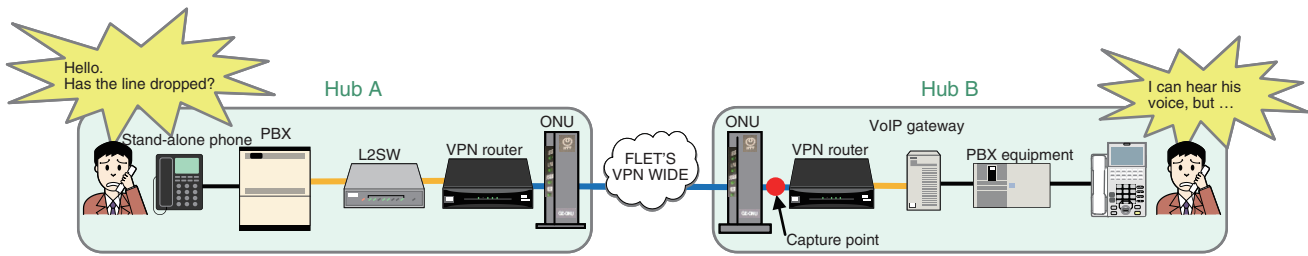
Fig. 1. Connection configuration and data collection point.

The customer had installed a PBX in hub A and a VoIP gateway in hub B and was making extension calls between these hubs via the FLET'S VPN WIDE virtual private network service. In this configuration, a one-way-voice problem was periodically occurring in extension calls between these two hubs.

To collect and analyze data at the time of problem occurrence, we captured packets in the Ethernet section at the point marked with "●" in **Fig. 1**.

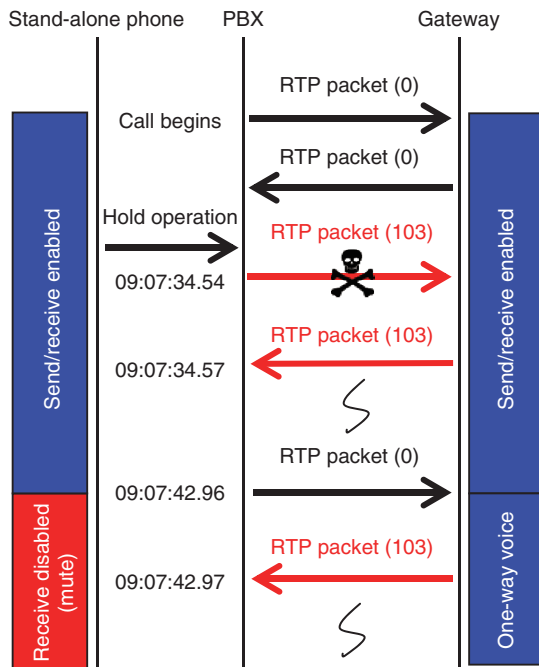
Fig. 2. Results of RTP packet analysis.

The results of analyzing Real-time Transport Protocol (RTP) packets at the time of problem occurrence are shown in **Fig. 2**.

The analysis of captured data revealed that the payload type (PT)<sup>\*1</sup> of RTP packets suddenly switched to “103” (Dynamic RTP-103) at the time of problem occurrence.

The customer’s system applies PT “0” indicating G.711PCMU—a pulse code modulation standard for voice communications—to voice calls, but at the time of problem occurrence in a certain voice call, the PT of RTP packets in both directions suddenly switched to “103” beginning at 9:07:34. Later, however, the PT of RTP packets only in the direction from hub A to the

VoIP gateway returned to “0,” at which time the one-way-voice problem occurred.

Countermeasure 1: Set the PBX so as not to switch to PT “103” used for fax communications.

Of these countermeasures, we considered that countermeasure 1 would be the least burdensome for the customer and therefore implemented it to check its effectiveness. We did this by connecting the stand-alone phone actually used by the customer to a test PBX and noted that no one-way-voice problem occurred when transmitting the above hold tone during a call. On the basis of this result, we were able to

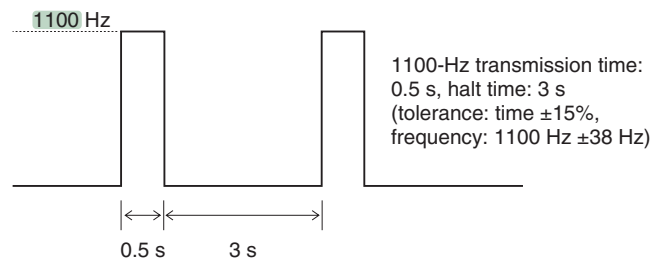
Fig. 3. Format of CNG signal.

We decoded the captured data collected in the Ethernet section into analog audio and analyzed the result using open source audio analysis software (WaveSurfer). We found that a frequency component of 1100 Hz, namely, a calling (CNG) signal (Fig. 3) used in fax communications, appeared in the audio signal directly before the problem occurred (Fig. 4).

This frequency component was included in the hold tone (tune: “Let It Be”) output by the extension telephone (stand-alone phone) accommodated by the PBX. An actual CNG signal is specified as the transmission of a 1100-Hz tone for a period of 0.5 s ±15% (0.425–0.575 s), but the analyzed audio included the transmission of a 1100-Hz tone for a period of 0.7 s, which was outside the CNG specified value. Nevertheless, we still considered the possibility that the PBX erroneously recognized the audio signal as a fax CNG signal and switched the PT to “103” accordingly, so we continued with our analysis.

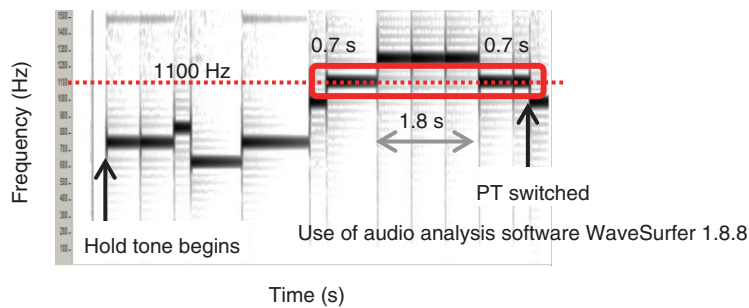
Fig. 4. Results of analyzing audio components.

The one-way-voice problem described in this report occurred for the following reason. On observing the transmission of an 1100-Hz audio component for 0.7 s closely resembling the CNG signal used in fax communications within the audio of the customer’s extension call, the PBX erroneously recognized that frequency component as a CNG signal and switched the PT of the RTP packets to “103” used in fax communications.

Countermeasure 2: Change the source of the hold tone.

This problem was solved by setting the PBX so that it would not switch the PT to “103” for fax communications.
