Case Studies of Problems in Digital Cordless Phones

This article describes various faults that were occurring with digital cordless phones and the investigations and countermeasures implemented to solve the problems. This is the forty-third article in a series on telecommunication technologies. This contribution is from the EMC Engineering Group, Technical Assistance and Support Center, Maintenance and Service Operations Department, Network Business Headquarters, NTT EAST.

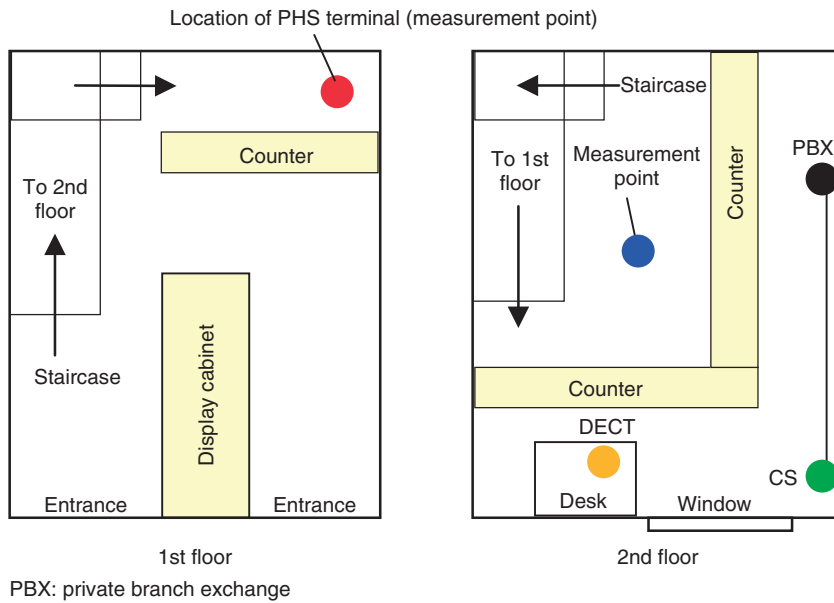
Fig. 1. Equipment configuration (customer's store).

A customer using digital cordless phones (PHS: 1.9-GHz band) connected to NTT's α NX II business phone system reported a problem in which calls could not be made or received within the customer's retail store (behind the counter on the first floor: see **Fig. 1**). In this configuration, one cell station (CS) is located near the window on the second floor, and two PHS terminals are in use. Replacing the terminals did not solve the problem.

The results of the above measurements led us to infer that this problem occurred because the PHS terminals were being used at a location that was too far away from where the CS was installed, resulting in insufficient signal strength at the terminal usage location.

We received the customer's consent to add a CS near the location where the PHS terminals were being used (near the first floor counter). We found that stable communications could be achieved with the signal strength of -65 dBm at the terminal usage location.

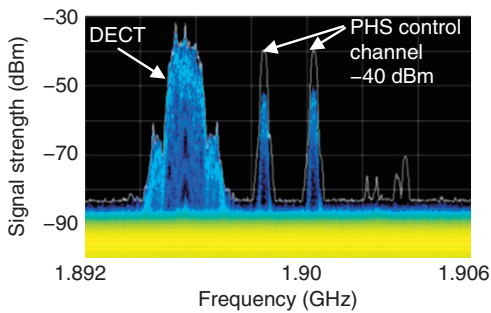
(a) 2nd floor

A spectrum analyzer (Keysight Technologies N9020A) was used to measure the signal strength at the center of the store on the second floor and behind the counter on the first floor. The CS is located near the center of the store on the second floor, so we were able to observe signals that had sufficient strength (-40 dBm) at that measurement point (**Fig. 2(a)**).

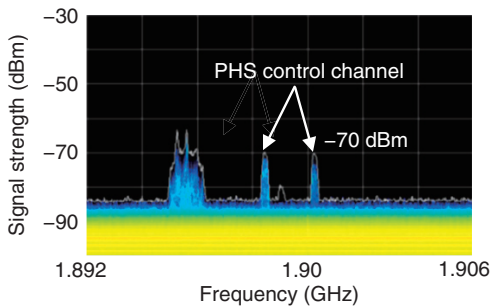
(b) Behind 1st floor counter

DECT signals were also observed in addition to PHS signals. At the measurement point behind the counter on the first floor, the signal strength from the

CS installed on the second floor was found to have dropped to as low as -70 dBm (Fig. 2(b)).

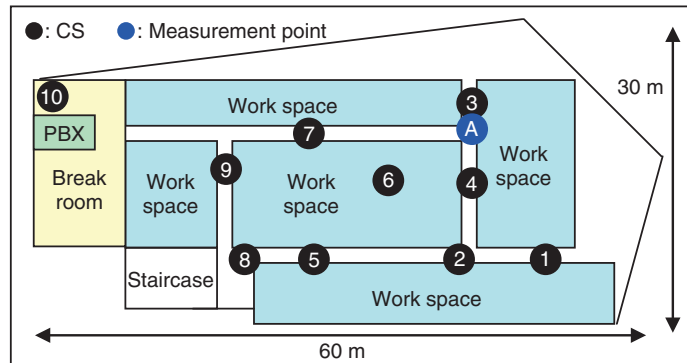
Fig. 3. Floor diagram.

by the PBX. A total of 10 CSs were installed throughout the floor, and 109 PHS terminals were being used (Fig. 3). Replacing terminals failed to solve the problem.

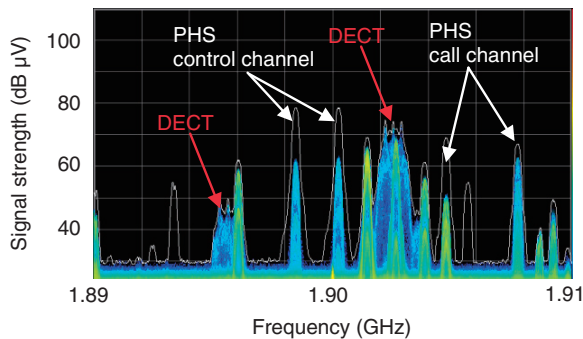
Fig. 4. Radio signal environment (measurement point A).

We used a spectrum analyzer (Keysight Technologies N9020A) to measure the radio signal environment in the PHS band below CS 3 (see Fig. 3). In this measurement, DECT signals could be observed in addition to PHS control-channel and call-channel signals (Fig. 4).

The results revealed that the DECT and PHS signals were interfering with each other. This led us to infer that the cause of noise in the phones was this interference between DECT and PHS signals. Although PHS and DECT have functions for mutually avoiding interference, it can be inferred that a high channel utilization rate may leave no empty channel available for interference avoidance, resulting in the occurrence of interference and dropped

To prevent this phone noise from occurring, we recommended to the customer that no DECT terminal be used or alternatively that the DECT terminal be exchanged with a terminal using frequency bands other than the 1.9-GHz band (2.4-GHz digital cordless phones, 5-GHz Wi-Fi devices, etc.).

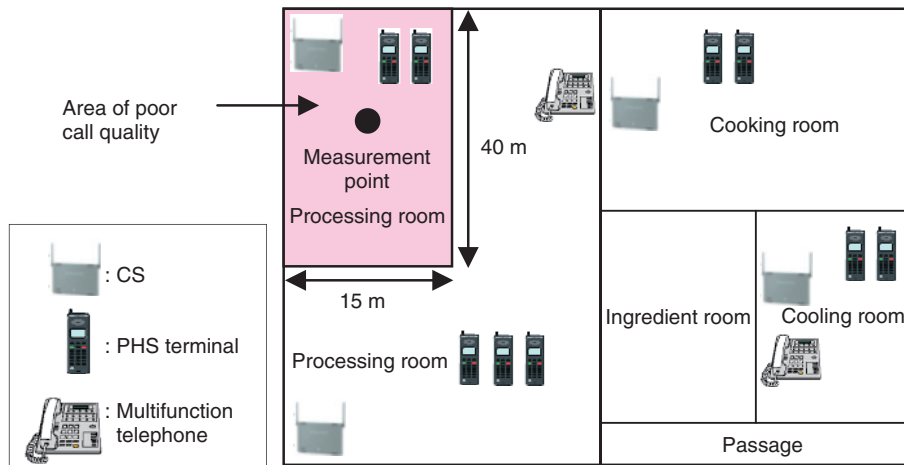
Fig. 5. Equipment configuration (2nd floor of plant); PBX is installed in main distribution frame room (MDF) on third floor.

Dropped calls and line disconnections were occurring in digital cordless phones (PHS: 1.9-GHz band) accommodated by NTT’s αNX II-L business phone system. The customer reported that such problems occurred frequently in the processing room of the food plant depicted in Fig. 5. Measures such as replacing terminals or adjusting signal power failed to solve the problem.

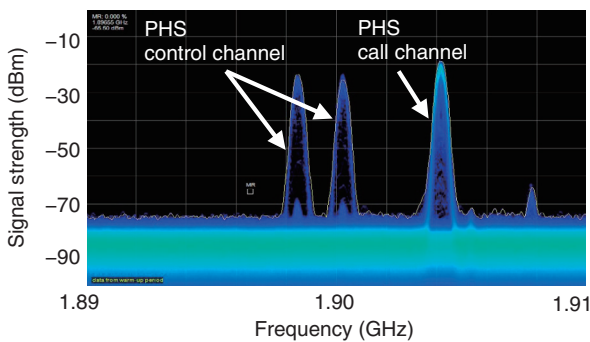
Fig. 6. Results of measuring signal strength.

We used a spectrum analyzer (Tektronix RSA6114A) to measure the radio signal environment at the measurement point within the processing room (see Fig. 5). The PHS signal strength was found to be sufficiently strong, and no interfering signals were observed (Fig. 6).

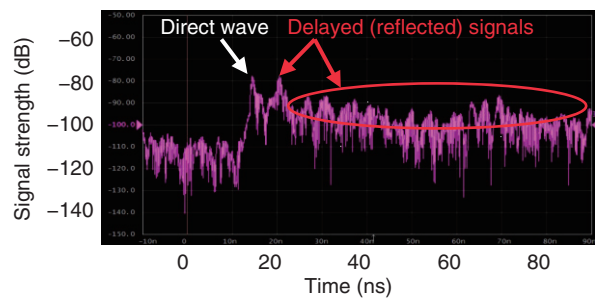
Fig. 7. Results of measuring reflected signals (at time of a dropped call).

and machinery made of stainless steel and other types of metal, so we considered that reflected signals might have an effect on call quality. We measured such reflected signals with a network analyzer (Keysight Technologies E5071C) and observed the delay (reflected) signals of nearly the same strength as direct waves and long-delay (reflected) signals of 80 ns or longer (Fig. 7). When compared with a location enabling normal communications (Fig. 8), the above results revealed the existence of a multipath.

The results led us to infer that dropped calls in the processing room were caused by reflected signals.

for radio signals. We explained to the customer that such an environment made the use of digital cordless phones difficult and proposed the use of fixed-line phones. To prevent future problems, we recommended

that call tests be performed before introducing a new service to see whether dropped calls or other problems might occur.
