Case Study of Problem in Multifunction Telephones Connected to a Business Phone System

Technical Assistance and Support Center, NTT EAST

This article describes a non-activation problem that was occurring in customer's multifunction telephones connected to a business telephone system and the investigation that was carried out to determine the cause. This is the forty-seventh article in a series on telecommunication technologies.

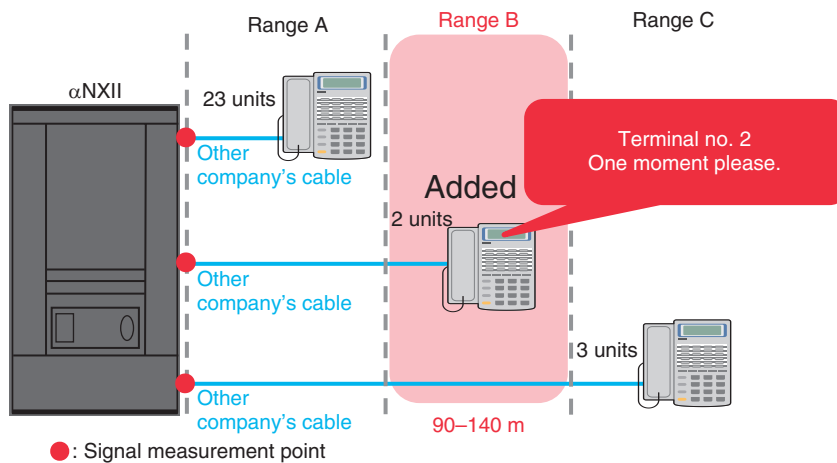
Fig. 1. Equipment configuration (customer's premises).

The equipment configuration is illustrated in **Fig. 1**. As shown, multifunction telephones are connected to NTT's αNXII business phone system, with 23 phones connected in range A, 2 in range B, and 3 in range C. A star wiring scheme is used to connect all of these multifunction telephones using existing cables manufactured by another company.

The 23 multifunction telephones in range A and the 3 in range C were all determined to be operating normally. However, it was found that the 2 multifunction telephones in range B were displaying the message

"One moment please" and were failing to activate.

On-site maintenance personnel replaced the other company's cables that were connecting the non-activated multifunction telephones with NTT cables. As a result, the two terminals were activated, and the fault was resolved.

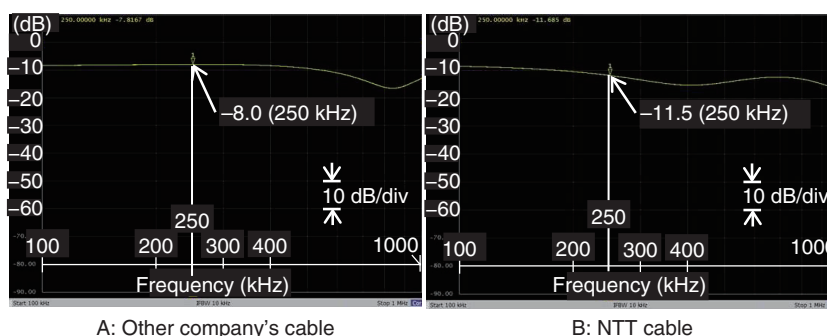
Fig. 2. Measurement results for reflection.

The results of measuring the amount of reflection (item (5)) when connecting a multifunction telephone at 250 kHz were −8.0 dB for cable A and −11.5 dB for

cable B, a difference of 3.5 dB. The measurement results are shown in **Fig. 2**.

The impedance of the NTT cable was 110 Ω, which satisfies the business-phone operating conditions of 110±20 Ω, but the impedance of the other company's cable was 85 Ω, which does not satisfy the conditions. Furthermore, on examining the reflection when connecting a multifunction telephone, we found that the reflection of the other company's cable was found to be 3.5 dB greater than that of the NTT cable, so it could be considered that this reflection was affecting the signal.

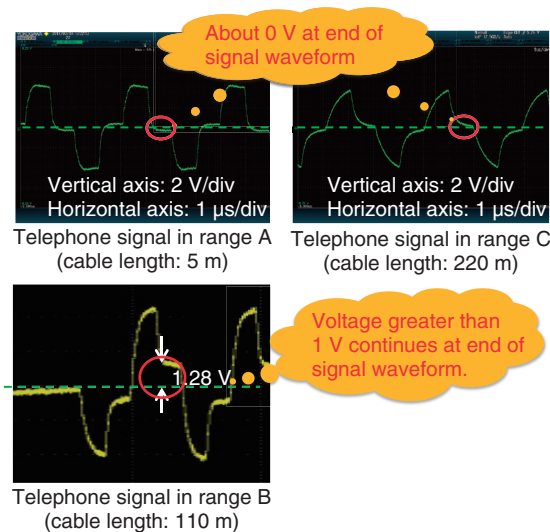
Fig. 3. Results of measuring signal waveforms with oscilloscope.

The results of measuring signal waveforms (for ranges A, B, and C) by oscilloscope are shown in Fig. 3. When we examine the portion within the red circle for each range, we can see that the voltage of the waveform was about 0 V for normal operation in ranges A and C and greater than 1 V at the non-activated time in range B.

data (Fig. 4). The above results show that this voltage was about 0 V in ranges A and C, indicating normal operation. In range B, however, a voltage of 1.28 V (reflected wave) occurred due to the reflected-wave effect, with the result that the terminal could not recognize the signal normally and could not be activated.

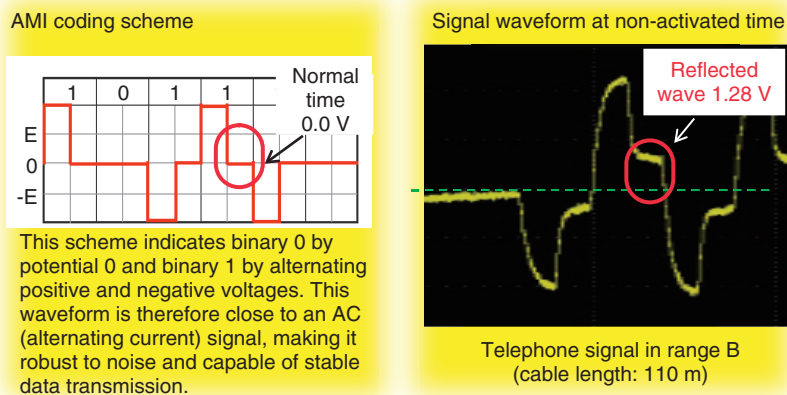
Fig. 4. AMI coding scheme.

The α NXII business phone uses the Alternate Mark Inversion (AMI) coding scheme. If the voltage at the end of the signal waveform within the red circle is greater than 1 V, the signal cannot be read as normal

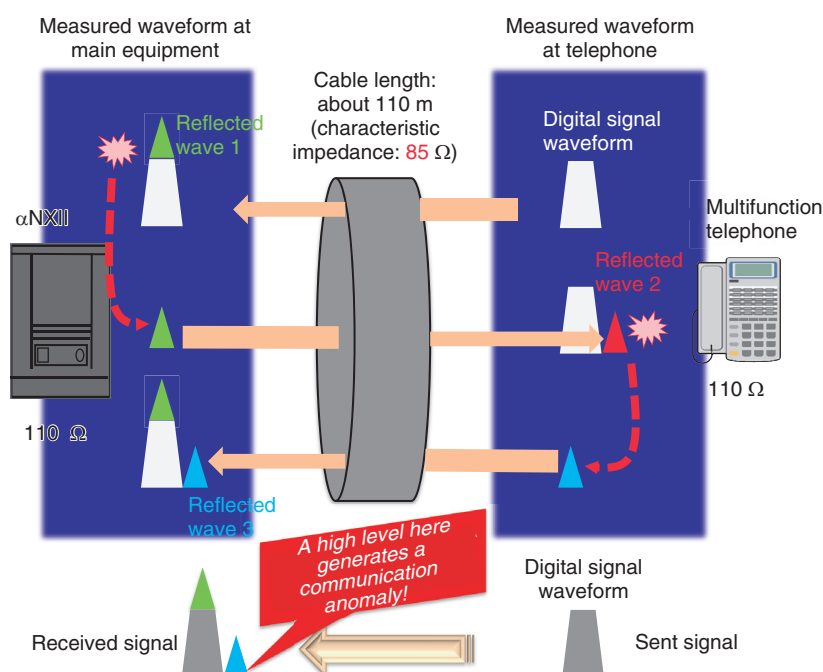
Fig. 5. Fault generation mechanism.

The test results presented above indicate that the characteristic impedance of the other company's cable used for equipment wiring was 85 Ω , which does not satisfy the characteristic impedance of the business phone system used here (110 \pm 20 Ω). Consequently, when a multifunction telephone was connected to this type of cable, there was large signal reflection, which affected the signal within a certain range of cable length.

We inferred from these results that the fault was caused by a breakdown in the signal transmitted by the multifunction telephone. The breakdown was due to the impedance mismatch in the other company's cable, which prevented the main equipment from correctly reading the signal. The fault generation mechanism is depicted in Fig. 5.

In range A, voltage greater than 1 V at the end of the

signal waveform does not continue, and although a reflected wave exists, the reflection duration is short, so there is little impact on the signal.

Likewise, in range C, voltage greater than 1 V at the end of the signal waveform does not continue. This can be explained by considering that while a reflected wave exists, the cable length is long, which has the effect of attenuating the signal itself as well as the reflected wave. The effect of the reflected wave on the signal is consequently small.

a) Replace with an NTT cable

Effect: Achieves impedance matching between the terminal and cable, suppresses reflected waves, and activates the terminal normally.

b) Insert a countermeasure device (attenuator)

Effect: Attenuates the reflected wave and activates the terminal normally.

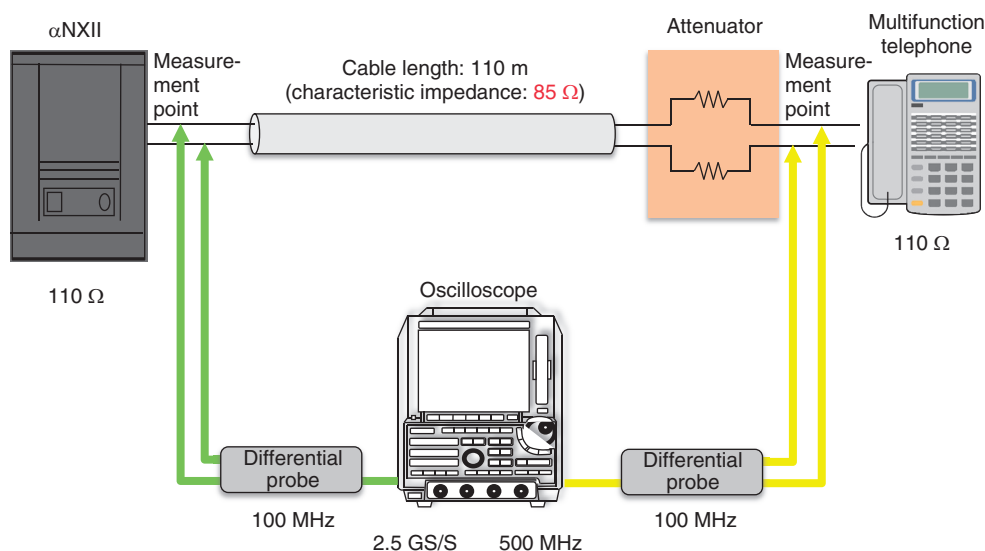
Fig. 6. Test configuration.

We inserted an attenuator (resistance) in a 110-m length of the other company's cable and checked the effect of reducing the voltage level in the reflected wave (Fig. 6).

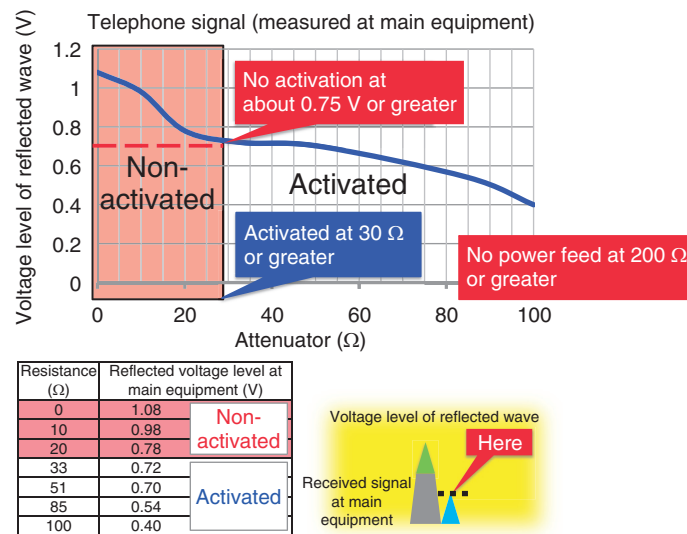
Fig. 7. Checking effect of attenuator.

The test results are shown in **Fig. 7**. The following conclusions were made based on these results.

- Inserting a resistance of 30 Ω or greater in the attenuator results in activation.
- No activation occurs if the voltage level of the reflected wave is approximately 0.75 V or greater.
- Inserting a resistance of 200 Ω or greater disables power feeding.

We found based on the above results that setting resistance in the range of 30–100 Ω would work well as a countermeasure to this fault.
