## Investigation of the Cause of Disconnection of Call Parking on a Business Phone

*Technical Assistance and Support Center, NTT EAST*

*Keywords: call park, business phone, line monitoring system*

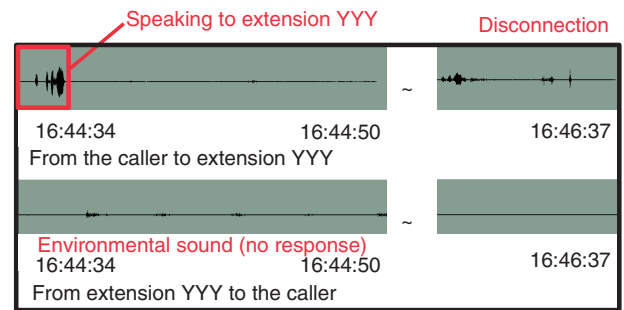
Fig. 2. Audio waveform when extension YYY does not answer the call.

An audio-data waveform constructed from packet-capture data when the call-park problem occurred (only after the call-parking line was responded to by extension YYY) is shown in **Fig. 2**. Although the caller is speaking to extension YYY, the voice waveform from extension YYY to the caller cannot be confirmed because there is no verbal response to the caller’s utterance from extension YYY. The amplitude of the sound was barely confirmed after the

call-park response was confirmed except for a rustling sound—as if something was rubbing against something else—or the sound of the surrounding environment.

When staff members carry a digital cordless phone at work, they often put the phone in their breast pocket; as a result, it is conceivable that the line key flashing in the call-park state might be accidentally pushed by another object (e.g., a pen), and the phone might unintentionally respond to a parked call. For that reason, it is presumed that the staff member who responded to a parked call did not notice that the digital cordless phone was in a call state (accounting for the rubbing or environmental sound rather than a verbal response from extension YYY), and there was no response to a call from a caller.

Since the customer's setting was to respond to all parked calls by pressing the line key of all their digital cordless phones, the above-described unintended call-park response occurred. Because of the fact that users often put their digital cordless phones in their breast pockets along with other objects, we proposed the following three measures to prevent the unintentional call-park response.
