## Examples of Wireless LAN Problems Caused by IP Packets and Wireless Encryption Scheme

*Technical Assistance and Support Center, NTT EAST*

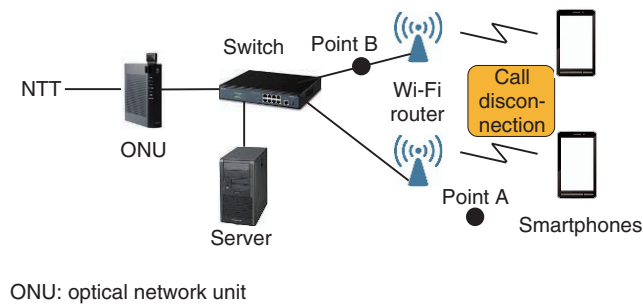
Fig. 1. Configuration of equipment.

We were notified that calls on specific terminals were constantly being disconnected at a customer's site. The site was configured with a Session Initiation Protocol (SIP) server, Wi-Fi routers, and other devices connected to a FLET'S Hikari optical line in a manner enabling communication by smartphones via

### Wi-Fi (Fig. 1).

The radio-wave environment near the AP (point A in Fig. 1) was measured using a spectrum analyzer

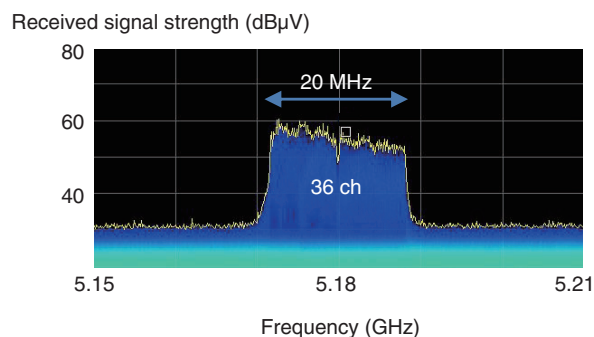
Fig. 2. Results of radio-wave environment test.

(Tektronix RSA 6104A). The measurement results revealed that the received signal strength was sufficiently high at 60 dBμV (with the minimum reception sensitivity at 27 dBμV), and no disturbance waves or interference waves were found to be present (Fig. 2).

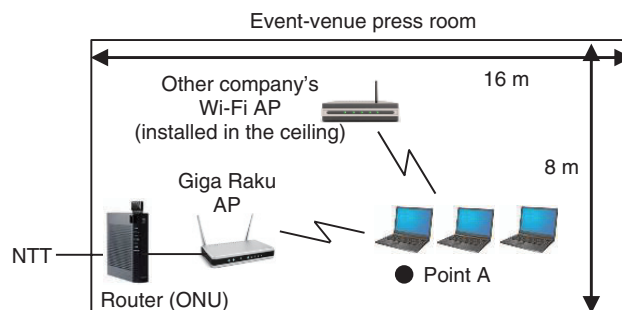
Fig. 3. Configuration of equipment.

nected to a *Giga Raku Wi-Fi* AP (high-end-type made by company C) under an ONU (optical network unit) integrated router. Another company's Wi-Fi AP was set up in the center of the press room (Fig. 3).

A spectrum analyzer (Tektronix RSA6104A) was used to measure the radio-wave environment at the location of the failure (point A in Fig. 3). According to the results of that measurement, although another Wi-Fi radio wave (from the other company's Wi-Fi AP) was recognized on the same channel as the radio wave from the Giga Raku Wi-Fi AP (channel 1), no other disturbances were discovered (Fig. 5).

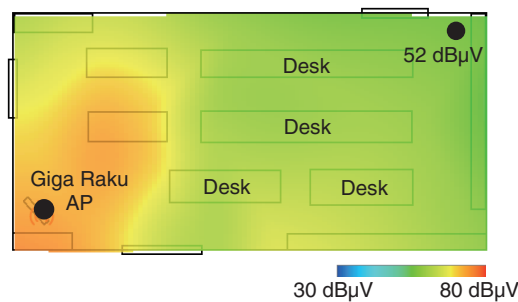
Fig. 4. Distribution map of received signal strength.

Received signal strength in the room was measured by using the received signal strength-distribution map-creation function of the wireless LAN tester. The results of that measurement indicated that the received signal strength was 52 dBμV (with a minimum reception sensitivity of 27 dBμV) even at the lowest location, which indicates that the received signal strength was sufficient anywhere in the room (Fig. 4).

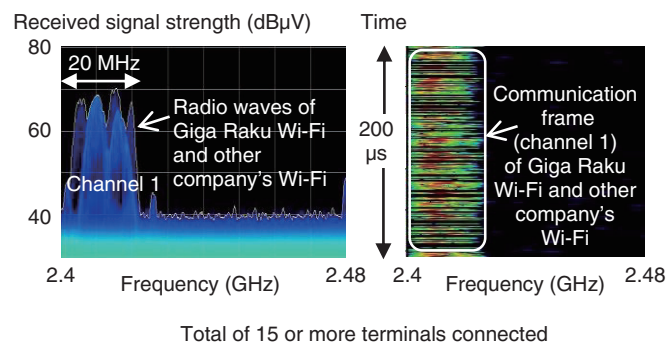
Fig. 5. Communication spectrum and communication status.

Since both Giga Raku Wi-Fi and Wi-Fi of other companies use channel 1, throughput is reduced when many terminals communicate on channel 1. We expect that changing the channel of the Giga Raku Wi-Fi from channel 1 (automatic setting) to channel 11 (fixed setting) will improve throughput. When we actually changed the channel in that manner, we found that throughput was improved by approximately 30 Mbit/s.

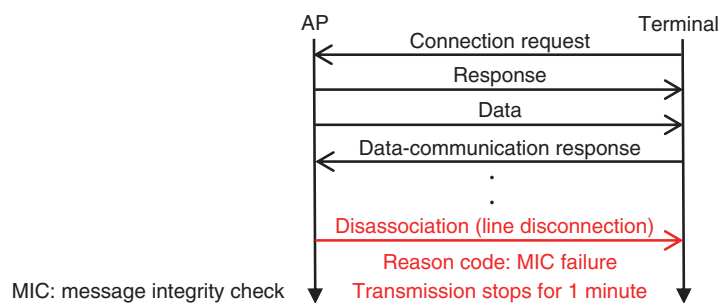
Fig. 6. Result of protocol measurement during communication.

A Wi-Fi failure-analysis tool (Air Magnet) was used to measure the protocol for communication between the APs and terminals. According to the results of that measurement, a so-called disassociation packet was sent from the AP to the terminal to confirm that a disconnection had occurred (Fig. 6). This disconnection was due to a message integrity

check (MIC) failure. This kind of communication disconnection occurs when there is a tampering-detection-code error in the cryptographic frame used in Wi-Fi Protected Access (WPA) encryption.

The Wi-Fi communication is disabled (stopped) for one minute on detection of an MIC failure in WPA encryption. WPA is not recommended because of its cryptographic vulnerabilities [3]. Accordingly, changing the setting to allow only WPA2 encryption is considered a potential measure to eliminate the failure.
