Introduction to Troubleshooting Cases Related to Telephone Systems in Customer Premises

Technical Assistance and Support Center, NTT EAST

In this article, we introduce two cases involving problems that occurred in telephone systems. In the first case, a connection could not be established even when the customer dialed the correct number. In the second case, silence suddenly occurred during the connection. We investigated and solved these problems using various measurement tools and analysis methods. This is the fifty-fourth article in a series on telecommunication technologies.

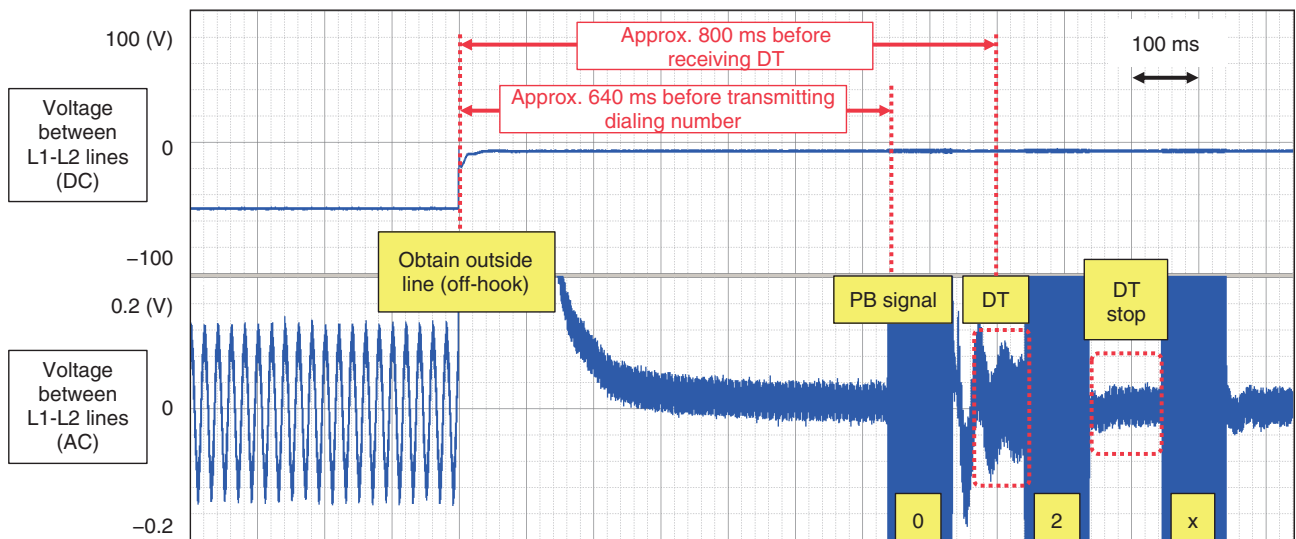
Fig. 2. Waveforms at time of problem.

The following information was obtained from the waveform recorder. The waveforms obtained when the problem occurred are shown in **Fig. 2**.

- The PB signal of the first digit dialed ('0') was transmitted approximately 640 to 790 ms after connecting to an outside line (loop closure).
- The dial tone (DT) was received from the exchange after the PB signal of the first digit had already been transmitted ('0').
- The DT stopped when the second digit was dialed ('2').
- It took approximately 800 to 900 ms for the DT to be received in the customer's environment.

first digit dialed ('0') was transmitted from the telephone before receiving the DT from the exchange, preventing that digit from being recognized by the exchange. Furthermore, since the PB signal of the second digit dialed ('2') (transmitted after receiving the DT) was processed by the exchange, and given that the first digit of a local office number is '2,' a connection was made to an existing 6-digit local tele-

phone number. The calling sequence is shown in Fig. 3. This problem was solved by changing the initial value of the guard interval before transmitting the first digit of the dialed number from 600 ms to 1000 ms. This can be easily set by using the αGX-M master equipment system data, that is, the 07-47 early dialing prevention timer for making an outside call. The waveforms when setting this value to 1200 ms

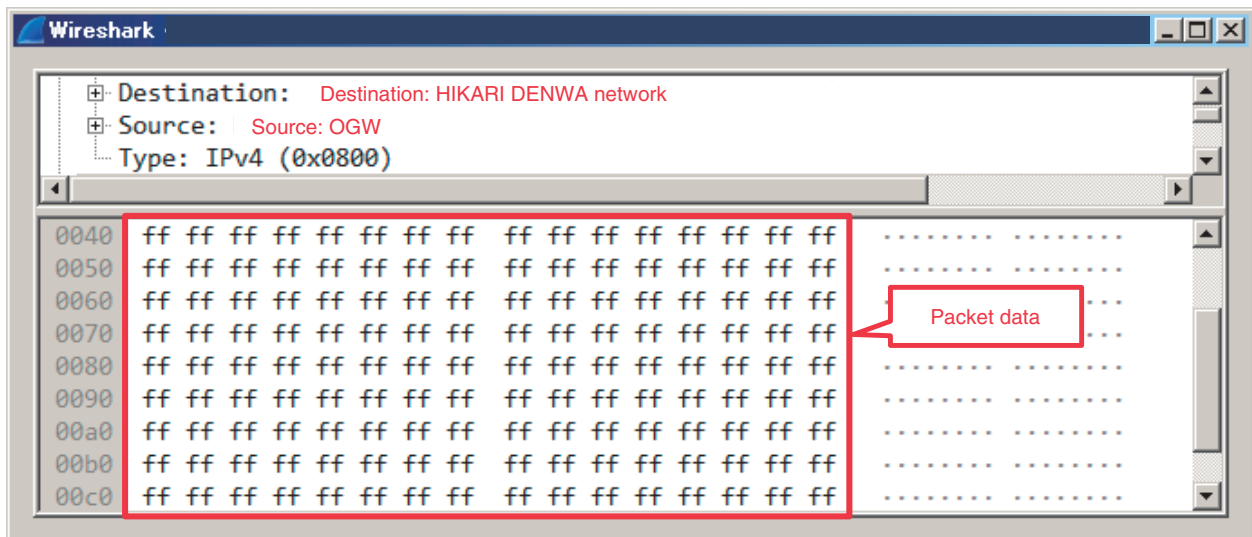
Fig. 6. Voice packet data from Company B.

analyzer) revealed that voice packet data from Company B contained “ff,” which indicates complete silence (Fig. 6). This state continued until the call was disconnected.

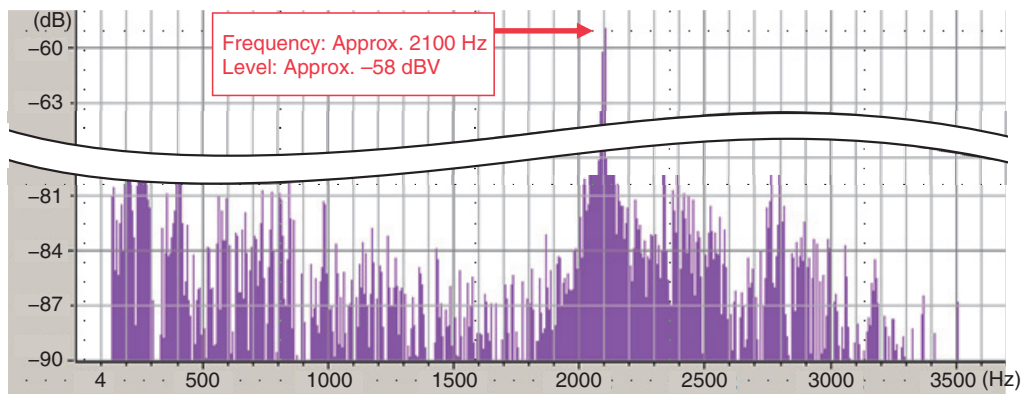
Fig. 7. Results of analyzing frequency components.

- Analysis of voice packet data indicated that the sound of facsimile (FAX) communications was mixed in with the voice call from Company A.
- This mixed-in sound is the called terminal identification (CED) tone (frequency: 2100 Hz), which is the response signal issued on receiving a FAX (Fig. 7).

After analyzing the collected data, we inferred that one of the causes of this problem was the mixing in

of the FAX CED tone from Company A during the call. Consequently, on checking the surroundings near the telephone set at Company A, we found that the telephone set having extension number 25 was installed about 1 m away from the FAX machine, and the machine was transmitting the sound of FAX communications from the speaker used for monitoring its operation. Thus, the monitor sound during FAX communications was picked up by the microphone of telephone number 25. To avoid unintended pickup of the sound, the volume of the monitor sound during FAX communications was decreased.

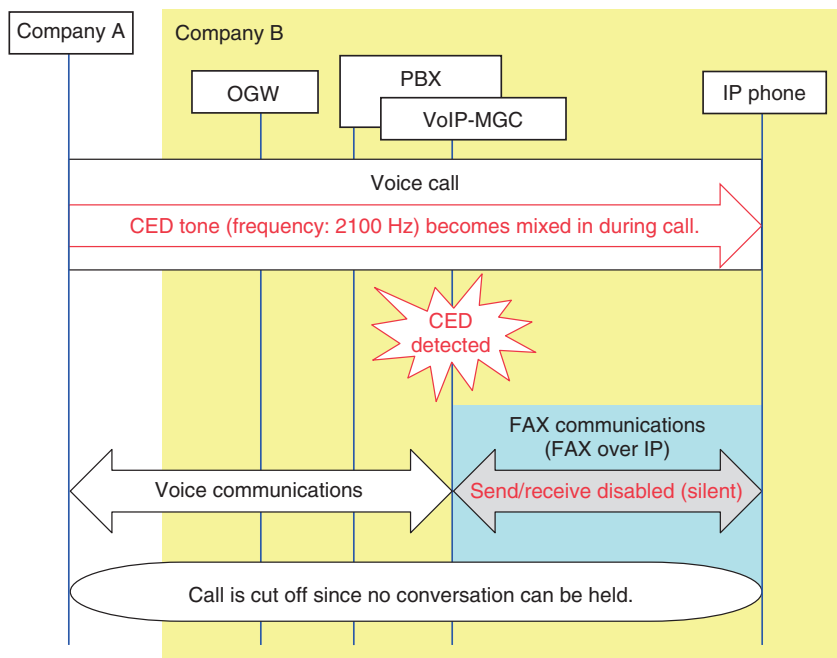
Fig. 8. Conditions of problem occurrence.

PBX at Company B. We added a 2100-Hz signal to the voice communication between Company A and Company B. As a result, the voice communication was disabled. Furthermore, on checking the specifications of the PBX equipment, we found that this problem would occur under the following conditions, as shown in **Fig. 8**.

- The equipment configuration included IP phones (with a Voice over Internet Protocol (VoIP) Media Gateway Card installed) used as extension telephones.
- The VoIP Media Gateway Card would switch to the FAX communications mode (FAX over IP) from the voice communications mode when it detected a CED tone (2100 Hz).
- A voiceless condition would occur after the card switched to FAX communications mode because the telephone set (i.e., IP phone) was not a FAX machine.

with another destination. Therefore, we proposed that the PBX (VoIP Media Gateway Card) should be set to disable the switching to FAX communications mode during a call (set FAX over IP to *disabled*). This proposal was accepted and implemented, and then problem was solved.
