Troubleshooting Facsimile Communication by Analyzing IP and POTS Protocols

Technical Assistance and Support Center, NTT EAST

This article presents an investigation on a problem in which a part of a fax image is blanked out using various measurement tools. This is the fifty-seventh article in a series on telecommunication technologies.

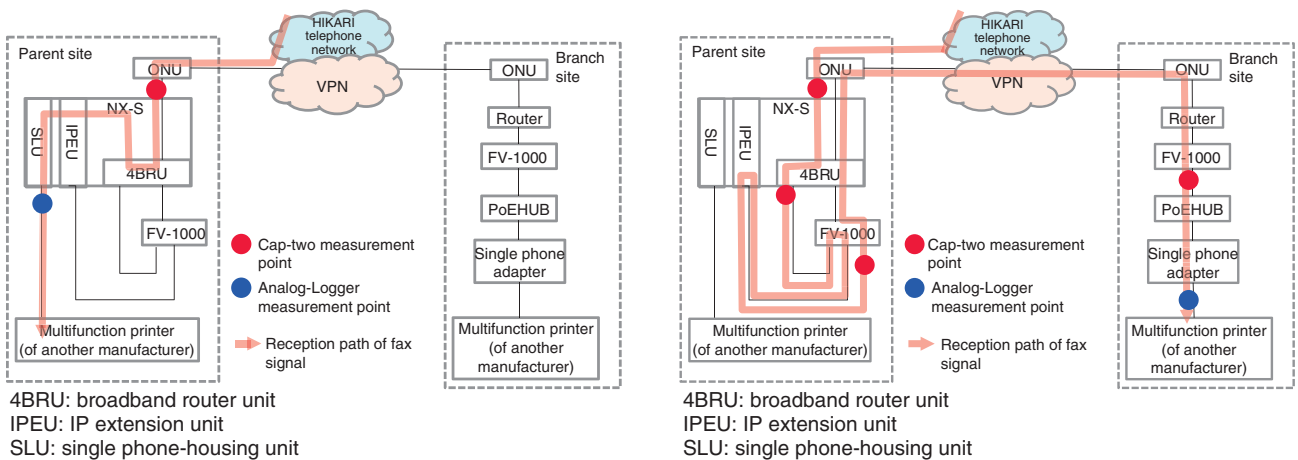
Fig. 2. Configuration of customer network and measurement points.

The configuration of the network in customer premises we investigated is shown in **Fig. 2**. The network had two parts, the parent office and branch site. These sites connected to each other with a virtual private network (VPN) service to extend the network, and each site connected to a HIKARI IP-telephone line to use public telephone services. A multifunction printer manufactured by another company was connected to each part and provided facsimile and printer functions. However, regardless of site location or line

In the investigation, measurement tools (listed below) were installed along the receiving paths of the fax signal arriving by an external line to acquire and analyze IP packets and signals passing along each path. As a result, the fax communication was correct at each measurement point (Fig. 2). Since occurrence of the problem was rare, we decided to carry out long-

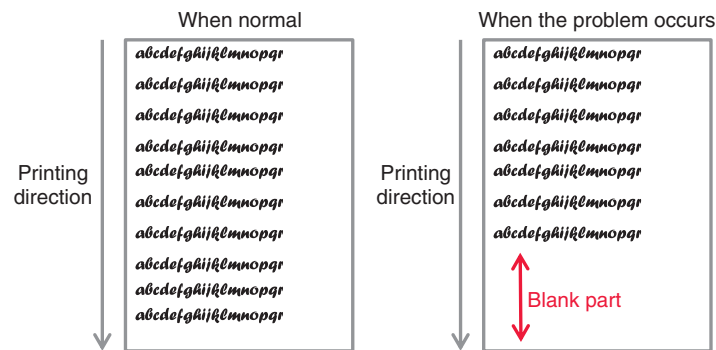
Fig. 3. Output of multifunction printer when a problem occurs.

used (internal or external), the received faxed image was sometimes partially blank, as shown in Fig. 3.

According to a declaration from the customer, the problem (i.e., a partially blank fax) occurred about once a week, and its cause could not be found out even though the manufacturer of the multifunction printer investigated it. Moreover, NTT had been confirming and changing the settings of the optical network unit (ONUs), key telephone system (αNX-typeS), and VPN-terminating equipment (FV-1000) connecting each site as well as replacing terminals, etc. However, the problem was not resolved, so we conducted an on-site investigation.

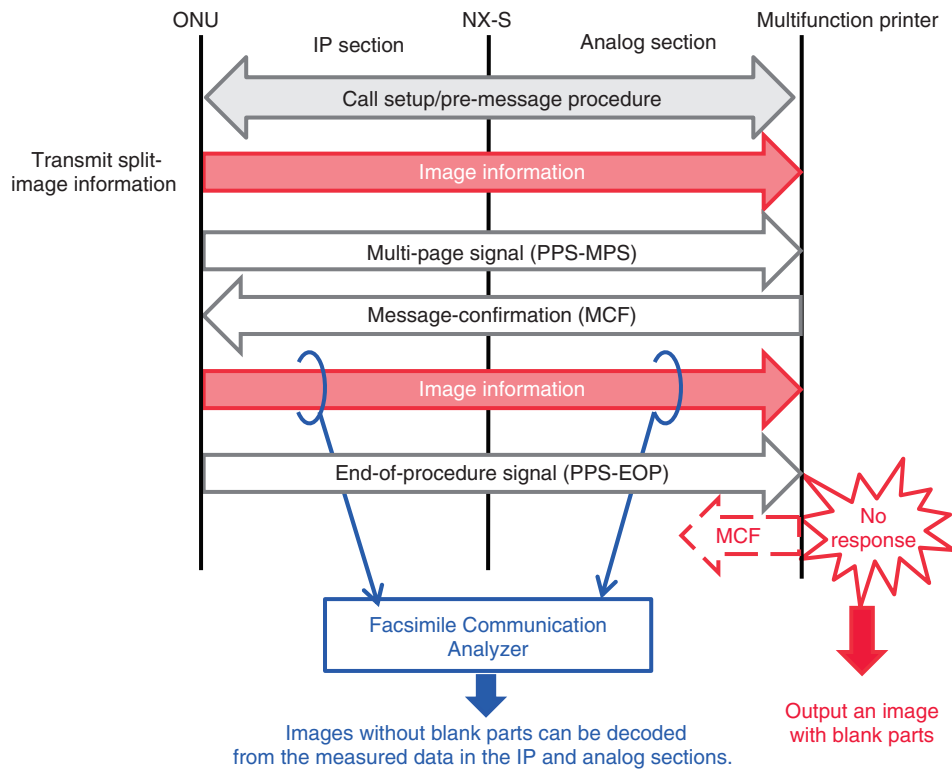
Fig. 7. Sequence of fax signals when blank-fax problem occurs.

One month after installation of the tools, we recognized that the problem occurred twice (i.e., two blank faxes were received). The fax sequence as shown in Fig. 7 were checked when the problem occurred. As a result, the following four points were clarified.

- (1) After successfully completing the call setup and pre-message procedure, the sender divides the image information and sends it.
- (2) After all the split-image information is transmitted, the partial page signal - end of procedure (PPS-EOP) signal is transmitted from the sender.
- (3) The multifunction printer is disconnected after it does not respond to the PPS-EOP signal.
- (4) The multifunction printer outputs a blank fax. When the received image was decoded from the

packet and waveform data measured in the IP and analog line sections, respectively, the images received in both sections were successfully decoded. It is therefore concluded that no abnormality occurred in the fax signals transmitted via the sections subject to maintenance by NTT. Moreover, the multifunction printer did not respond to the proper signal it should be responding to; therefore, it is confirmed that the blank facsimile image occurred due to the setting/function of the multifunction printer. According to the results of the investigation, the customer requested the manufacturer of the multifunction printer to reinvestigate the problem. After reinvestigation was carried out, the blank-fax problem was eliminated.
