Case Studies of Telecommunication Failure Caused by Electromagnetic Noise from Inverters

Technical Assistance and Support Center, NTT EAST

This article introduces case studies of telecommunication failure caused by electromagnetic noise generated from inverters, which are increasingly being installed near telecommunication facilities. This is the fifty-eighth article in a series on telecommunication technologies.

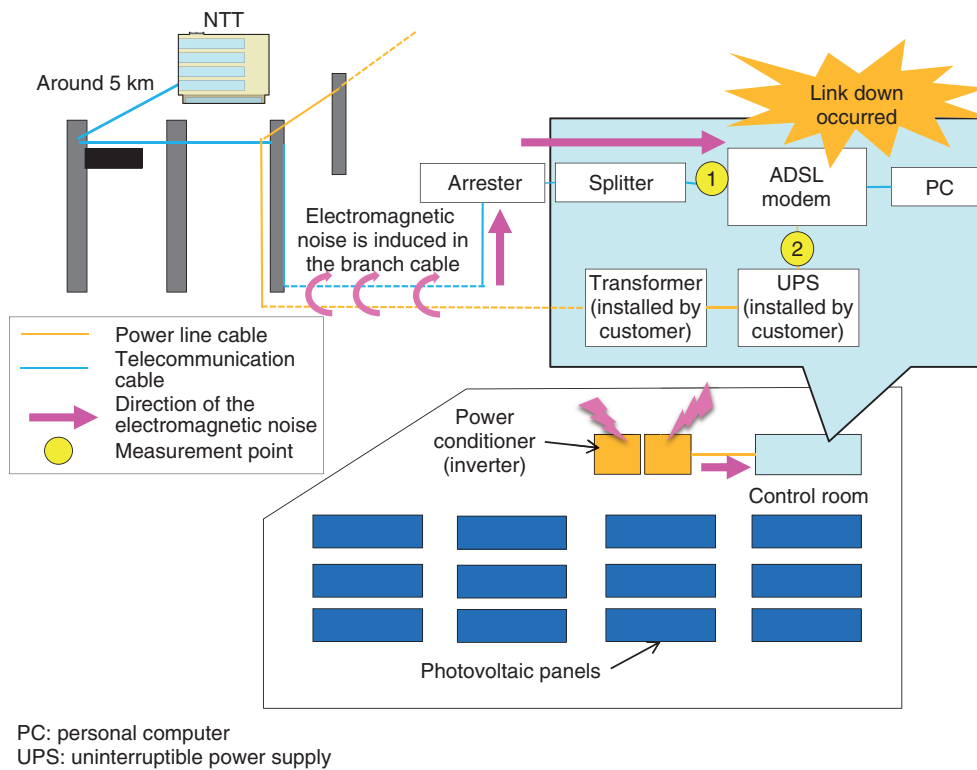
Fig. 1. Telecommunication failure state and facility configuration.

A customer who manages a photovoltaic power system reported that link down of their ADSL frequently occurs (**Fig. 1**). The local maintenance personnel took countermeasures such as replacing the ADSL modem; however, link down persisted, so TASC carried out an investigation of the cause of the telecommunication failure.

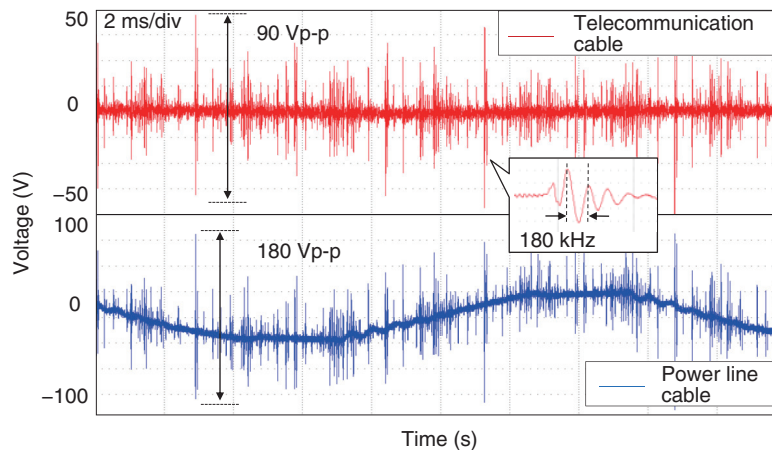
Fig. 2. Voltages on telecommunication and power line cables.

To observe electromagnetic noise in the ADSL modem, an oscilloscope (Yokogawa DLM4058) was used to measure the voltages on the telecommunication cable of the ADSL modem (measurement point (1): L1 to the earth) and on the power line cable (measurement point (2): cold line to the earth). The results showed that voltages with a repetition frequency of 180 kHz existed on the telecommunication cable (around 90 Vp-p) and on the power line cable (around 180 Vp-p) (**Fig. 2**). The magnetic-field strength around the modem was measured using a spectrum

the photovoltaic power system being induced in the telecommunication cable (branch cable), which was laid out in parallel with the power line cable, and it affected the ADSL signal. As a countermeasure to this electromagnetic noise, a noise filter (V-MJS^{*1}) was installed on the telecommunication cable (circuit-line side) of the ADSL modem. As a result of that countermeasure, the voltage generated on the telecommunication cable was reduced to 10 Vp-p and link down of the ADSL did not occur.

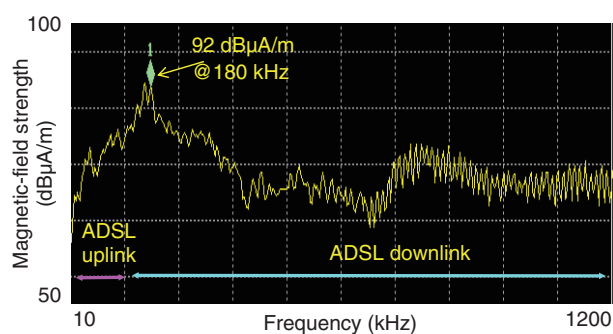
Fig. 3. Magnetic-field strength around inverter.

analyzer (KEYSIGHT N9020A) and loop antenna (ETS-LINDGREN6512). The results showed that the largest electromagnetic noise (92 dB μ A/m) occurred around the power conditioner (with a built-in inverter) of the photovoltaic power system over the entire ADSL telecommunication band with a peak at 180

kHz (Fig. 3).

The results of the investigation indicated that this telecommunication failure was caused by electromagnetic noise generated by the power conditioner of

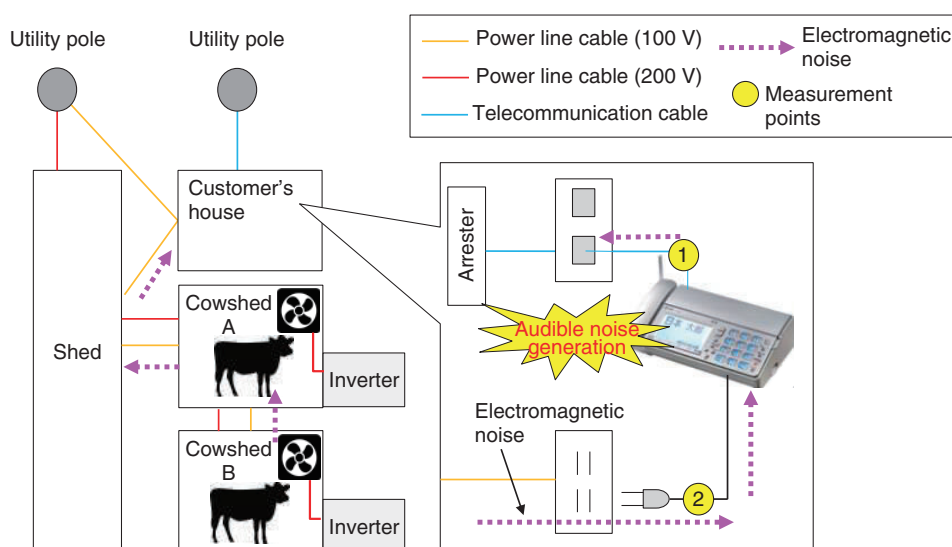
Fig. 4. Telecommunication failure state and facility configuration.

A customer using a telephone fitted with a facsimile (hereafter simply referred to as the phone) reported that audible noise (a “bee...” sound) was always heard during telephone calls (Fig. 4). The local maintenance personnel replaced the wire with shielded one, but those measures did not resolve the telecommunication failure. Accordingly, TASC carried out an

invaded to the phone through its power line cable. As a countermeasure against this electromagnetic noise, the phone was replaced with one without a power line cable and a noise filter (DMJ-100k^{*1}) was installed on the telecommunication cable of the phone.

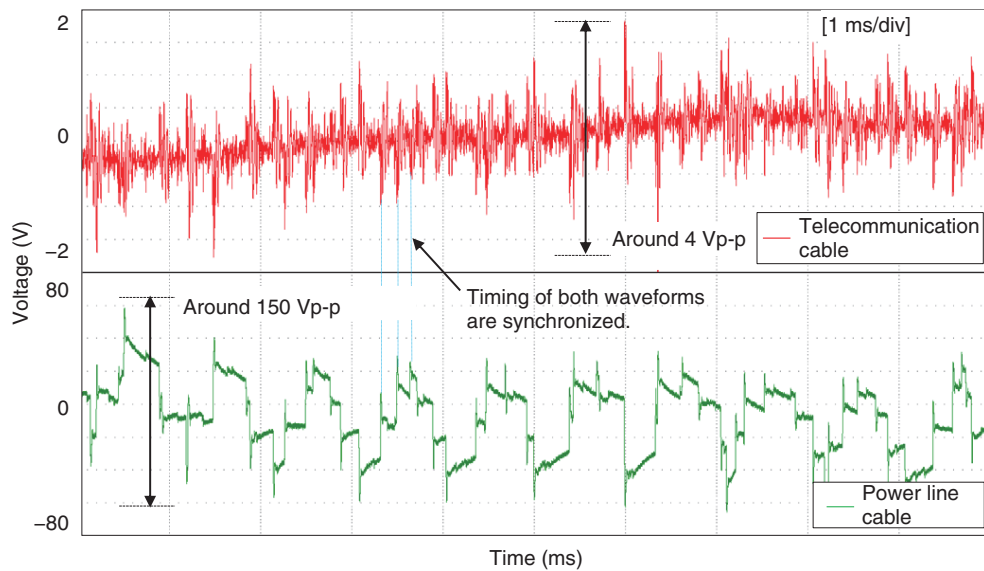
Fig. 5. Voltages on telecommunication and power line cables.

To observe electromagnetic noise entering the phone, an oscilloscope (Yokogawa DLM4058) was used to measure the voltages on the telecommunication cable (measurement point (1): L1 to the earth) and on the power line cable (measurement point (2): cold line to the earth) of the phone. The results showed that the voltages on the telecommunication and power line cables were around 4 and 150 Vp-p, respectively (Fig. 5). When the measured values were subjected to fast Fourier transform (FFT) processing, electromagnetic noise centered on 120 kHz was observed.

Additionally, the electromagnetic noise source was investigated by applying a noise propagation direction identification device (developed by TASC). The result of that investigation revealed that the inverter for the ventilation fan in cowshed B was the source of the electromagnetic noise. Accordingly, when the power of the inverter was turned off, the electromagnetic noise on the telecommunication and power line cables was reduced, and the audible noise on the phone line was eliminated.

According to the results, it is revealed that this telecommunication failure was caused by the electromagnetic noise, which is generated from the inverter,

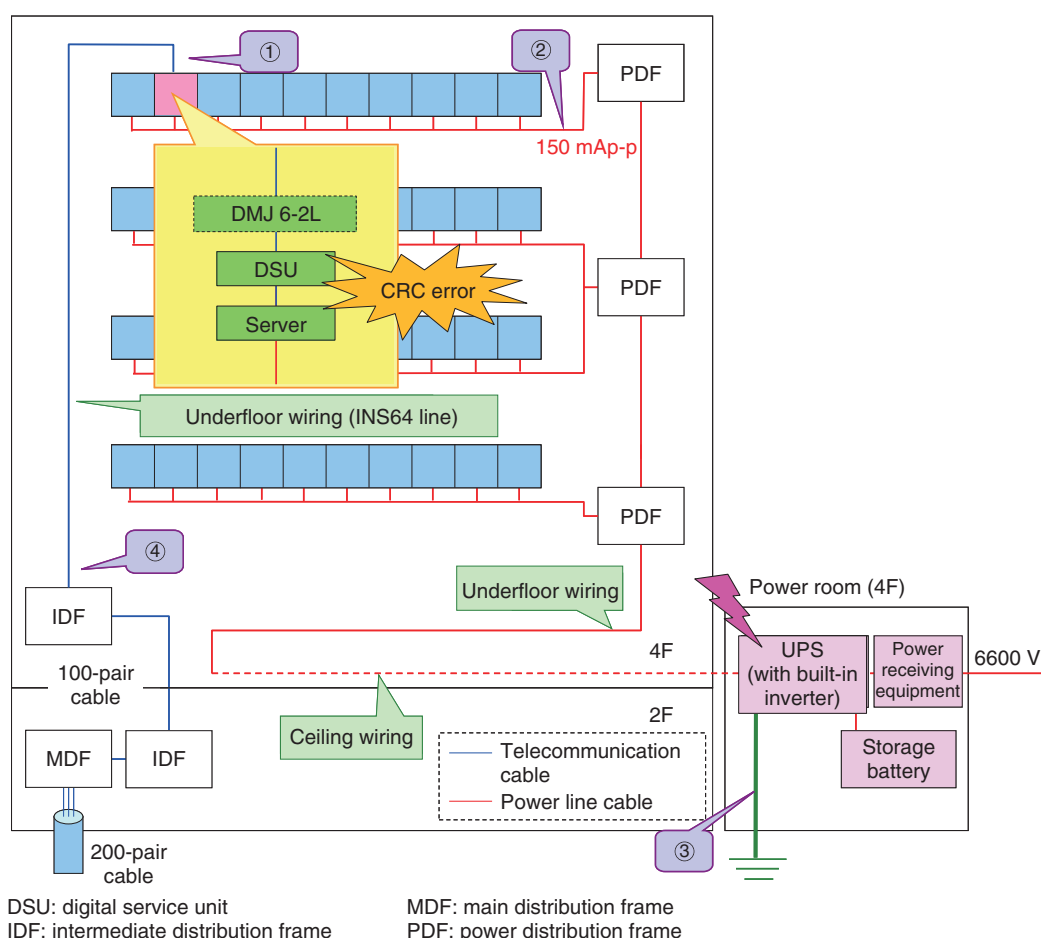
Fig. 6. Configuration of facility.

A customer using an integrated services digital network (ISDN) line at a datacenter reported that a cyclic redundancy check (CRC) error occurred (Fig. 6). The local maintenance personnel resolved the error by installing a noise filter (DMJ 6-2L^{*1}) on the ISDN line, but the cause of the telecommunication failure was not determined, so an investigation was requested.

To observe electromagnetic noise entering the customer server, an oscilloscope (Yokogawa DL9040) and current probe (EMCO 91550-2) were used to measure the currents on the ISDN line (measurement point (1)), on the power line cable under the PDF^{*2} (measurement point (2)), and on the ground wire of the uninterruptible power supply (UPS) (measurement point (3)). As a result of FFT processing on

According to the results, it is revealed that this telecommunication failure was caused by the electromagnetic noise, which is generated from the UPS, invaded to the DSU^{*4} through the power line cable, PDF, and IDF. As a countermeasure against this electromagnetic noise, a noise filter (DMJ 6-2L^{*1}) was installed in the same manner as done by the local maintenance personnel.

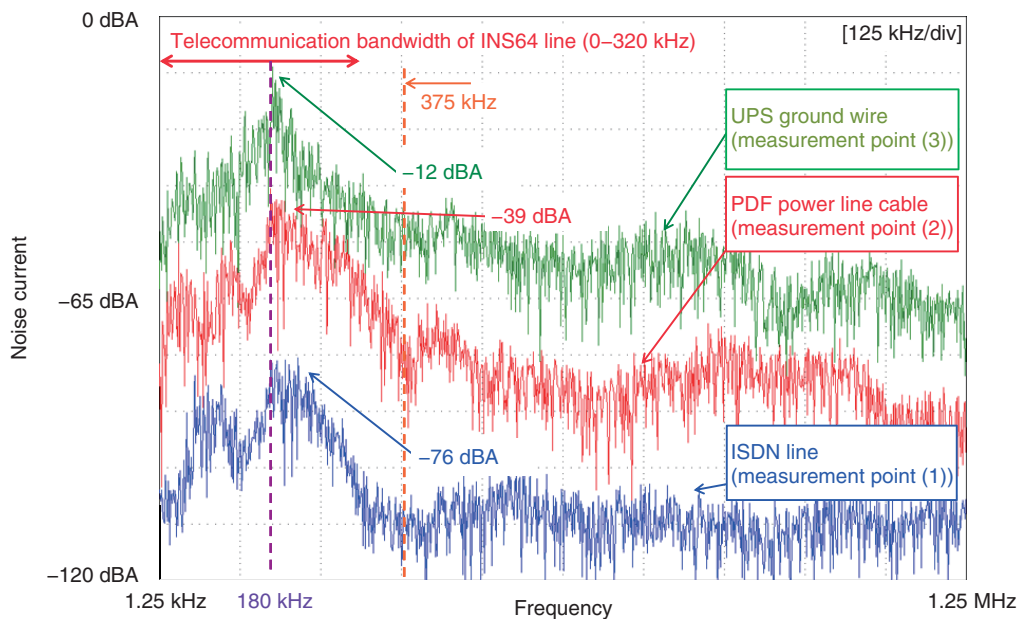
Fig. 7. Current spectrum at each measurement point.

measured data, electromagnetic noise centered at 180 kHz was observed at all the measurement points; currents of -76 dBA (0.16 mA) and -39 dBA (11 mA) were observed at measurement points (1) and (2), respectively, and a largest current of -12 dBA (250 mA) was observed at measurement point (3) (Fig. 7).

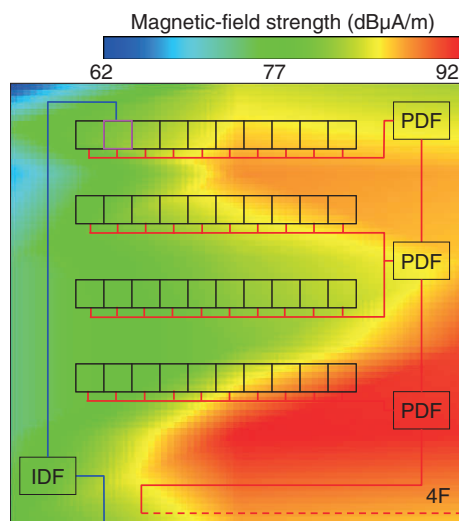
Fig. 8. Distribution of magnetic-field strength at 180 kHz.

A spectrum analyzer (Rohde & Schwarz PR100) and loop antenna (ETS-LINDGREN 6512) were used to measure the magnetic-field strength at 180 kHz inside the datacenter. The measurement results confirmed electromagnetic noise of up to 79 dB μ A/m on the PDF side (Fig. 8). It was also observed that as for the power line cable side and ISDN-line side of the server, electromagnetic noise on the power line cable side was low and did not change even when the ISDN line was disconnected from the IDF^{*3} (measurement point (4)).
