## Grounding-system Evaluator for Preventing Lightning Damage to Telecommunications Center Buildings

*Technical Assistance and Support Center, NTT EAST*

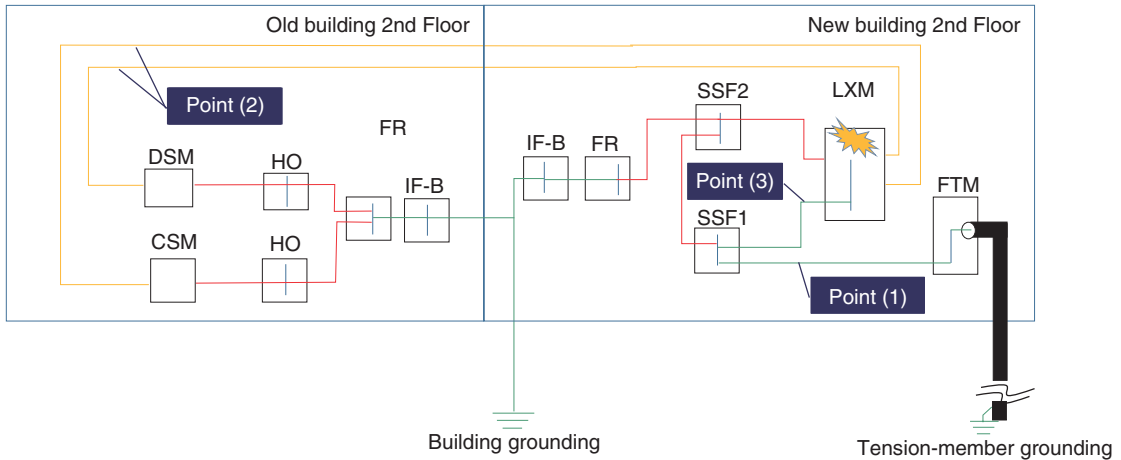
Fig. 5. On-site investigation of the building and identified configuration points.

The status of a grounding-system configuration obtained from the on-site investigation is shown in **Fig. 5**, and points to be addressed are listed in **Table 1**. **Figure 6** shows the simulation results of the grounding-system evaluator, focusing on the fiber termination module (FTM) on the second floor of the new building and **Figure 7** shows details of wiring errors. The simulation results show that the wiring between the FTM and SSF1 (a power supply distributor) is incorrect, and the FTM should be wired to Interface – B (IF-B).

Table 1. Wiring status of key points.

Wiring status	Content
Point (1)	The optical-cable tension member is connected to SSF-1 via the frame ground (FG) of the FTM.
Point (2)	LXM and CSM/DSM are connected by a clock cable across the building, but IF-C is not inserted.
Point (3)	The ground of LXM is connected to another rack (SSF1) instead of the rack receiving power supply (SSF2).

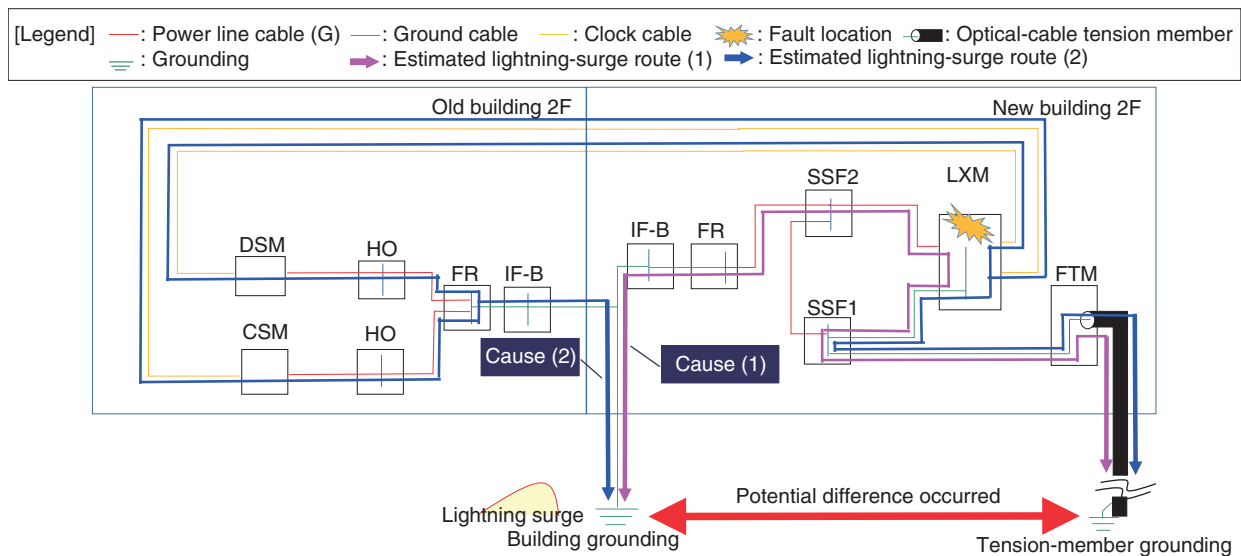
Fig. 8. Estimated lightning-surge route.

On the basis of the results obtained from the investigation, the estimated invading route of the lightning surge that caused the failure is shown in **Fig. 8** and **Table 2**. Due to the increase in the ground potential

caused by the lightning strike near the telecommunications center building, a potential difference

occurred between the building ground and tension-member ground. Thus, a lightning surge current was

Table 2. Estimated lightning-surge route.

Lightning-surge route
Route (1)	Building grounding ⇔ New building IF-B ⇔ SSF2 ⇔ LXM ⇔ SSF1 ⇔ FTM ⇔ TM grounding
Route (2)	Building ground ⇔ Old building IF-B ⇔ CSM/DSM ⇔ LXM ⇔ SSF1 ⇔ FTM ⇔ TM grounding

generated and propagated through cables, i.e., the lightning-surge current flowed from the ground cable into the LXM via the metal cables and flowed out to the ground cable and clock cable.
