Investigation on Damage to Optical Fiber Cables Caused by Freezing and Thawing of Water in a Lifting Pipe

Technical Assistance and Support Center, NTT EAST

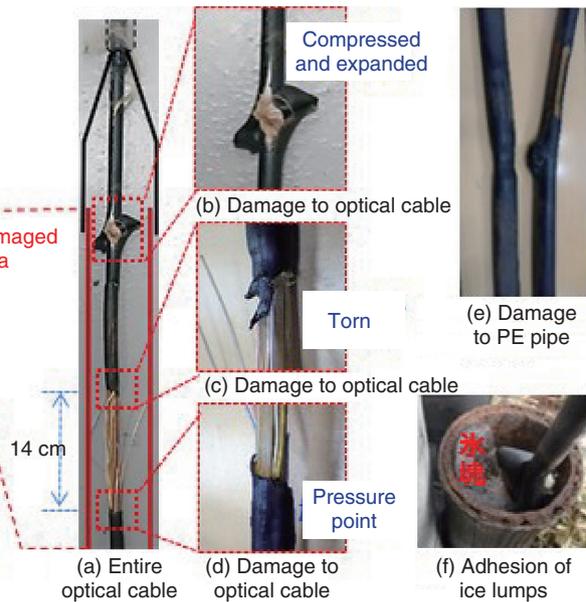
Fig. 2. Observed damage.

damaged within a 60 cm from the upper end of the lifting pipe. The sheath of the optical fiber cable was torn in the longitudinal direction in a manner that exposed the inner-core wire (**Figs. 2(a), (c), and (d)**), and the upper section of the exposed part was in a state in which the cable sheath was compressed, torn, and expanded (**Fig. 2(b)**).

We also found that the PE pipe was torn due to being crushed and bursting under pressure (**Fig. 2(e)**). The tip of the waterproof cap covering the top end of the lifting pipe was also damaged. During a field survey, we also found lumps of ice at the top-end of the lifting pipe (**Fig. 2(f)**).

pipe was pushed upward, we assumed that the compressed and expanded damage (**Fig. 2(d)**) to the sheath of the upper part of the optical fiber cable was caused by the repeated upward force exerted toward the fixture point (stainless-steel band) on the utility pole.

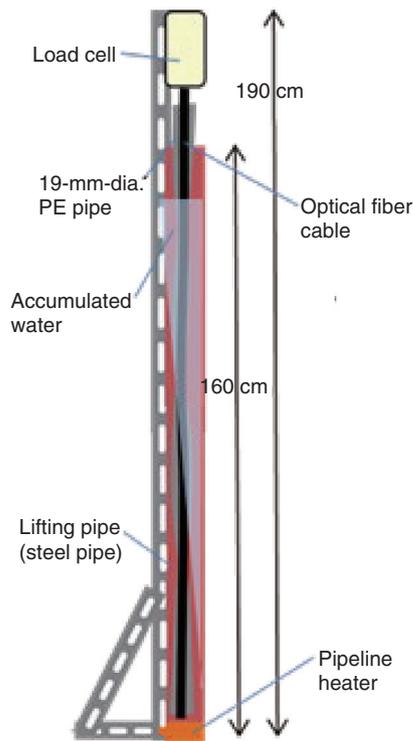
Fig. 3. Apparatus for reproducing lifting pipe.

The optical fiber cable and PE pipe rose by 1.7 cm when the water in most of the steel pipe (except for the heater section) froze and thawed. The measurements on the load cell showed that the tip of the optical fiber cable was pushed by an upward force of up to about 780 N during the thawing of the accumulated water. Note that the strong upward force was not recorded at the lowest temperature of -15°C , that is, it was always recorded during the subsequent temperature increase.

These results indicate that the freezing and thawing of the accumulated water in the lifting pipe generated an upward force on the optical fiber cable and PE pipe. Since the optical fiber cable outside the lifting

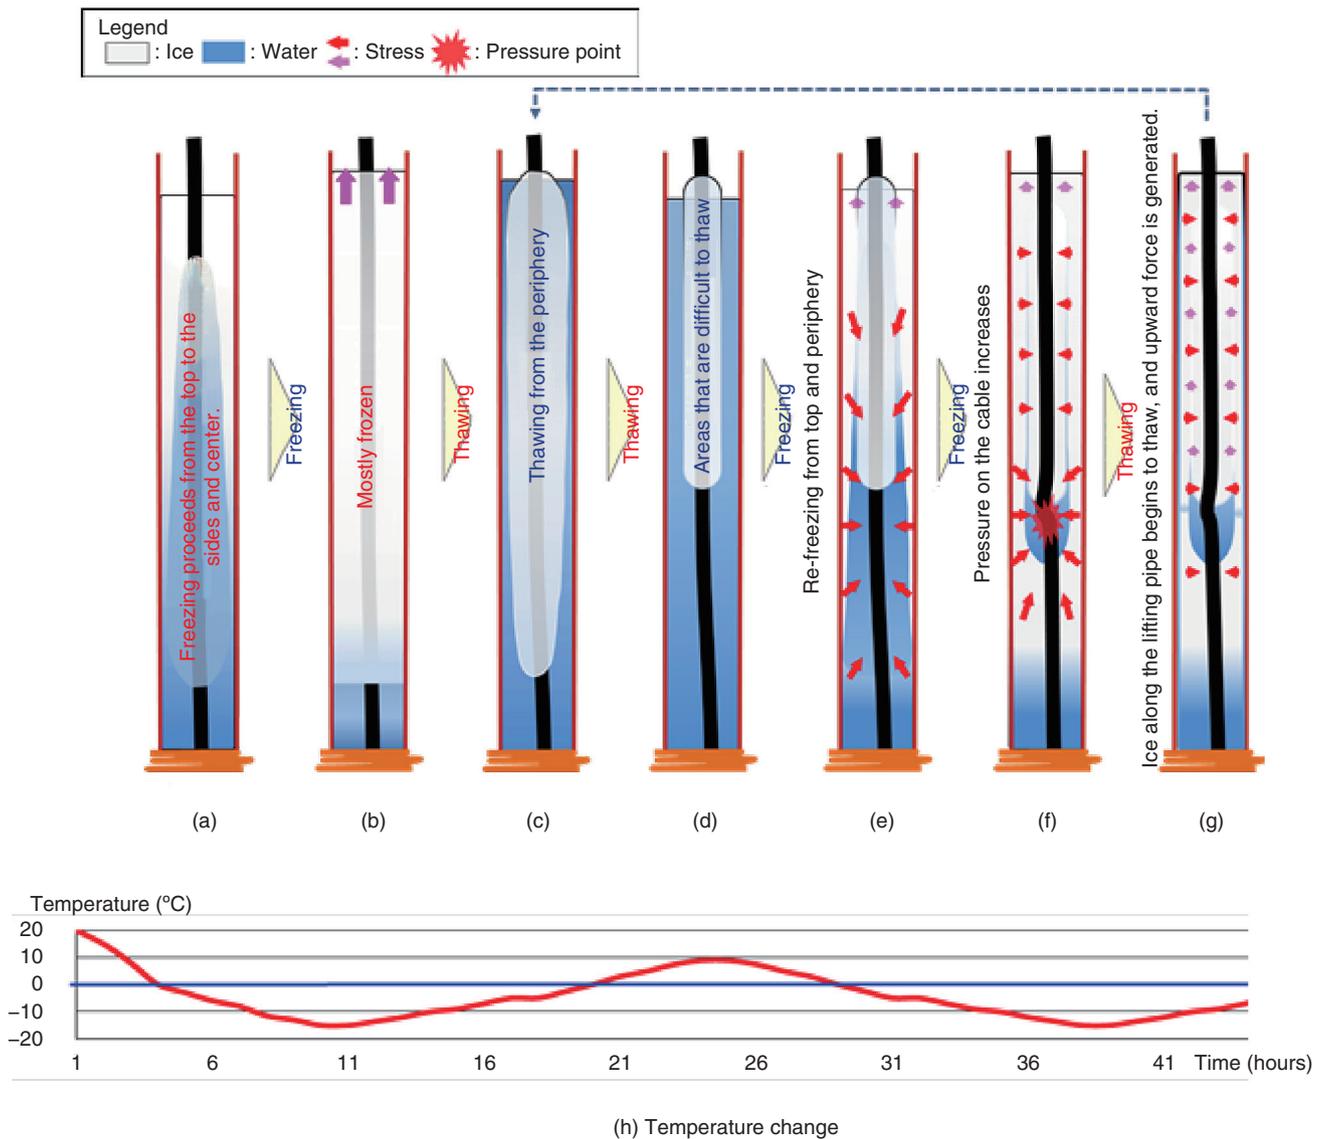
Fig. 5. Results of verification (2).

Result 1: Freezing progressed from the top of the PVC tube to the sides, bottom, and center, and most of the tube froze except for the area near the heater. The water surface (Fig. 5(a)) also rose by about 2.5 cm (Fig. 5(b)).

Result 2: When the temperature was gradually increased from the frozen state, thawing progressed from the outside of the PF pipe, but ice remained from the center to the upper part of the pipe, wrapping around it (Fig. 5(d)).

Result 3: When the water was re-frozen from the state described in Result 2*2, new ice was formed in addition to the remaining ice from the center to the top of the PF pipe, and the water surface rose again (Figs. 5(e) and (f)). In the unfrozen area between the remaining ice and newly formed ice, the PF pipe was deformed as if it had been crushed under pressure (Fig. 5(f) and **Fig. 6**).

From the results of the two verifications described above, it is conceivable that the optical fiber cable installed in a lifting pipe is pushed up during the process by which rainwater infiltrates the pipe and the accumulated water repeats freezing and thawing for the following three reasons: (i) the ice remaining near the top and center of the pipe solidifies when surrounding the cable; (ii) the internal pressure of the unfrozen part increases due to the expansion pressure caused by the subsequent new freezing from the periphery (Figs. 5(d) to (f)); and (iii) as the temperature increases, the surrounding ice begins to melt, and the optical fiber cable is pushed up from the pressure point when its internal pressure is released while being held by the ice (Fig. 5(g)).

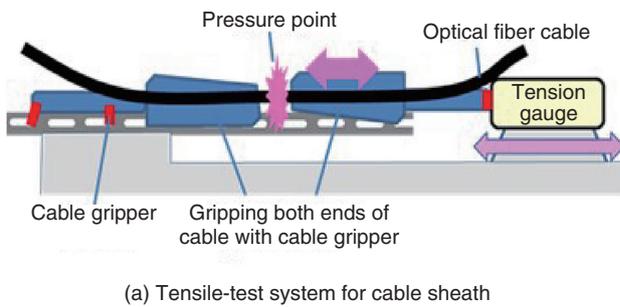
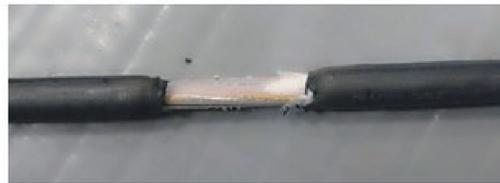
Fig. 7. Tensile test on cable sheath.

ing thawing after the water in the steel pipe froze. To verify whether the tensile force due to repeated freezing and thawing during winter would damage the outer sheath of the optical fiber cable, we conducted a test in which one end of the cable was fixed and the other end was pulled with a force of 780 N (Fig. 7(a)).

The test was carried out by repeatedly applying then releasing the tension under the environment in which freezing and thawing are repeated. Applying and releasing tension, the outer sheath was damaged on the 35th repetition, and gradually torn off by further repetition (Fig. 7(b)).
