Case Study of Audible Noise on Analog Leased Lines Caused by Electromagnetic Disturbance

Technical Assistance and Support Center, NTT EAST

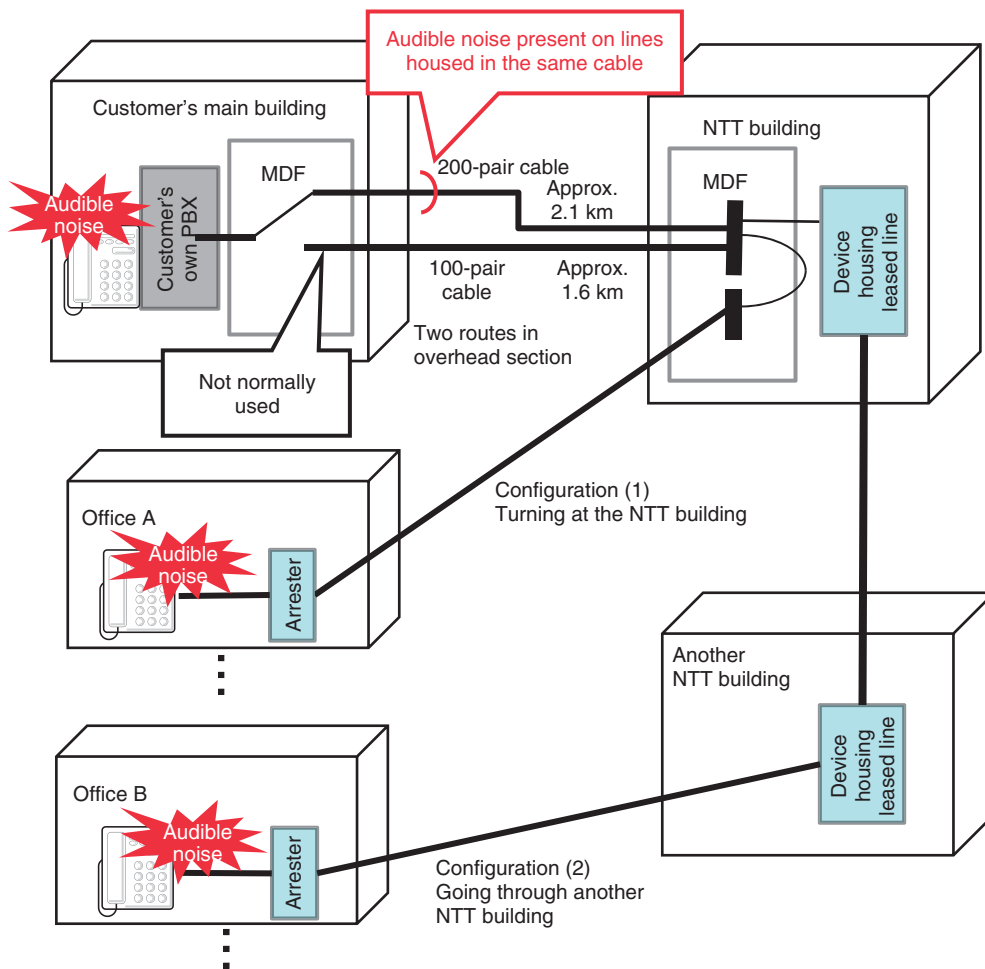
The customer operates their own private branch exchange (PBX) and uses 3.4k analog leased lines between the PBX in the customer's main building and several offices located in the same city or surrounding areas, for extension calls. The configuration of the equipment is shown in **Fig. 1**. A redundant configuration is adopted between the customer's main building (in which the customer's PBX is installed) and an NTT building (telecommunication central office), having two different telecommunication access routes in the overhead section, so that the 3.4k analog leased lines can be maintained even in the event of a cable failure in the access network section. The route can be switched by changing the jumper cable in the main distribution frame (MDF) in the customer's main building. There are two routes between the NTT building connecting to the customer's main building and customer's offices: (1) a route turning at the MDF

Fig. 1. Configuration of equipment.

To confirm the details of the noise, on-site telecommunication maintenance personnel investigated all 300 lines installed in the customer's main building using a cable tester, and it was confirmed that the audible noise was present on 17 lines of the 200-pair cable in use. No audible noise was generated on lines of the other 100-pair cable. As a countermeasure, the telecommunication maintenance personnel changed a line number within the same 200-pair cable, but the audible noise was not cleared, so the cable was switched to the stand-by 100-pair cable in the redun-

The line with the highest audible noise was a stand-by line that had been taken out of service due to the reconstruction of office B, but the jumper cable in the NTT building had been left connected. When the stand-by line connected to the MDF in the NTT building was disconnected, the audible noise on

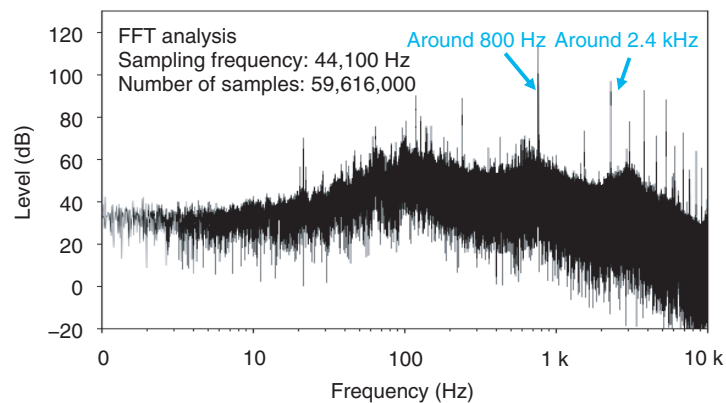
Fig. 2. Results of FFT analysis.

To confirm the frequency characteristics of the audible noise reported by the customer, it was recorded at the site. The recorded sound files were subjected to First Fourier Transform (FFT) analysis by TASC. The results of this analysis are shown in **Fig. 2**. It was found that the level of the noise signal was higher at the fundamental frequency (which is approximately 800 Hz) and its harmonics at odd multiples. It was also found that the audible noise was occurring periodically (every 20 to 30 s).

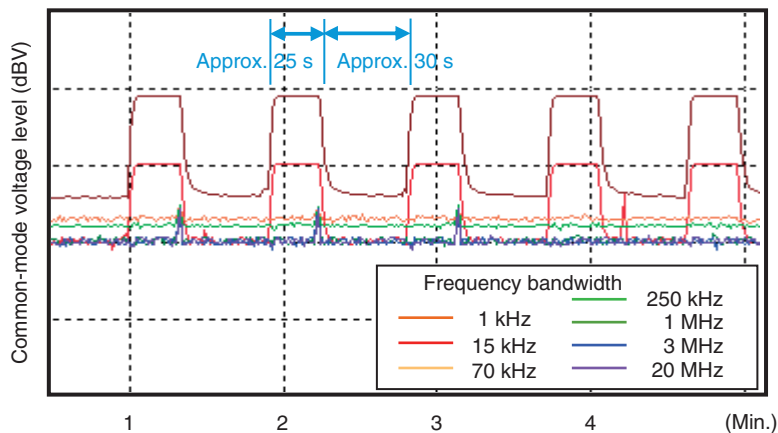
The measurement results of the lines with the highest common-mode voltage level are shown in **Fig. 3**. It was found that the highest common-mode voltage level (about -2 dBV) occurred in the 1 kHz band, i.e., voltage level at frequencies between 500 kHz and 1.5 kHz.

Since this frequency range includes 800 Hz, i.e., the fundamental frequency of the recorded sound file, TASC concluded that it corresponds to the common-mode voltage level of the audible noise reported by the customer. It was also found that the common-mode voltage level fluctuates periodically and corre-

sponds to the phenomenon observed by playing back the sound file, i.e., a high-pitched noise (at approximately 800 Hz) occurring periodically every 20 to 30 s.

Fig. 3. Measurement results of common-mode voltage levels of audible noise using Noise Search Tester.
