The Occurrence of Mold in Telecommunication Equipment and Facilities and Its Impacts on Material Degradation

Technical Assistance and Support Center, NTT EAST

This article provides two case studies of the occurrence of mold in telecommunication equipment and facilities and its impacts on the materials of the equipment and facilities. This is the seventy-third article in a series on telecommunication technologies.

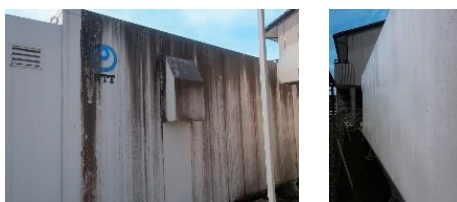
Fig. 2. Appearance of outdoor telecommunication box. Left: side with poor sunlight; right: side with good sunlight.

the exterior wall of the outdoor telecommunication box. We observed no adhering substances on the walls of the box that received plentiful sunlight due to the location of the facility; to the contrary, we observed adhering substances on the walls that received poor sunlight. We also observed peeling paint on the wall surfaces where the adhering substances were observed (**Fig. 3**). In contrast, we observed no significant peeling of the paint on the walls without adhering substances of foreign matter.

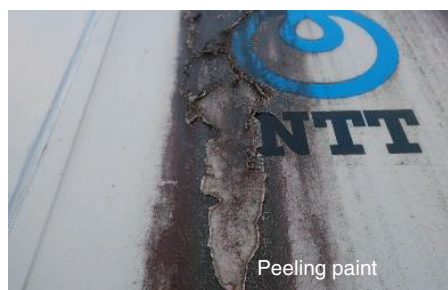
Fig. 3. Adhering substances and peeling paint on the wall.

box, regardless of the presence or absence of the adhering substances, we concluded that mold was not the direct cause of the decrease in adhesive strength of the paint. However, we presumed that the adherence of foreign matter such as mold created a high-humidity state, which further accelerated degradation such as the observed peeling of paint.

Mold like this and other adhering substances on walls can result in degradation of paint being overlooked and accelerate such degradation. It should thus be cleaned and removed from the walls of outdoor telecommunication boxes during inspection. When degradation is observed, such as a decrease in adhesion strength of the paint or peeling of paint, repairs such as repainting are necessary.

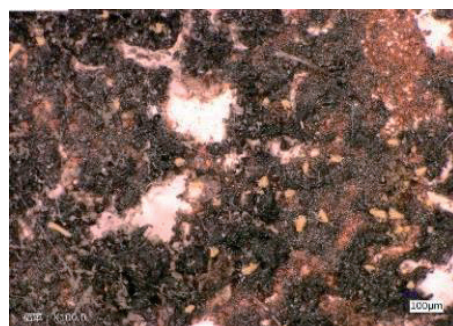
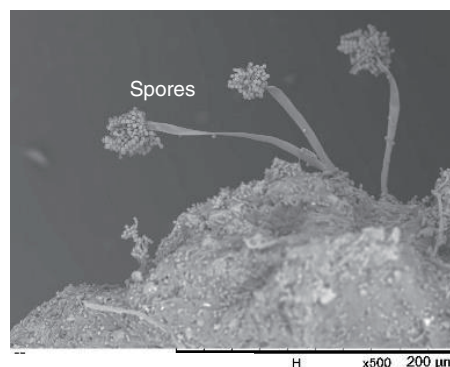
The results of the EDS analysis indicate that the adhering substances were mainly composed of carbon and oxygen, i.e., organic matter. The environment surrounding the outdoor telecommunication box in question, which is located in a mountainous area, suggests that the adhering substances also contain organic matter such as moss and dust. However, the shape, size, color, and other characteristics of the spores observed in the SEM and optical-microscope images—as well as the fact that the adhering sub-

Fig. 4. Adhering substances on the walls. Top: optical-microscope image; bottom: SEM image.

stances were observed mainly in the shade—confirmed that the adhering substances on the walls were molds.

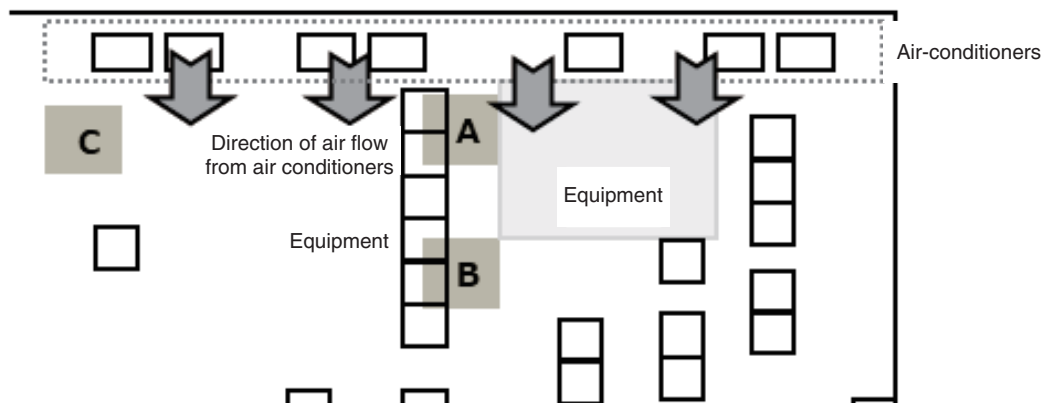
Fig. 5. Layout of equipment in machine room.

White foreign matter was observed at locations A and B in the figure, but not at location C. The local maintenance personnel asked TASC to investigate this white foreign matter and determine if it was mold and what impacts it had on the equipment in the double floor and people's health.

Compared with locations where no foreign matter was observed (location C in Fig. 5), the locations where foreign matter was observed (locations A and B) were found to be in a low-temperature, high-humidity environment.

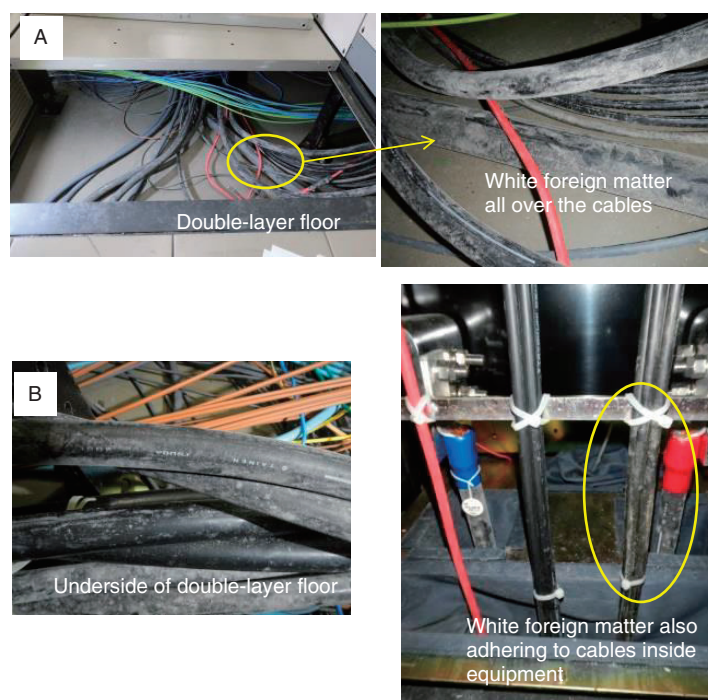
We inspected the detailed state of the foreign matter. As shown in Fig. 6, the foreign matter was found adhering to cables, the underside of the double-layer floor, and duct openings at locations A and B in the machine room. Upon checking around the inside of the equipment, we also found the foreign matter at the points at which the cables housed inside the equipment were installed above the floor.

Fig. 6. Condition of facilities.

The main component of the foreign matter was mold, and the cause of growth of the mold was the high-humidity environment; therefore, to prevent mold growth, the relative humidity of the machine room must be kept constantly below 60% [3]. The presence of moldy and non-moldy areas in the same machine room also indicates that temperature and humidity are unevenly distributed in the room. Although the mold identified in this investigation is harmless to humans, the presence of a mold-prone environment in some parts of the machine room may cause condensation or other problems that may affect

Under those circumstances, two countermeasures to prevent recurrence of mold outbreaks are necessary: (1) remove the mold with ethanol-containing paper towels or other means; (2) check whether the current statuses of the outside-air inflow and the temperature and humidity distributions in the machine room are properly controlled, identify the cause of high humidity, and implement improvements to the air-conditioning system.
