## Case Study of Malfunctions of Outdoor Security Cameras Caused by Lightning Surge

*Technical Assistance and Support Center, NTT EAST*

This article introduces the malfunctions of outdoor security cameras caused by lightning strikes. The path of the lightning-surge current and countermeasures against the malfunctions are also explained. This is the seventy-fifth article in a series on telecommunication technologies.

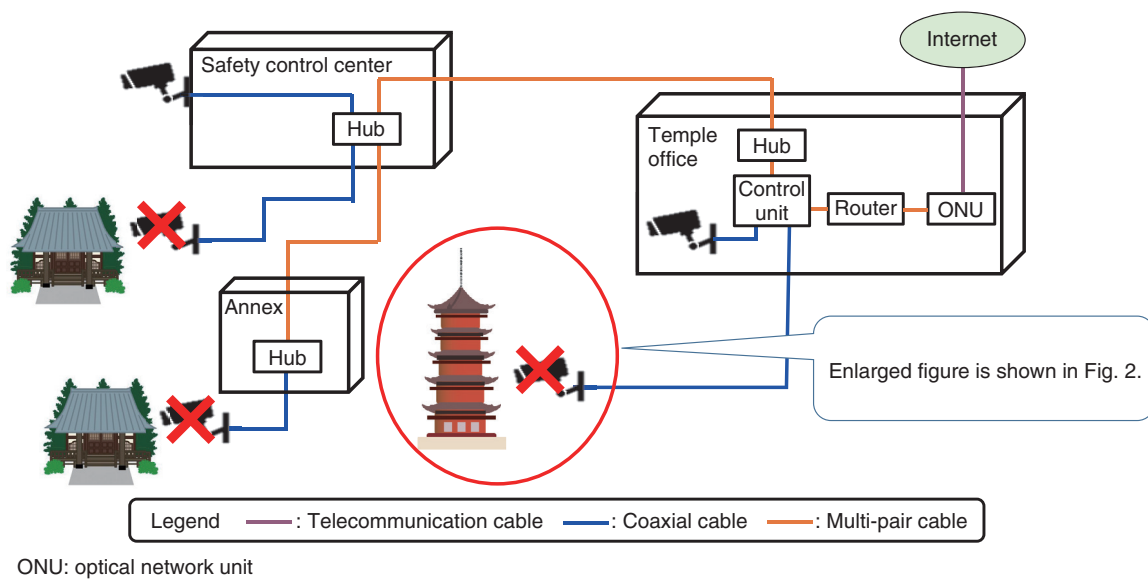
Fig. 1. Network and equipment configuration.

The configuration of the security network when the malfunctions occurred is shown in **Fig. 1**.

The five security cameras (four outdoor and one indoor) are controlled and managed by a control unit located in the temple office, and the cameras and control unit are connected using coaxial cables. The three cameras that malfunctioned were all outdoor types, and other equipment did not malfunction.

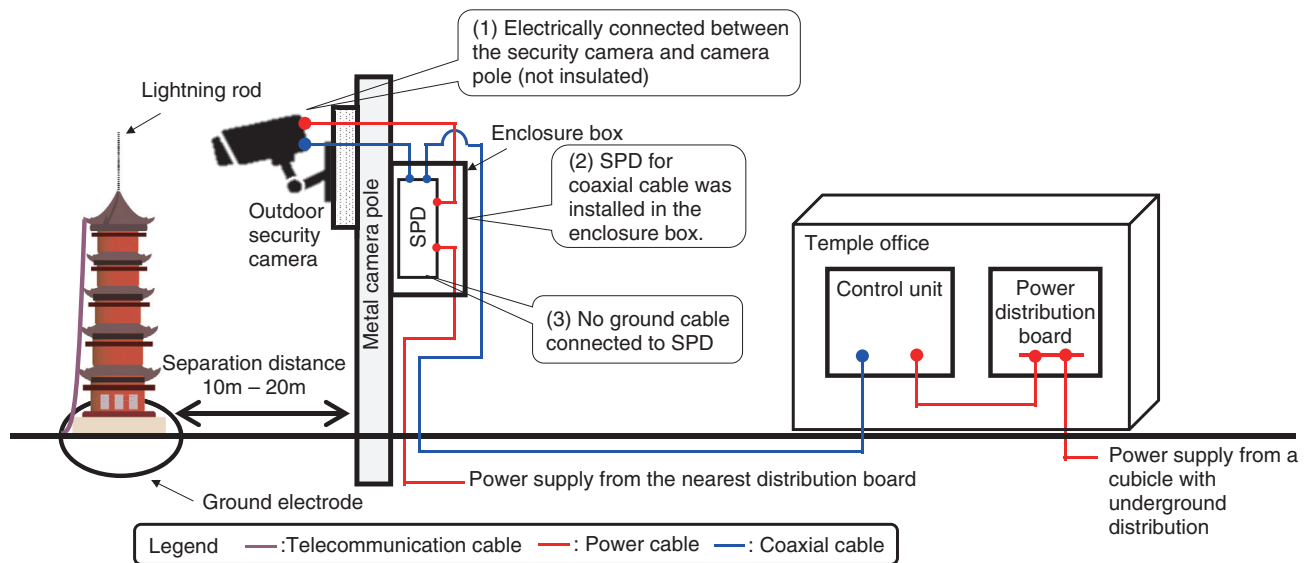
Fig. 2. Equipment conditions when the malfunctions occurred.

The equipment conditions at a malfunction location and results of the on-site investigations are shown in **Fig. 2**.

A lightning rod is installed on the temple building and connected to a ground electrode buried around the building. The outdoor security cameras are installed on metal camera poles, and the distance between the building and security cameras is 10 to 20 meters. The power supply for the outdoor security cameras is fed from a power cable wired underground.

We conducted an on-site investigation to check the installation conditions of the outdoor security cameras at the three locations where the malfunctions occurred and the equipment conditions connected to the cameras. The results of the on-site investigation were (1) the outdoor security cameras and camera pole were not insulated; (2) a surge protective device (SPD) for a coaxial cable was installed in an enclosure

box near the camera, and the coaxial cable and power cable went through the SPD; and (3) the ground cable was not connected to this SPD.

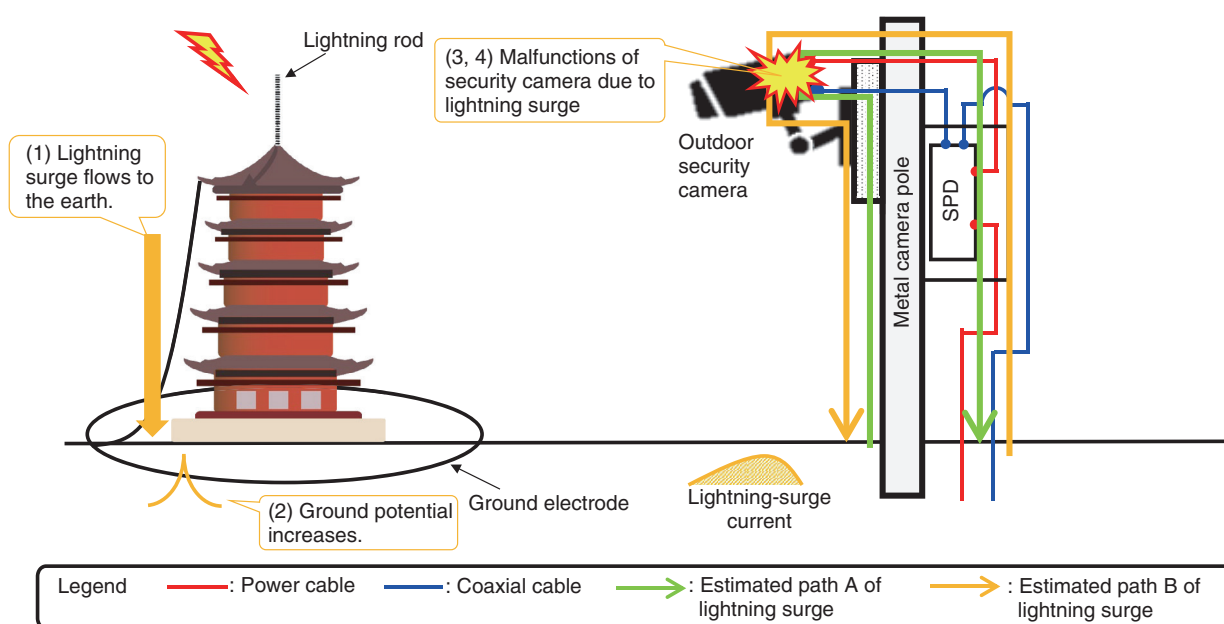
Fig. 3. Estimated lightning-surge path.

investigation, we estimated the path of the lightning surge that caused the malfunctions (**Fig. 3**).

- (1) Due to a lightning strike to the lightning rod, the lightning surge flowed to the earth from the ground electrode.
- (2) Flow of the lightning surge into the earth caused an increase in the ground potential.
- (3) The increase in the ground potential caused the lightning surge to flow into the nearby camera pole (estimated path A) or into the coaxial-cable shield and power cable laid underground (estimated path B).
- (4) The lightning surges flowed through the camera pole and into the security camera (estimated path A) or flowed into the camera from the shield of the coaxial cable or power cable (estimated path B).
