Deterioration of Telecommunication Equipment and Facilities in Salt-damage Environments—Case Studies of Corrosion in Guy Wires and Maintenance Holes

Technical Assistance and Support Center, NTT EAST

This article presents examples of equipment and facility deterioration due to corrosion of guy wires and maintenance holes installed in coastal areas as well as examples of countermeasures to protect equipment and facilities from salt damage. This is the seventy-sixth article in a series on telecommunication technologies.

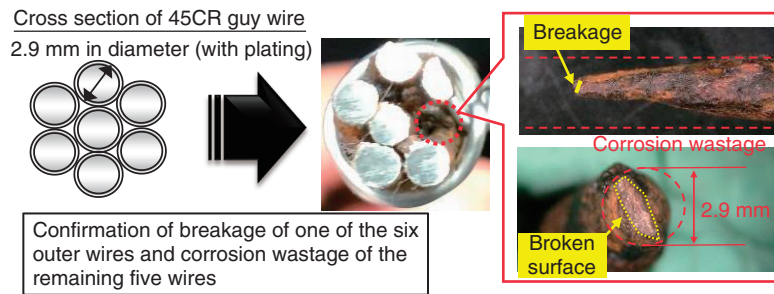
The cross section of the severe corrosion area of the guy wire is shown in Fig. 3. We measured the residual

Fig. 3. Cross section of the severe corrosion area of the guy wire and the state of corrosion of the outer wires.

strength of the wires within the guy wire. As listed in **Table 1**, the residual strength of the wires had decreased by an average of 77%. The progression of corrosion in areas other than the severe corrosion area is shown in **Fig. 4**, which shows the number of par-

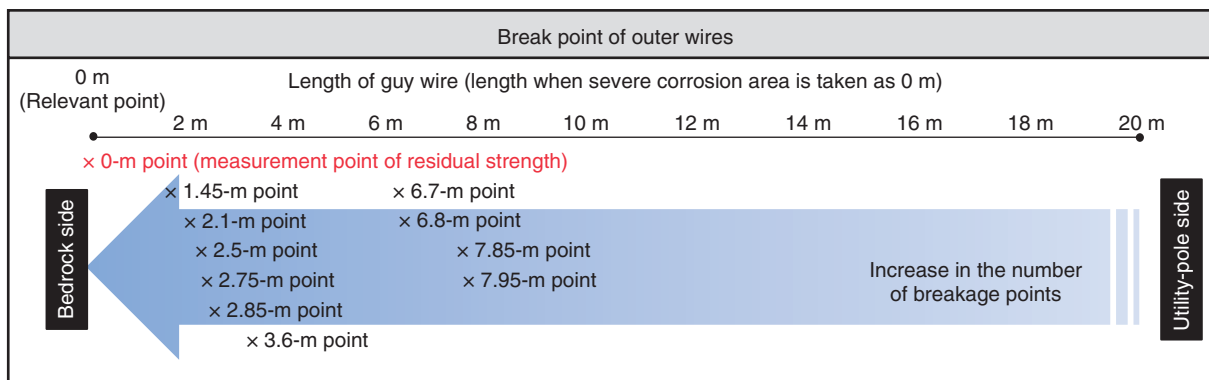
Fig. 4. Progression of corrosion in areas other than the severe corrosion area of the guy wire (partially broken outer wires: 11 locations in total).

tially broken outer wires (“×” in the figure) increases from the utility-pole side to the bedrock side. This confirms that corrosion areas are more prevalent on the bedrock side than on the utility-pole side.

For a countermeasure against salt damage, it is first necessary to identify areas where corrosion progresses rapidly and requires careful inspection by referencing salt-damage maps, etc. Second, when conducting inspections, it is necessary to ensure that the entire facility is thoroughly inspected since the corrosion rate may vary—even for the same facility—owing to differences in environmental conditions such as wind exposure, which makes it possible to reliably detect unsafe equipment. When messenger wires and guy wires are renewed, implementing cor-

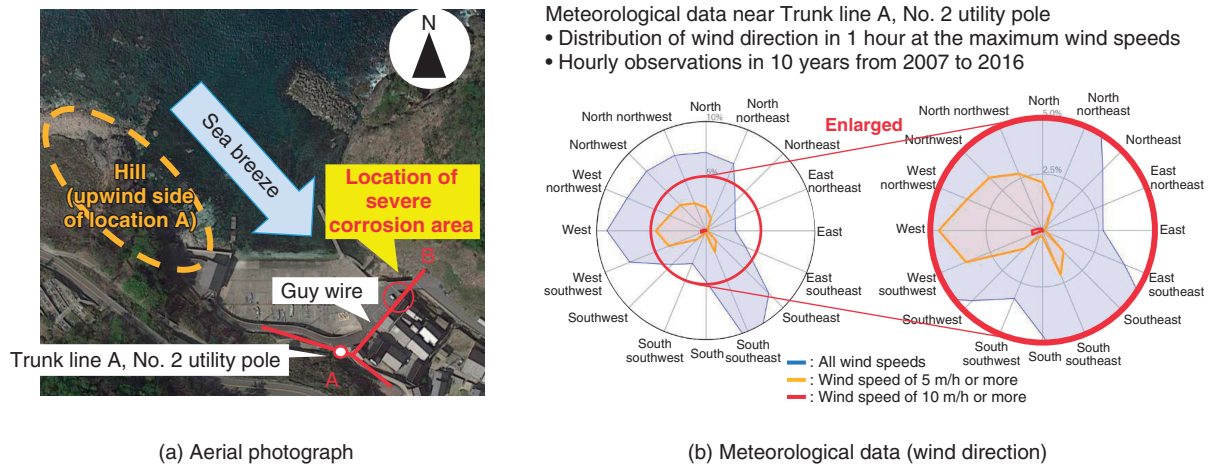
Fig. 5. Local aerial photograph and meteorological data (wind direction).

The reason that the guy wire had severe corrosion on the bedrock side but light corrosion on the utility-pole side was estimated as follows and illustrated in Fig. 5(a). On the bedrock side, there are no obstacles blocking the air containing sea-salt particles above the sea from being carried by the sea breeze to the severe corrosion area of the guy wire. In other words, sea-salt particles in the air above the sea are blown in as they are. On the utility-pole side, however, the hill acts as an obstacle blocking the sea breeze and captures sea-salt particles blown in by the sea breeze. It can therefore be concluded that the difference in the corrosion state in those two sides of the guy wire is due to the difference in the amounts of sea-salt particles in the air blowing on those sides. This estimation is supported by the meteorological data (wind direction) shown in Fig. 5(b), that is, the hill on the upwind side of location A is located in a position where it obstructs sea breeze from the most-frequent wind direction (northwest).

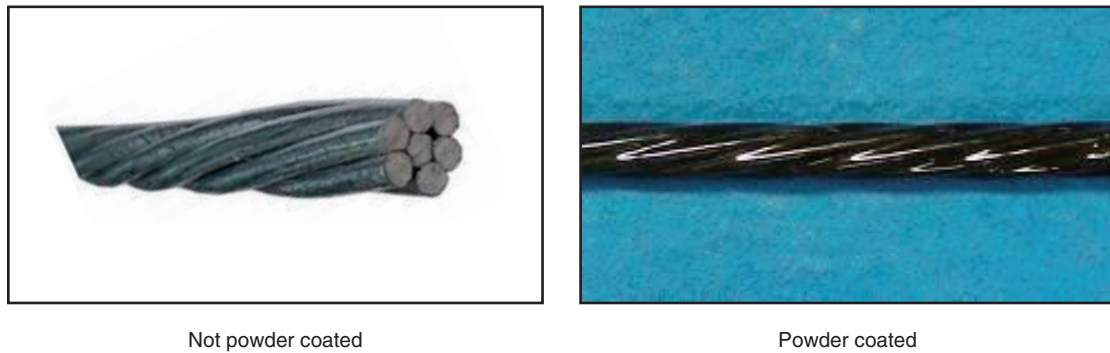
Fig. 6. Example of anti-corrosion measure for messenger wires and guy wires (powder-coated messenger wires).

rosion countermeasures such as replacement with products with stronger anti-corrosion treatment (e.g., powder coating [3]), as shown in Fig. 6, can be expected to extend the service life of equipment.

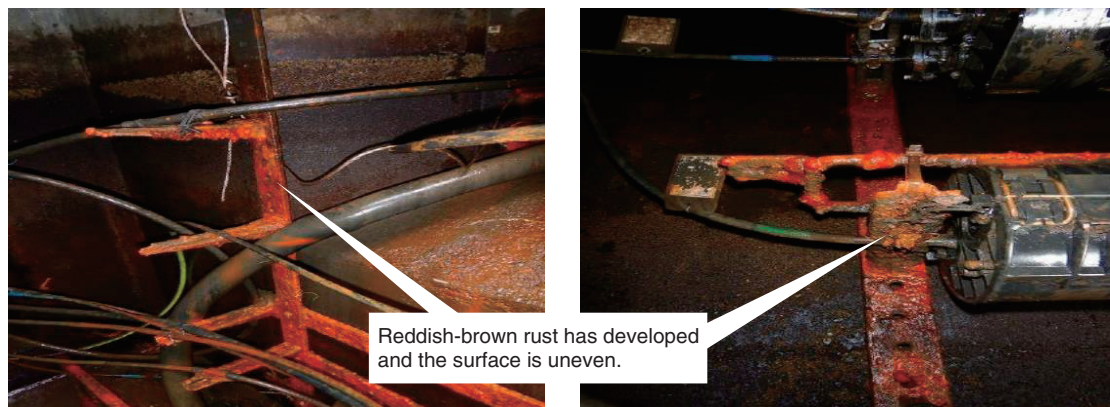
Cases of metal corrosion in a maintenance hole in a section located along a river are shown in Fig. 7. As shown in Fig. 8, the maintenance hole is located about 20 m from the river and about 400 m from the sea. It was previously confirmed that the bottom of the maintenance hole is 0 m above sea level or lower and that the water level inside the maintenance hole rises and falls due to the ebb and flow of the tide, so it was suspected that river water flows into the maintenance hole.

Fig. 7. Appearance of metal corrosion on fixtures inside a maintenance hole.

From the results of the above investigation, we estimated that salt-containing river water flowed into the maintenance hole and increased the salinity of the water retained in the maintenance hole, which in turn accelerated metal corrosion. Effective countermeasures against corrosion include (i) installing a stop-

cock in ducts (**Fig. 10**) to prevent inflow of seawater into the maintenance hole in question and surrounding maintenance holes in the same installation environment; (ii) replacing metal fixtures inside maintenance holes with ones that have powder coating [3] providing robust corrosion resistance (**Fig. 11**); and (iii) attaching a galvanic anode to the metal fixture, i.e., by connecting a metal with lower electrical potential than the metal of the target fixture, which sacrificially corrodes instead of the target fixture.

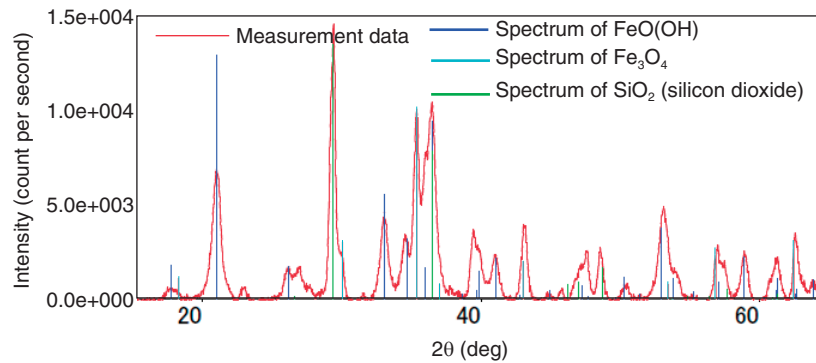
Fig. 9. Results of X-ray structural analysis of metal-fixture adhering substance 1.

The results of the X-ray structural analysis of the mounting hardware and metal-fixture adhering substances are shown in **Fig. 9**. They indicate that metal-fixture adhering substance 1 contains iron-corrosion products, indicated by peaks at the spectral positions of hydroxides (goethite: FeO(OH) and magnetite: Fe₃O₄), which are formed when iron corrodes. As shown in **Table 3**, the other samples (the mounting hardware and metal-fixture adhering substance 2) were confirmed to contain a hydroxide, FeO(OH), which is an iron-corrosion product. Since iron corrosion is accelerated as the concentration of chloride ions increases and FeO(OH) generates Fe₃O₄, the above results suggest the effect of salt damage.

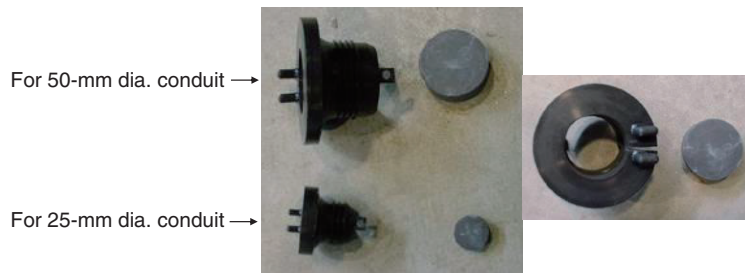
Fig. 10. Examples of stopcock.

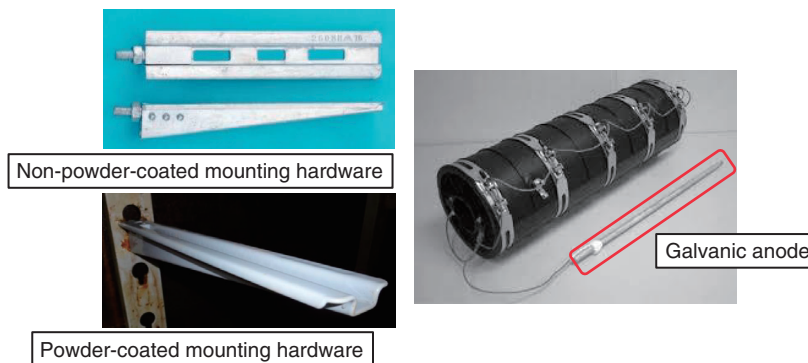
Fig. 11. Examples of corrosion countermeasures for metal fixtures.
