## Case Study of Voice Disconnection During Calls on the Hikari Denwa IP Telephone Service due to DHCP Conflicts

*Technical Assistance and Support Center, NTT EAST*

This article describes a case study of a failure in which voice calls on the Hikari Denwa IP telephone service were being disconnected due to DHCP (Dynamic Host Configuration Protocol) conflicts. This is the eighty-fourth article in a series on telecommunication technologies.

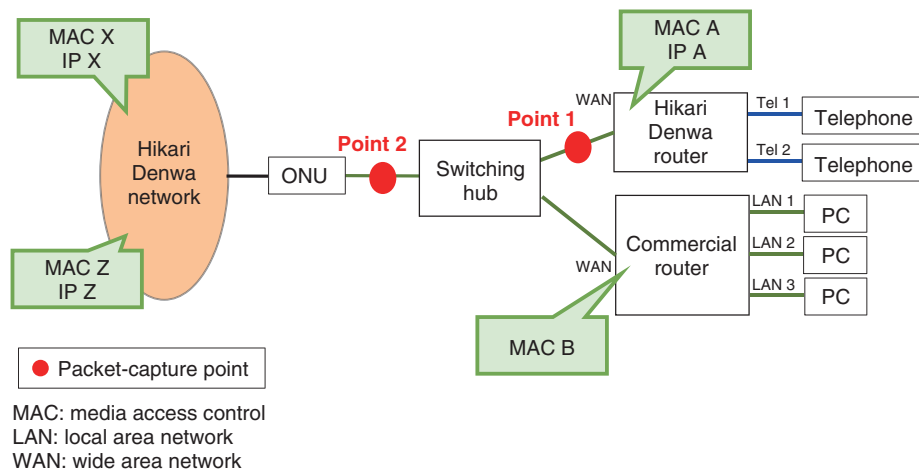
Fig. 1. Configuration of customer's equipment and capture points.

The configuration of the customer's equipment is shown in **Fig. 1**. A switching hub is connected to downstream of an optical network unit (ONU) of the Hikari Denwa network, and the signal from the ONU is branched into a Hikari Denwa router and Internet-access router (referred to as the commercial router). This Hikari Denwa router has four analog ports, but only two are used to connect to analog telephones. Multiple personal computers (PCs) for Internet communication are connected to the commercial router.

To investigate this failure, we made a test call and sent a hold tone from a test terminal to check the voice status. At that time, we captured Hikari Denwa packets and Internet-communication packets at points 1 and 2 in Fig. 1 and analyzed the status of Real-time Transport Protocol (RTP) packets.

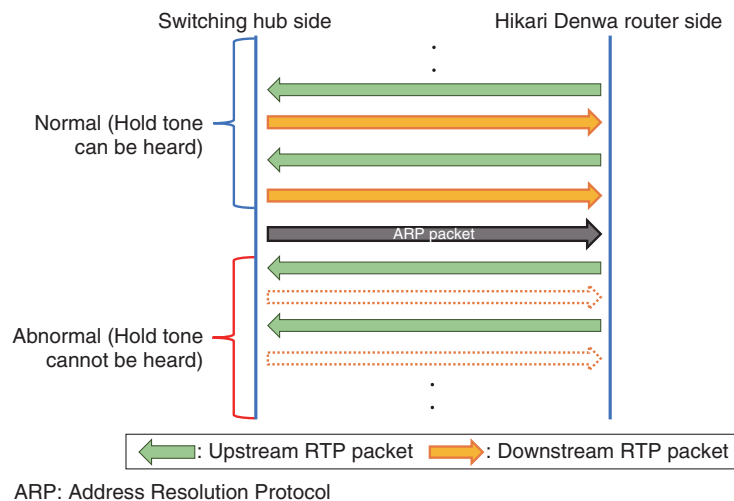
Fig. 2. Flow of Hikari Denwa packets at point 1.

As a result of our analysis of the RTP packets at point 1 (Fig. 2), we confirmed that both upstream and downstream RTP packets flowed normally at the start of the test call. However, three minutes later, the downstream RTP packets (the hold tone from test terminal) stopped, but the upstream RTP packets (the voice from the customer's telephone) were flowing normally.

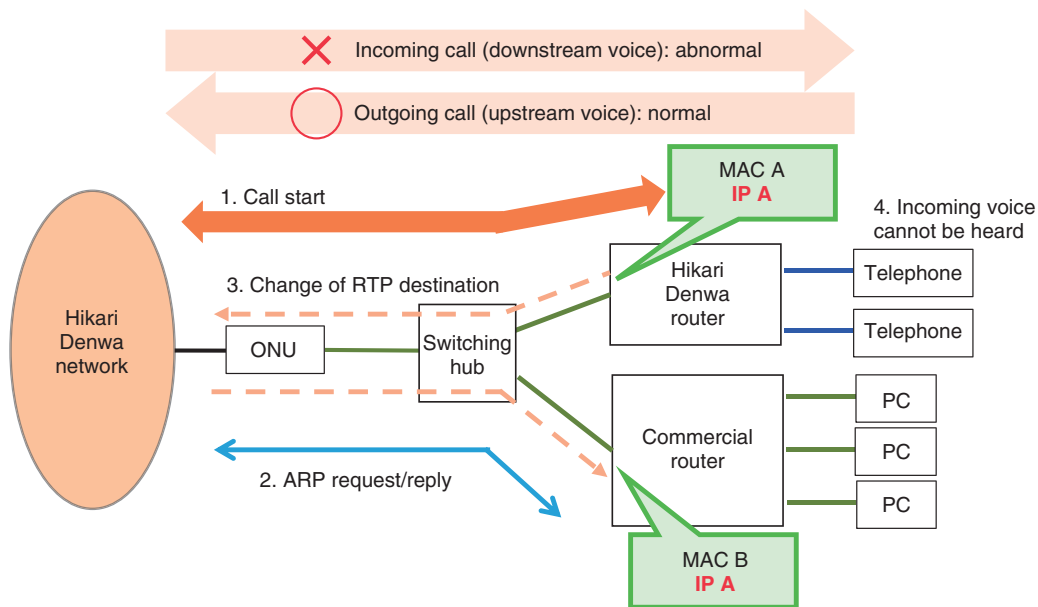
Fig. 5. Mechanism of occurrence of disconnected voice call.

On the basis of the above results of the investigation, it is concluded that the cause of this failure was the change of the destination MAC address of the downstream RTP packets from the Hikari Denwa router to the commercial router. Therefore, the downstream RTP packets are sent to the commercial router, the RTP packets do not reach the Hikari Denwa router, and the voice becomes disconnected (Fig. 5).

At the customer’s equipment, the commercial router was connected to the switching hub in parallel with the Hikari Denwa router. The DHCP client function of the commercial router used for the Internet connection should be disabled; however, for some reason, the commercial router was also operating as a DHCP client, so the same IP address as that of the Hikari Denwa router was issued from the Hikari Denwa network, which resulted in sharing the same IP address.

switching hub, an ARP packet was sent from the commercial router during the call; thus, the destination MAC address of the RTP packet sent from the network side was rewritten as the MAC address of the commercial router.

The switching hub learns the MAC addresses for each port and assigns the destination port to the Hikari Denwa router or commercial router on the basis of the destination MAC address. If the destination MAC address is rewritten, downstream RTP packets are no longer transmitted to the Hikari Denwa router; the result is a status in which the upstream voice can be heard, but the downstream voice cannot be.
