Manual for Assisting with Troubleshooting in PHS Digital Cordless Telephone Systems

Technical Assistance and Support Center, NTT EAST

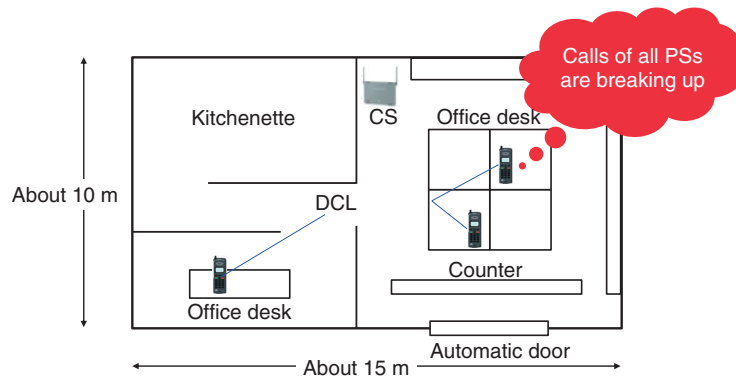
Fig. 3. Configuration of customer's equipment.

A customer using a DCL of the αA1 key telephone system reported that “calls in the store are breaking

up.” The customer’s equipment is illustrated in **Fig. 3**. A CS is installed near the center of the first floor in the store.

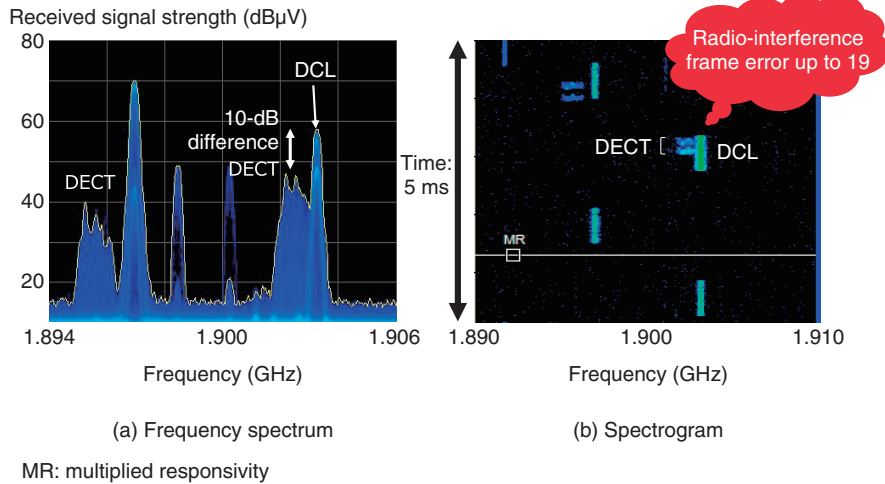
Fig. 4. Results of measuring radio environment.

The PSs were set to the terminal-maintenance mode on the first floor of the store, and the investigation was conducted according to the flow chart shown in Fig. 2. In this case, the handover was not executed since there was only one CS. The investigation was therefore started by checking the received signal strength. The strength in the customer’s store was 40 dBµV or higher, so there was no issue with that. Then the FER was checked, revealing that the FER increased in a specific place in the store.

manual indicate that radio waves of other wireless systems may have been interfering with the DCL radio waves. However, no equipment using other wireless systems was found in the store. To evaluate the electromagnetic environment in more detail, the radio-wave spectrum was measured using a spectrum analyzer where the problem occurred. The results of that measurement are illustrated in **Fig. 4**. The frequency spectrum and spectrogram (i.e., time change of the spectrum) when a call was interrupted are shown in Figs. 4(a) and (b), respectively. From Fig. 4(a), we can see the DCL signals exist in the frequency band of the DECT. Similarly, the spectrogram revealed that the DCL and DECT signals overlap. These results indicate that the reported problem was due to interference between the DCL and DECT

As a result of investigating the electromagnetic environment including the area outside the customer's store, we found that DECT terminals were being used in an adjacent store and the radio waves from those terminals were interfering with other terminals in the customer's store. The DECT can usually prevent interference with DCL radio waves by detecting the usage status of radio waves with carrier sensing and switching channels depending on the results. However, in the case of this customer's environment, interference prevention would not work well because the terminals in the two stores were far apart.

We confirmed that wireless signals including those from the adjacent store are transmitted by less than 12 slots in the customer's area and replaced the customer's PSs, i.e., A1-DCL-PS terminals (DCL), with A1-DECT-PSSET terminals (DECT), which can be adapted for up to 12 slots (12 terminals) in the same frequency band.
