A More Efficient Method of Inspecting Utility Pole Damage Caused by Major Earthquakes

Real-world Problems

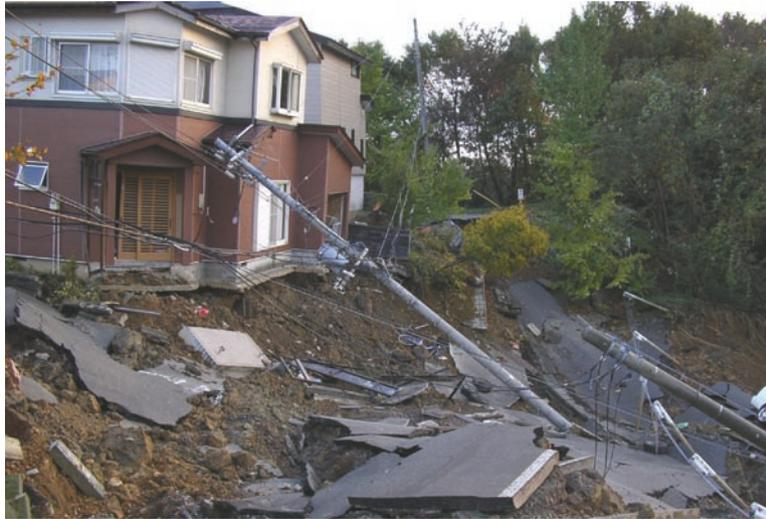
The Niigata Prefecture Chuetsu earthquake, which occurred on October 23, 2004, registered a maximum seismic intensity of 6.9 on the Richter scale. It caused serious loss of life and many injuries and severe damage to homes, buildings, roads, and infrastructure facilities such as gas, water, and electricity supplies. Damage to communication facilities was also severe [1]. A total of 3401 utility poles supporting communication cables were toppled, broken, or left leaning. That is about the same number of poles as damaged in the Hanshin-Awaji earthquake, which registered 7.2 on the Richter scale. Most of the damage in Niigata occurred because the poles had been installed on weak ground, so they were damaged by ground movement (**Fig. 1**).

Fig. 1. Utility poles damaged by landslide.

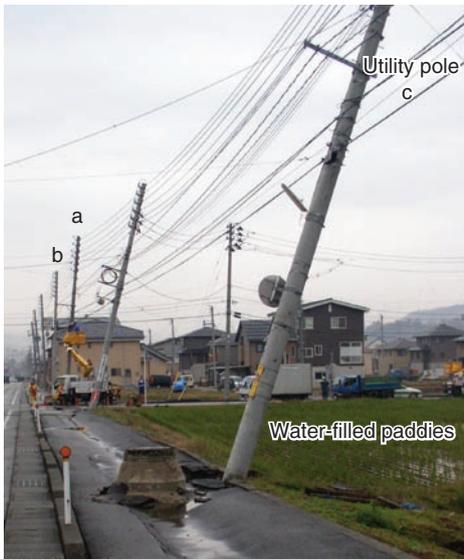
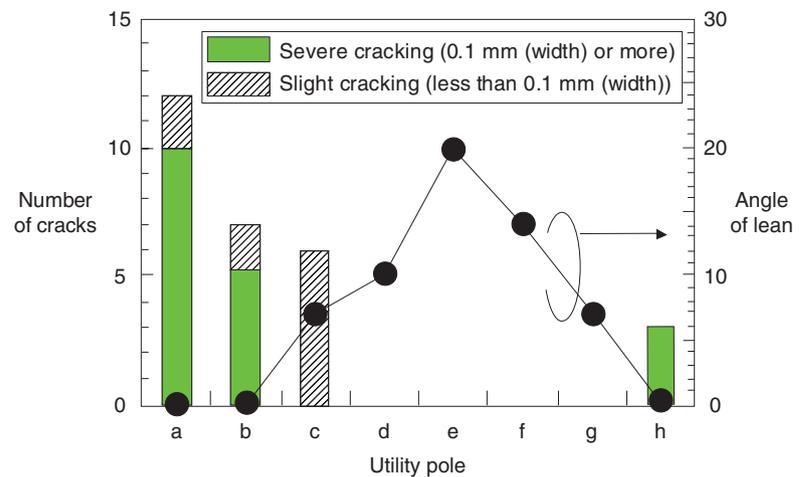
Toppled and leaning utility poles are most often seen in areas where the installation is on weak ground or adjacent to weak ground. In particular, in places where utility poles are installed beside roads and anchored in hard asphalt adjacent to water-filled paddies, the swaying of the pole tops during an earthquake tends to cause leaning toward the soft-ground side (**Fig. 2(a)**). In such damage areas, a utility pole that leans over more than the others (utility pole e) pulls down on the adjacent poles (a–h) (**Fig. 2(b)**) to produce a chain-like effect that results in a series of leaning utility poles. In such circumstances, cracking or other such damage is not seen in the pole that leans the most, but such other damage is found in the surrounding poles that lean only slightly. Therefore, it is necessary to inspect and repair the surrounding poles as well as to repair the

(a) Photograph of damage

(b) Damage data

Fig. 2. Chained leaning of utility poles in a rural area.

poles with the most obvious damage.

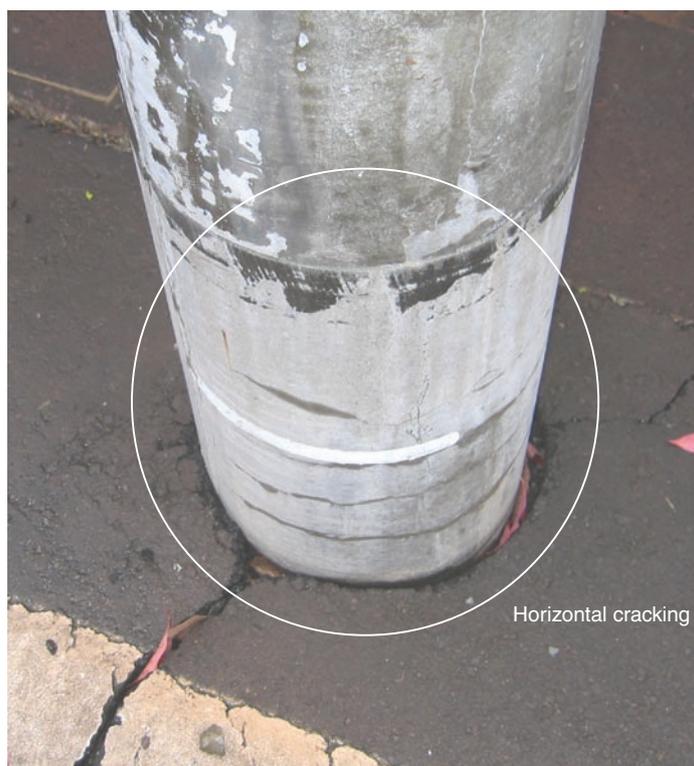
In residential districts and other such areas where utility poles are anchored in asphalt or other hard material that completely surrounds them, the leaning phenomenon seen in rural areas is seldom observed. Most of the damaged utility poles have horizontal cracking near the base (**Fig. 3**). This cracking is believed to result from the large moment created by the swaying pole top due to seismic movement and the firmly anchored base. For utility poles installed in

Fig. 3. Example of horizontal cracking in an urban area.

urban areas, it is therefore important to focus inspection on the part of the pole near the base, where damage is most likely to occur.
