# Technique for Repairing Bridge-supported Conduits

We have developed a technique for performing in-situ partial repairs on bridge-supported conduits that have cables running through them. The safe, inexpensive, and timely repair of corroded bridge-supported conduits is essential to improve the adaptability of optical services and prolong the lifetime of network installations. This article presents an overview of this new technique.

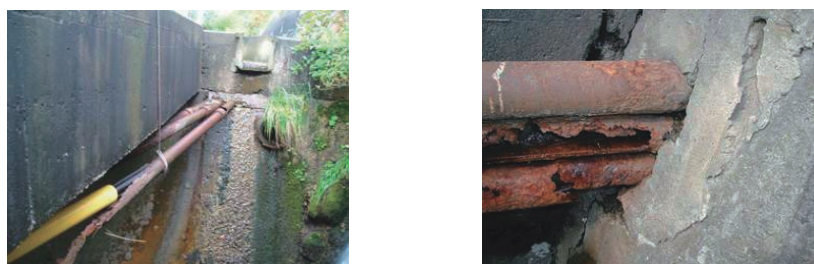
Fig. 1. Examples of corrosion (side of bridge abutment).

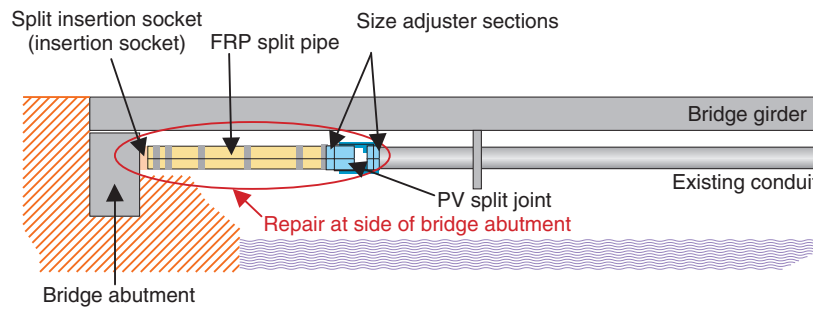
Fig. 3. Repair at side of bridge abutment.

The new repair technique that we have developed is applicable to various situations, but they can be broadly divided into cases where it is applied at the side of bridge abutments and cases where it is applied in the midsection of a bridge. The same repair method is used for both types of repair. It involves cutting away the corroded and degraded parts requiring repair and then incorporating repair pipe materials into existing conduit (**Fig. 2**). This repair technique can be used to repair any arbitrary length of up to 2 m (**Fig. 3**).

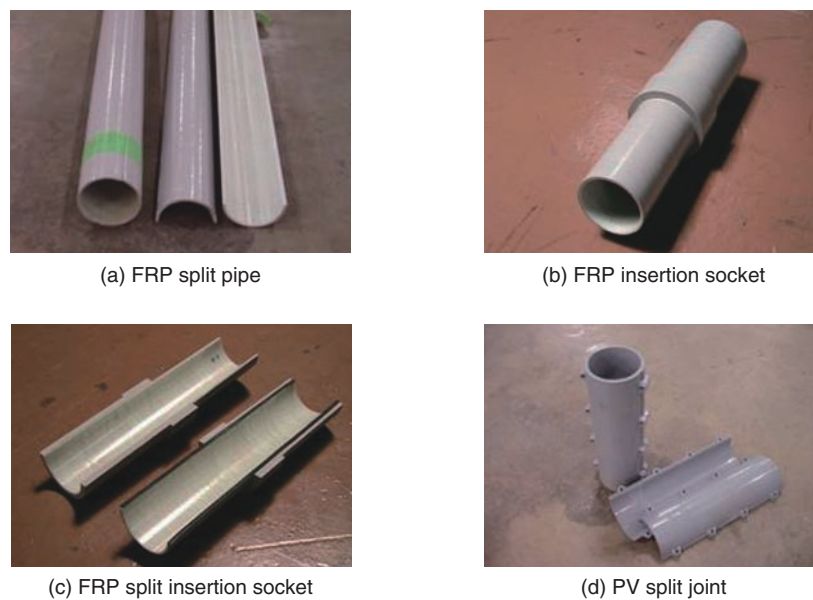
Fig. 4. Components used for repairing bridge-supported conduits.

The main constituents used in the repair of bridge-supported conduits are fiber reinforced plastic (FRP) split pipes, FRP insertion sockets, FRP split insertion sockets, and polyvinyl (PV) split joints (**Fig. 4**). The sockets are used in repairs at the sides of bridge abutments, where they are inserted into the conduit at the side of the bridge abutment after the corroded parts have been cut away. Solid insertion sockets are used for empty conduits while split insertion sockets are used for conduits that have cables running through them.

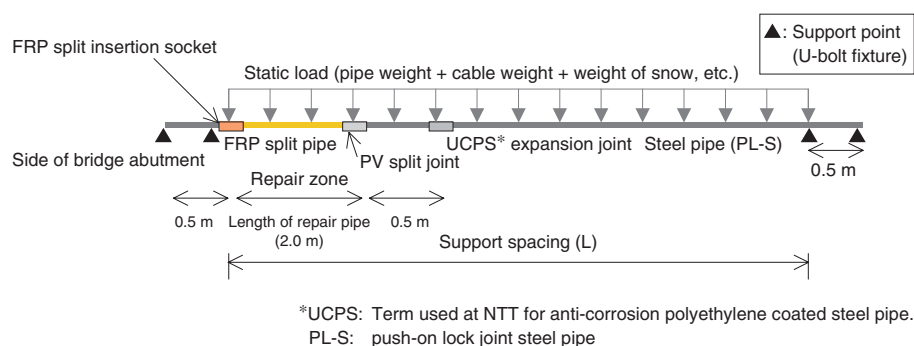
Fig. 5. Models used to verify the technique's ability to withstand static loading.

We conducted verification tests to determine whether a conduit repaired using our technique could retain a similar amount of twist to an existing bridge-supported conduit. This is a good criterion for evaluation under static loads. We determined the stresses acting on the conduit based on the physical properties and the loading forces described above. This was done using the experimental setup shown in **Fig. 5**. The length of the FRP split pipe was 2 m. We investigated the applicability of the technique to static loads that are constantly applied to a bridge-supported conduit by considering the loading patterns in three different regions of Japan—an ordinary region (snow depth  $\leq 0.5$  m) and two heavy snowfall regions ( $\leq 1$  m and  $\leq 2$  m)—and with different combinations of supporting intervals.

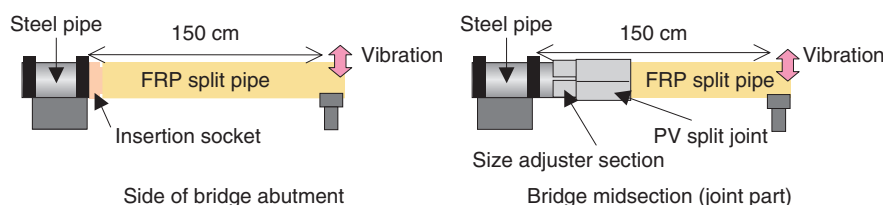
Fig. 6. Models used to verify the technique's ability to withstand dynamic loading.

Traffic vibration produces effects similar to those of an earthquake in that the bridge is vibrated by passing vehicles and this vibration propagates to the bridge-supported conduit via the supporting fixtures. We assumed that traffic vibration mainly causes the bridge-supported conduit materials to undergo repeated vibration in the vertical direction. We constructed the test setup shown in **Fig. 6** and performed verification tests by generating simulated vertical vibration. The results of these tests confirmed that no abnormalities were caused by vibration fatigue.

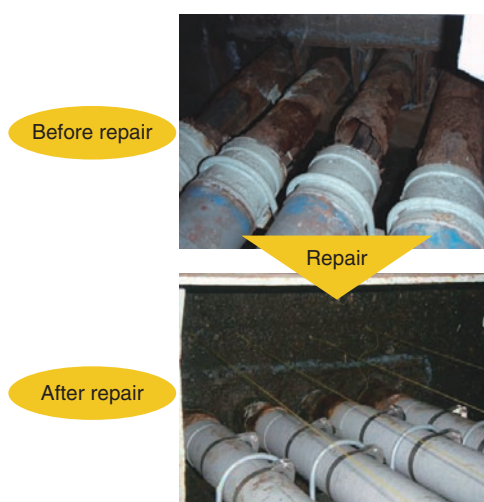
Fig. 7. Example of a repair at the side of a bridge abutment.

We performed trial verification work at actual installations, and we checked the operational constraints of this work and the quality of the resulting repairs (Fig. 7). It was possible to perform repairs without difficulty even on conduits with cables already installed. As a quality check on the finished shape, we also inspected the repaired parts after six months. We visually checked for signs such as discoloration of the pipe materials and the opening of gaps at interconnecting parts, and we used offset measurements to measure the amount of movement in the repaired parts. These checks did not reveal any obvious defects and confirmed that there were no quality issues.
