Case Studies of Insulation Failures in Outdoor Facilities and Countermeasures against Failures

In this article, we introduce failure cases in outdoor access equipment and a countermeasure to them. This is the twenty-second in a bimonthly series on the theme of practical field information on telecommunication technologies. This month's contribution is from the Materials Engineering Group, Technical Assistance and Support Center, Maintenance and Service Operations Department, Network Business Headquarters, NTT EAST.

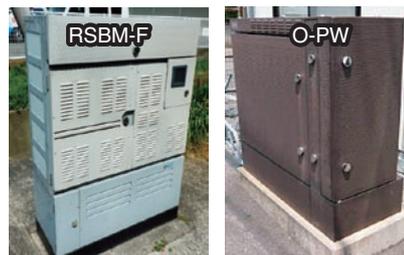
Fig. 1. Examples of outdoor RT equipment.

NTT EAST has been developing and deploying outdoor optical access equipment that accommodates multiple lines (referred to below as remote terminal (RT) equipment) in order to economically upgrade the metallic cable network. Compact RT equipment can be installed in small spaces such as in the corners of public sites and facilities and under pedestrian bridges, and many units have been installed throughout Japan (Fig. 1).

O-PW: Outdoor Cabinet with Power
RSBM-F: Remote SuBscriber Module-Feeder

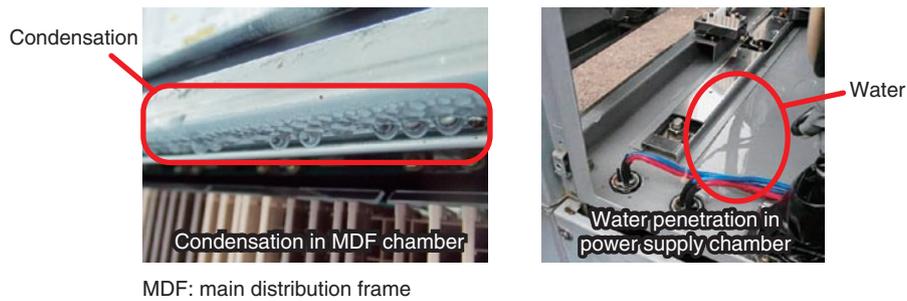
Fig. 2. Examples of water penetration in equipment.

Similar characteristics have been found in compact RT equipment in which insulation failures have occurred. Condensation has been observed inside the equipment on the inner side of the door and on the underside of the top panel, and traces of water have been found on the inspection sheet inside the equipment. In the worst cases, water has been found to collect on the floor of the power supply chamber (Fig. 2). These conditions led us to infer that external environmental factors such as rain and humidity contributed to the insulation failures in the equipment.

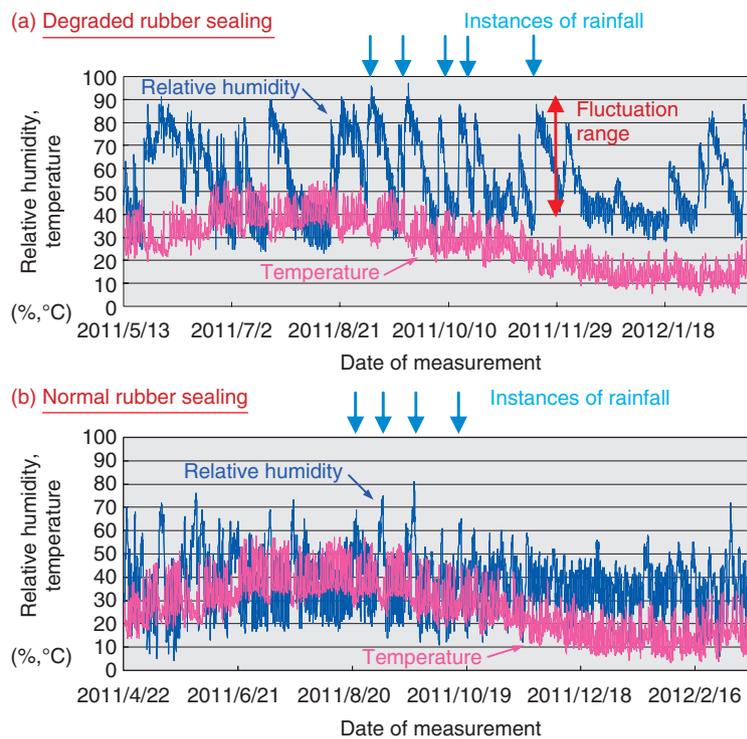
Fig. 3. Temperature/humidity inside compact RT equipment before and after rainfall.

The changes in temperature and humidity inside equipment were measured when there were cases of normal and degraded rubber sealing. The results are shown in **Fig. 3**. These graphs show that after a rainfall, the internal relative humidity rises remarkably in equipment with degraded rubber sealing, whereas it shows little change in equipment with normal rubber sealing. In other words, it can be inferred that the housing is not airtight in equipment with degraded rubber sealing, and that the equipment can consequently be affected by moisture in the outside air or can be penetrated by rainwater.

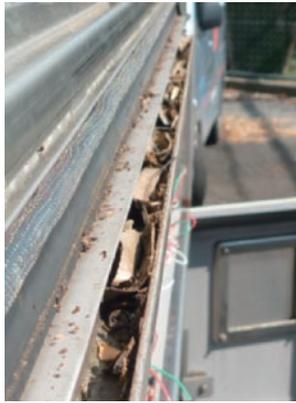
Fig. 4. Clogged drainage duct.

A drainage duct is installed in each door of the compact RT equipment in order to lower the risk of rainwater penetration. However, if fallen leaves clog

the drainage duct (**Fig. 4**), or if the amount of water flowing into the drainage duct is excessive due to heavy rain, the rubber sealing may come into contact with rainwater as the drainage duct overflows. This raises the risk of rainwater penetrating the equipment through gaps in the rubber sealing (**Fig. 5**). Surveys that we have conducted to date have revealed that rubber sealing often deteriorates and cracks when equipment doors are frequently opened and closed during circuit-deployment or maintenance work. They have also shown that it is not unusual for rainwater to penetrate the equipment when leaves and branches become wedged between the door and the housing when the door is opened and closed (**Fig. 6**).

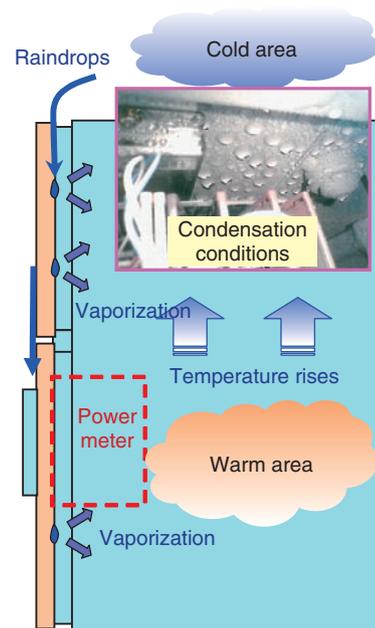
Fig. 7. Mechanism behind insulation failure.

supply section and other areas. At night, the outside surface of the housing can be cooled by cold outside air, and if the warm air inside the equipment comes into contact with the cooled inner side of the housing under such conditions, condensation can occur due to the temperature difference. However, the occurrence of condensation does not necessarily mean that an insulation failure will occur. We examined problem equipment in various regions and found that insulation failures had occurred under severe condensation in which many water droplets formed on the inside of the top panel. With this in mind, we postulated that insulation failures occur by the following mechanism (Fig. 7).

- (1) Rainwater and humidity (moisture) penetrate the equipment through gaps between the rubber sealing and housing.
- (2) Temperature inside the equipment rises when the penetrated rainwater vaporizes due to heat inside the equipment.
- (3) The temperature difference between the inside and outside of the equipment causes condensation (water droplets) to form on interior parts of the equipment at relatively lower temperatures (such as the top panel).
- (4) The water droplets drop into the gaps between terminals of the equipment, causing an insulation failure to occur.

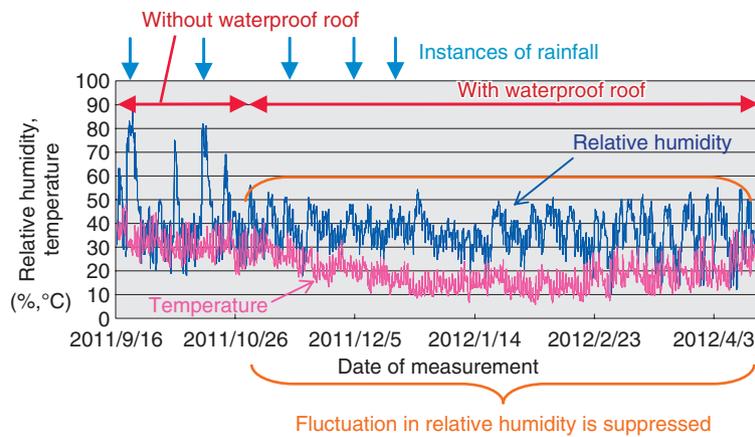
Fig. 9. Temperature/humidity before and after installation of waterproof roof.

The features of the developed waterproof roof are listed in **Table 1**, and the half-year result of a test case using the roof on actual equipment throughout Japan is shown in **Fig. 9**. This graph indicates the relative humidity before and after installation of the waterproof roof. It is clear from these results that installing the waterproof roof suppresses the fluctuation in relative humidity when rainfall occurs. Consequently, installation of a waterproof roof has the effect of preventing the penetration of rainwater and suppressing a rise in humidity within the equipment, which means that this countermeasure is effective in preventing insulation failures.

5. Overview of preventive measure

ity within the equipment; therefore, installing a waterproof roof can be expected to prevent the occurrence of insulation failures.
