Snow-stopper Pole as a Countermeasure for Preventing Snow Damage to Utility Poles

Technical Assistance and Support Center, NTT EAST

Abstract

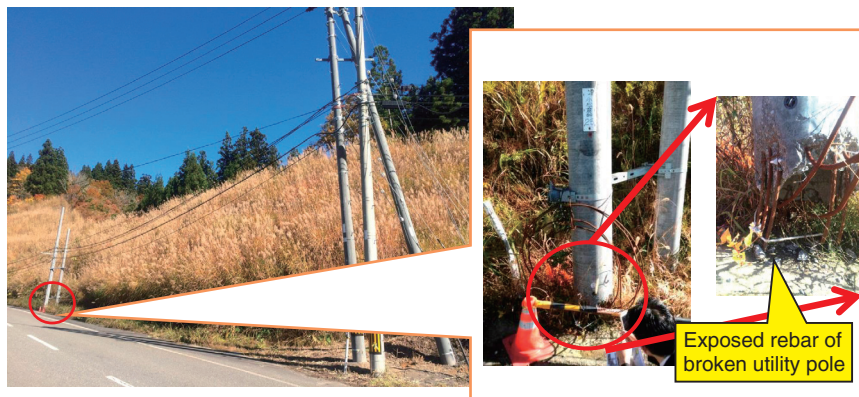
An example of breakage of a concrete utility pole located in a mountainous region that experiences heavy snowfall is shown in **Fig. 1**. In this example, breaks in the concrete of a utility pole affected by

snow damage occurred near the ground. The concrete was crushed, and the rebar inside the utility pole was exposed. Moreover, at the site shown in Fig. 1, there are no trees on the slope of the hillside above the utility pole, and Japanese pampas grass (*Miscanthus sinensis*) grows wild. Therefore, it is conceivable that lumps of snow on the hillside combine with each other to become a massive deposit of snow with heavy snow pressure that piles up on the dry grass with lower frictional resistance. Thus, snow damage can easily occur at this site.

Fig. 1. Site of snow damage and state of broken concrete utility pole.

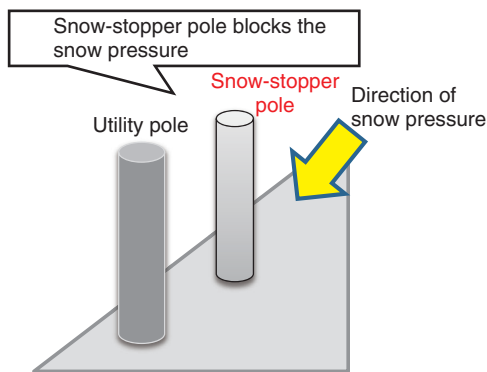
Fig. 2. Placement of snow-stopper pole.

As a countermeasure against snow damage, the snow-stopper pole (about 6 to 7 m in length and 40 to 50 cm in diameter) was set up close to the utility pole (on the upper side of the slope) about 1 m from the utility pole (**Fig. 2**). The snow-stopper pole will alleviate the snow pressure applied to the utility pole positioned below the snow-stopper pole by receiving the snow pressure. The snow-stopper poles are set to be about 40 to 50 cm in diameter, approximately the same size as the utility pole, which enables NTT construction contractors to install the poles themselves without having to undertake large-scale civil engineering work. Since the maximum snow depth in the area where a field trial with the pole was carried out is about 4 m, and the pole should be embedded 2 to 3 m deep, the total length of the snow-stopper pole

was set to 6 to 7 m. The separation distance between the snow-stopper pole and the utility pole was set to about 1 m. The effect of the snow-stopper pole was verified by both computer simulation and actual measurements in the field.

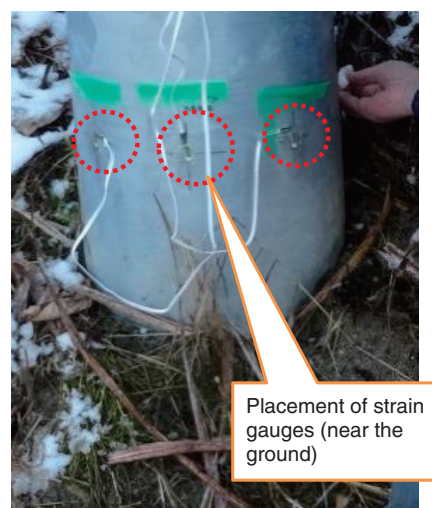
Installing snow-stopper poles as a countermeasure against snow damage is expected to be effective based on the results of the computer simulation described in the last section. Nevertheless, to verify the effectiveness more concretely and quantitatively, the snow pressure applied to the snow-stopper pole and utility pole was evaluated in the field. Stress on the snow-stopper pole and utility pole caused by snow pressure was evaluated by installing strain gauges on the base part of a utility pole and a snow-stopper pole installed exclusively for this test (near the ground, as shown in Fig. 4). Both the snow-stopper pole and utility pole for this test were made of

Fig. 4. Setup for evaluating applied stress due to snow pressure.

steel and had the same specifications (9.5 m/16 kN/STK490) with no overhead equipment attached. This test was performed from December 2016 to March 2017. The amount of snowfall during this period was less than usual for the area, and the maximum snow depth was about 2 m.

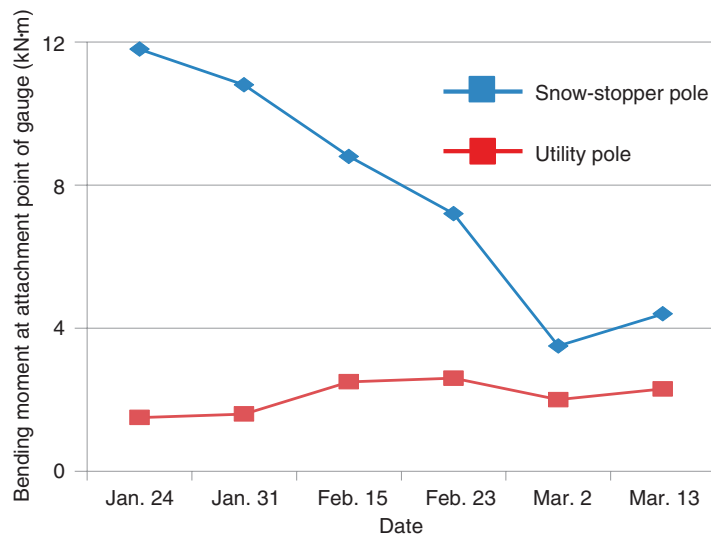
The results of evaluating applied stress due to snow pressure on the snow-stopper pole and utility pole by using strain gauges (Fig. 5) confirmed that the stress received by the utility pole was greatly reduced compared with that received by the snow-stopper pole. For example, the measurements taken on January 24 indicate that the magnitude of the stress received by the utility pole was reduced to about one-eighth of that received by the snow-stopper pole. Moreover, the stress received by the snow-stopper pole changes significantly with time, but the stress received by the utility pole was fairly constant. The snow-stopper pole receives the snow pressure directly from the snow on the slope above it, so the applied stress changes according to the fluctuation in the amount and depth of snow on the slope. In contrast, the utility pole receives snow pressure due to snow between itself and the snow-stopper pole as well as snow in the surrounding area. It is thus inferred that the snow on the slope does not move much, so the applied stress maintains a constant value to some extent.

Fig. 5. Results of evaluating applied stress using strain gauges.

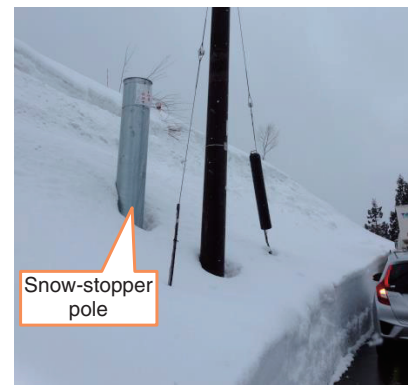
described, and the results of verifying the effectiveness of a countermeasure against such damage using a snow-stopper pole were presented. The verification results confirm the effectiveness of the snow-stopper pole in significantly reducing the snow pressure applied to the utility pole. In consideration of that result, snow-stopper poles have been installed at sites of utility poles in current use on a trial basis, and these trial installations have confirmed that as of the present time, no new cracks due to snow pressure have occurred in the utility poles (**Fig. 6**). The plan is to continue such trials in the future.

Fig. 6. Trial of snow-stopper poles with in-use utility poles.
