Initiatives Targeting Snow Damage to Communication Facilities

Technical Assistance and Support Center, NTT EAST

Many communication facilities installed outdoors are continuously exposed to harsh weather including snowfall. This article presents a countermeasure to prevent the bands that secure signboards to utility poles from breaking and a countermeasure to prevent snow from accumulating on overhead equipment. This is the forty-ninth article in a series on telecommunication technologies.

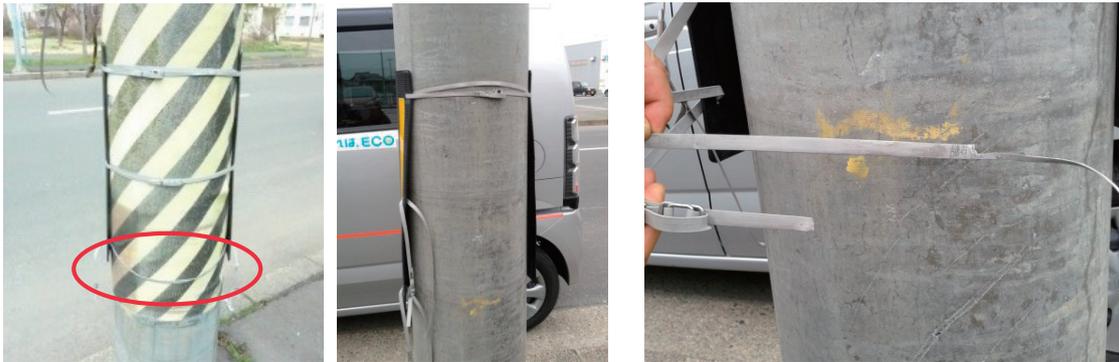
Fig. 1. Breakage of vinyl bands securing utility pole signboards.

Utility pole signboards are installed on utility poles along roads across the country for the purpose of preventing accidents such as vehicles accidentally hitting the utility poles (**Fig. 1**). The signboards are

affixed to the poles with vinyl bands. A common phenomenon that occurs is that one or more of the vinyl bands breaks due to the load of accumulated snow, and the band(s) and/or signboard falls off as a result. This band breakage occurs over a wide region and thus requires a large operation to replace the broken bands. Moreover, if the bands and/or signboards fall off, they might affect passing pedestrians or vehicles, possibly leading to accidents.

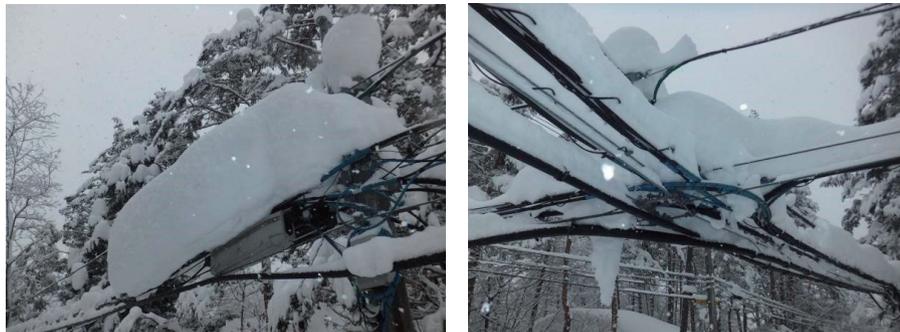
Fig. 2. Snow accretion on overhead equipment.

In snowy areas, snow accumulates on overhead equipment such as cable closures and cable intersections (**Fig. 2**). If the snow continues to fall for several days, repeated melting and resolidification will generate lumps of ice, and the risk of those ice lumps falling is a very dangerous one that may lead to traffic accidents resulting in injury or property damage (**Fig. 3**). Accordingly, maintenance to remove accumulated snow is carried out periodically to prevent such accidents. When workers clear snow in this kind of operation, they must use an aerial platform, the use of which is a major operation.

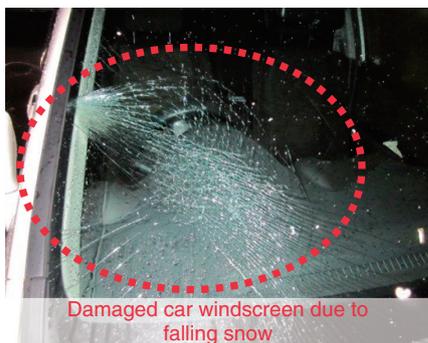
Fig. 3. Property damage accident caused by snow falling from overhead equipment.

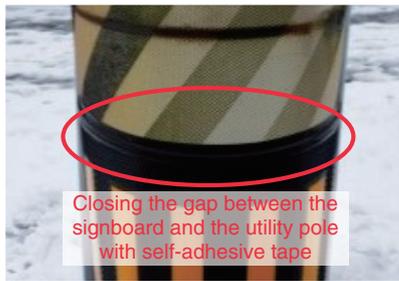
Fig. 4. Verification of state of band breakage.

We conducted a field trial to confirm the mechanism by which the bands break. In this trial, two patterns of load application by snow accumulation were assumed: (i) the case in which the bands break due to application of a load to the utility pole signboard and (ii) the case in which a load is applied only to the band itself, causing it to break. The aim of the trial was to verify by which pattern (or both) the bands break. During the trial, lasting from December 2015 to April 2016, a countermeasure was applied that involved closing the gap between the utility pole and the utility pole signboard (**Fig. 4**). This was done to verify the case in which the band broke due to snow

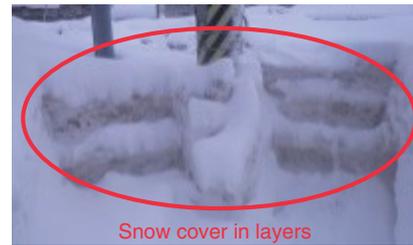
Fig. 5. Layers of accumulated snow in trial site.

loading on the band itself. A countermeasure involving protecting the band with sealants was also applied to verify the case in which the band broke due to snow loading on the utility pole signboard. The trial site used a utility pole placed in a residential area located at the foot of a mountain in a region that receives heavy snowfall. The amount of snowfall in the year of the trial (2016) was about 2.5 m, and the trial site was a location where snowfall and ploughed snow regularly pile up significantly (Fig. 5).

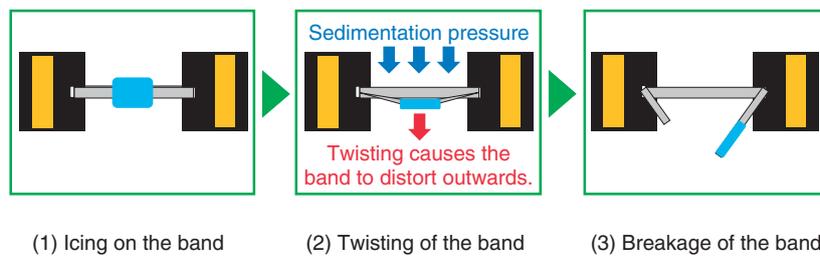
Fig. 6. Mechanism by which the band breaks.

We checked the state of the signboard and band during snowfall and after snow thawing. In the case where the gap between the utility pole and the utility pole signboard was closed by attaching tape, icing and twisting of the band’s fastener and the left/right ends of the band still occurred. These phenomena caused the band to break. Since breaking, sagging, and twisting of the band was confirmed even if the gap between the utility pole and the signboard was closed, it was assumed that sedimentation pressure (pressure caused when snow accumulates and settles in one place) acts directly on the band. The mechanism leading to the band breaking was considered to have three stages: (1) ice building up on the band, (2) generation of sedimentation pressure causing twisting of the band so it distorts outward, and (3) break-

age of the band (Fig. 6).

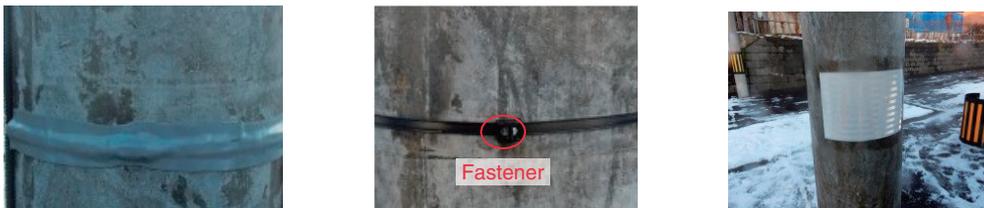
Fig. 7. Countermeasures: (1) standard sealant; (2) power band; and (3) reflective sheets (signboard with adhesive backing).

It became clear that the load is directly applied to the band by sedimentation pressure, so three proposed countermeasures against band breakage (Table 1) were tested in trials from December 2016 to April 2017 (Fig. 7).

Proposed countermeasure	Name	Principle
(1)	Standard sealant	Reduce the effect of sedimentation pressure by protecting the entire band.
(2)	Power band	Improve durability and resistance to sedimentation pressure by using a band resistant to twisting.
(3)	Signboard with adhesive backng*	Remove the need for a band by bonding signboard directly to the utility pole with adhesive sheet.

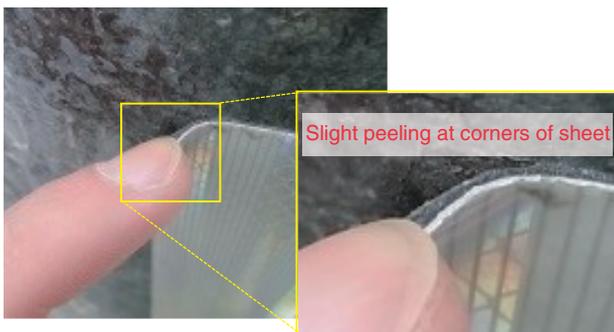
Fig. 8. Result of applying proposed countermeasure (3).

With proposed countermeasure (3), some of the trial samples showed slight peeling at the four corners of the sheet (**Fig. 8**), but the adhesiveness of the sheet was found to be basically satisfactory, and it was easy to apply the sheet evenly, with the correct alignment and without puckering or air bubbles.

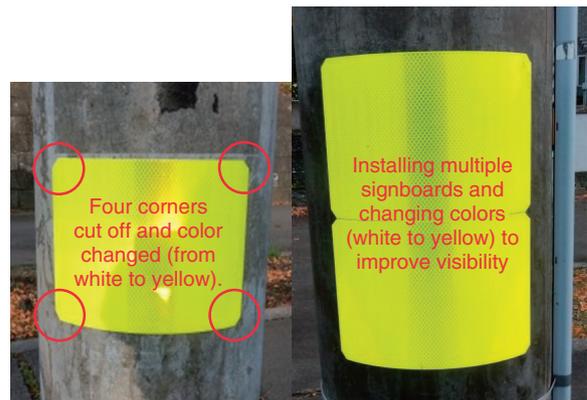
Fig. 9. Additional trial of signboard with adhesive backing.

an on-site trial of an improved version of this countermeasure (3), namely, a signboard with adhesive backing is continuing. In this trial, in addition to the adhesiveness and visibility of the signboard, the size and color suitable for installation are being evaluated (**Fig. 9**). Similar trials were also carried out on steel-pipe columns.

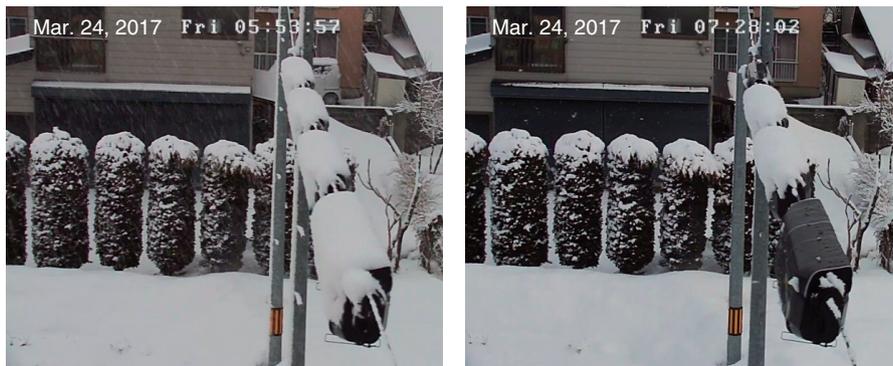
Fig. 10. Test to prevent snow accumulation on closures.

It is difficult to avoid snow accumulation on overhead equipment in snowy areas, but it is thought that if the snow falls off harmlessly before it turns into a lump of ice, accidental damage can be prevented. Therefore, an initial test was carried out to evaluate a method of prompting snow to fall from overhead equipment after it accumulates during snowfall. A water-repellent sheet was attached to the top of a cable closure, and the closure was observed to determine if the sheet caused the snow to fall off rather than to accumulate (Fig. 10). The test result revealed that by attaching the water-repellent sheet to the top of the closure, the snow that accumulates on that closure was eliminated in a short time (seen in the photo on the right), so that snow was prevented from becoming a lump of ice. Investigations will continue to monitor aging deterioration of the sheet and other
