Countermeasures against Insect Damage to User Equipment— Repellent Sheet and Repellent Spiral

Technical Assistance and Support Center, NTT EAST

Telecommunication equipment can malfunction if it is damaged by insects. It is therefore necessary to develop measures to prevent such damage. This article presents examples of the damage that can occur when cockroaches nest inside equipment and introduces two products designed to stop them from accessing the equipment. This is the fifty-third article in a series on telecommunication technologies.

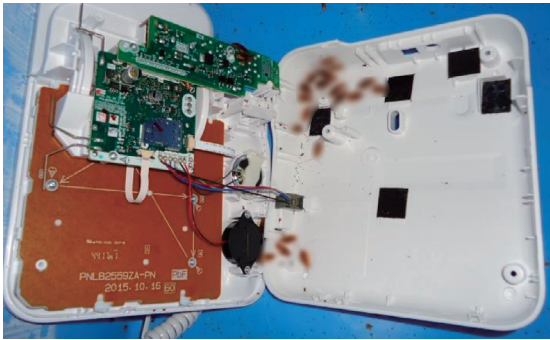
Photo 1. Cockroaches nesting inside a telephone (images of cockroaches are blurred).

If cockroaches invade and nest inside communication equipment such as a telephone and home gateway at a customer's premises, they may chew the substrate and wiring, or their habitation may cause a malfunction such as substrate shorting due to their excrement (**Photo 1**). In the field, although the equipment can be repaired or replaced, if the surrounding environment does not change, it is likely that the

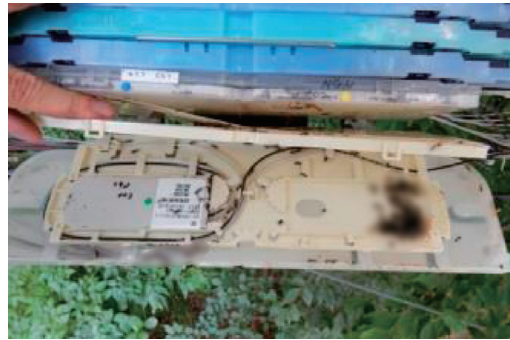
Photo 3. Inside a core-wire housing containing broken fibers (images of ants are blurred).

Damage by ants to access equipment was mainly caused by ants nesting in the optical closures of overhead equipment. The ants often chewed through optical-fiber core wires inside core-wire housings, disconnecting them (**Photo 3**). Moreover, inside metal terminal boxes, the ants chewed the outer sheaths of the core wires. The effect of formic acid^{*2} caused the core wires to come into contact with each

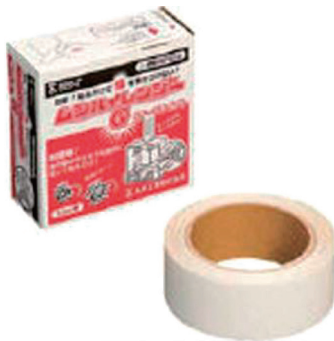
Photo 2. Repellent tape.

In the meantime, the Technical Assistance and Support Center has been examining damage to access equipment caused by insects such as ants. We have also been collaborating with pharmaceutical companies to promote measures to prevent such damage. These measures include producing a type of tape that contains a repellent composed primarily of a pyrethroid^{*1}, which has a repellent effect against insects (**Photo 2**).

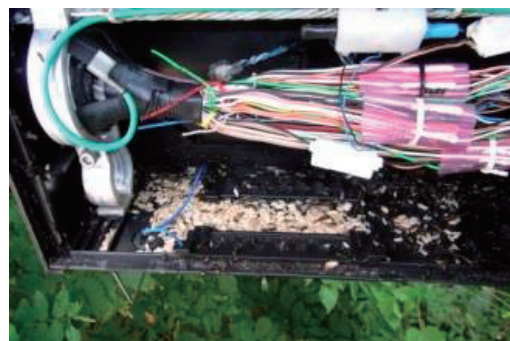
Photo 4. Interior of metal terminal box in which core-wire insulation is broken.

other, and that contact caused insulation failure (**Photo 4**). Implementing measures using repellent tape makes it possible to prevent ants nesting in optical closures and metal terminal boxes (**Photo 5**).

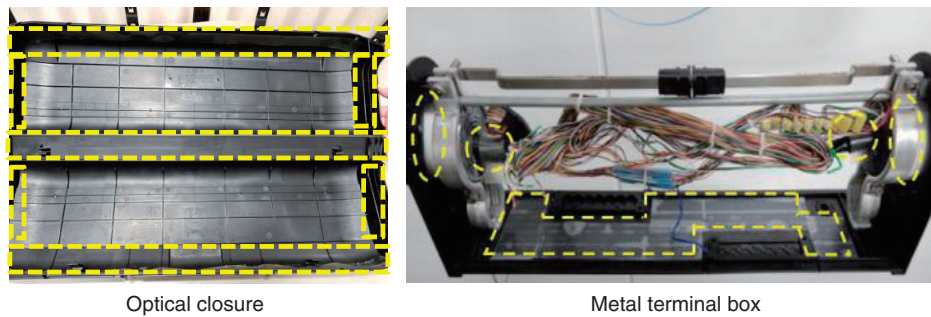
Optical closure

Metal terminal box

Photo 5. Installation of repellent tape.

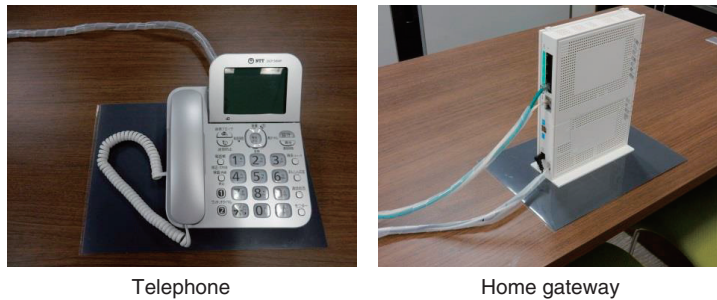
Telephone

Home gateway

Photo 7. Installation image of countermeasure products.

The repellent sheet can simply be placed under the main units of communication equipment, and the repellent spiral can simply be wrapped around power supply cords and cables by workers in a quick and easy manner (**Photo 7**). Moreover, the period during which the repellent effect of these countermeasure products lasts is about 10 years (for equipment
