Case Study of Noise Faults Originating in Metallic Leased Lines and Countermeasure

In this article, we introduce failure cases and a failure countermeasure for metallic leased lines. This is the fifteenth in a bimonthly series on the theme of practical field information on telecommunication technologies. This month's contribution is from the Network Service Engineering Group, Technical Assistance and Support Center, Maintenance and Service Operations Department, Network Business Headquarters, NTT EAST.

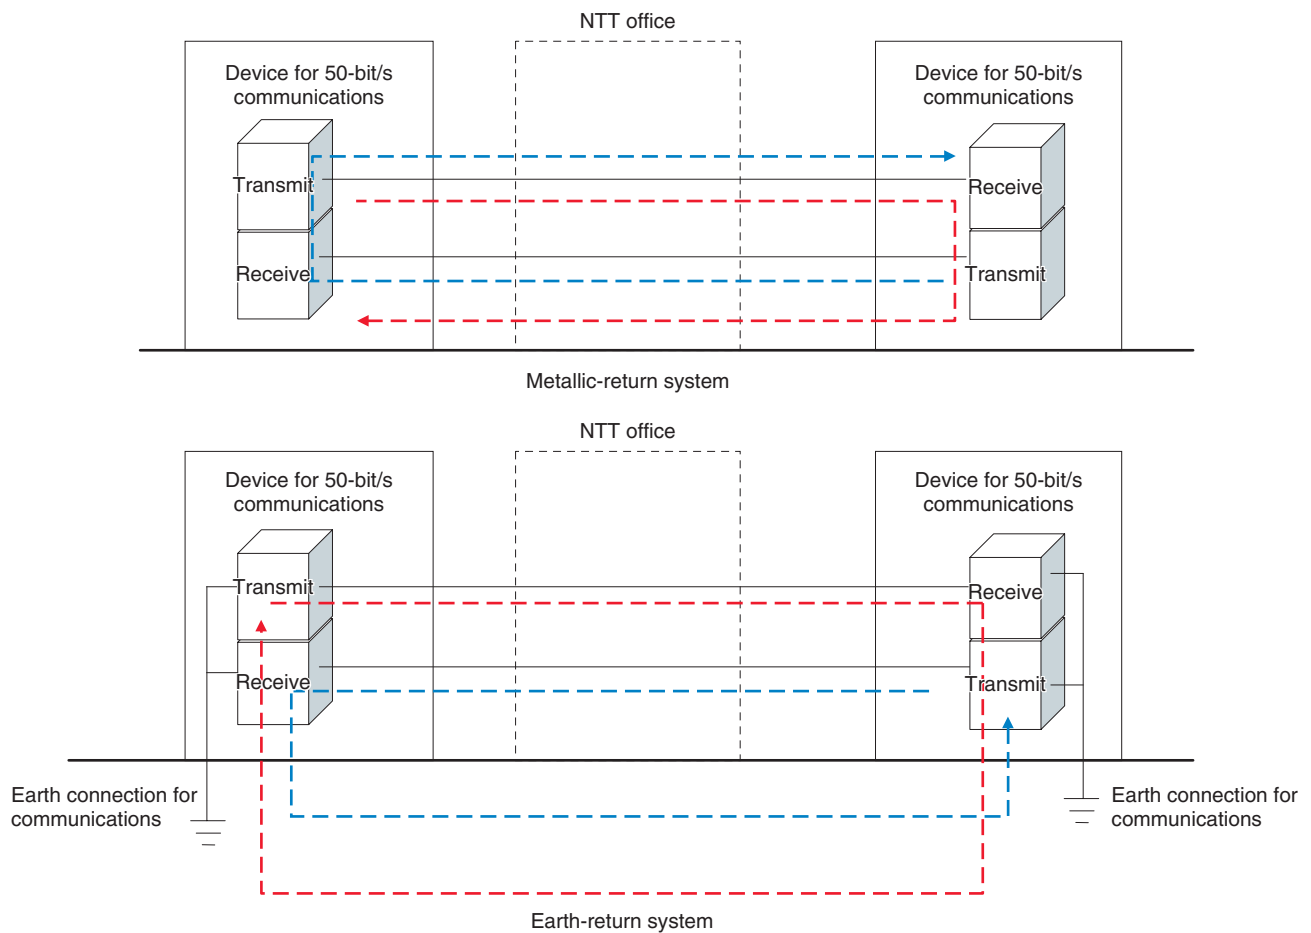
Fig. 2. Metallic-return and earth-return systems.

In the metallic-return system, the L1 and L2 lines are used as outward and homeward paths for the same signal, which means that the voltage induced in neighboring circuits is low.

In the earth-return system, however, different signals flow through L1 and L2; this results in a high induced voltage that can generate noise faults in neighboring circuits. These noise faults include mixing of noise in analog circuits and communication anomalies in metallic leased lines and in 3.4-kbit/s leased lines within the same cable.
