Fault Cases and Countermeasures for Optical Fiber Cables in Optical Network Facilities

This article introduces case studies of failures that have occurred in optical fiber cables as well as some countermeasures against such failures. This is the twenty-third of a bimonthly series on the theme of practical field information on telecommunication technologies. This month's contribution is from the Access Network Engineering Group, Technical Assistance and Support Center, Maintenance and Service Operations Department, NTT EAST.

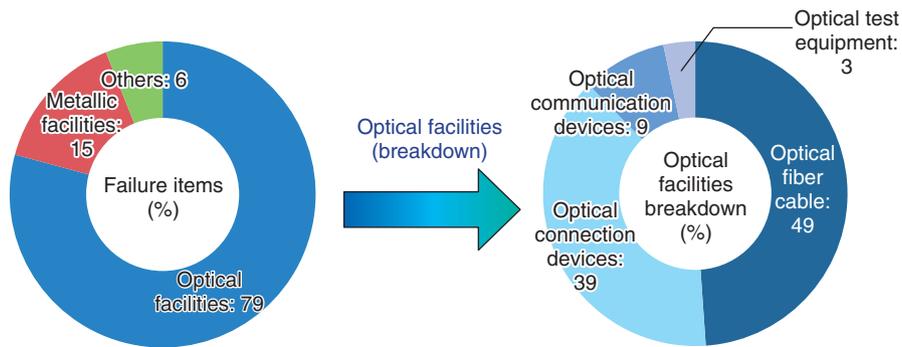
Fig. 1. Failures of access network facilities the Access Network Engineering Group investigated in 2012.

We investigated a range of failure items in 2012, as shown in **Fig. 1**. The figure indicates that optical fiber cable and optical connection devices account for nearly half of the total failures. We reported fault cases of field assembly connectors in optical access facilities in a previous issue (July 2011) [1]. Therefore, we report here the fault cases of optical fiber cables investigated in 2012.

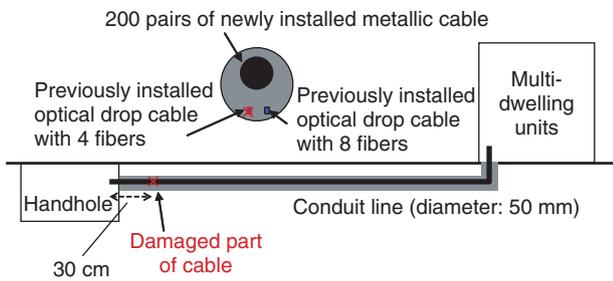
Fig. 2. Configuration of underground facilities where optical drop cable was damaged.

A new metallic cable was installed in the conduit line connecting a handhole to a multi-dwelling unit (**Fig. 2**). The installation involves first laying a rod for cables and using the rod to lay a polypropylene string. The rod is then removed, and the polypropylene string is used to install a metallic cable. Finally, the polypropylene string is removed.

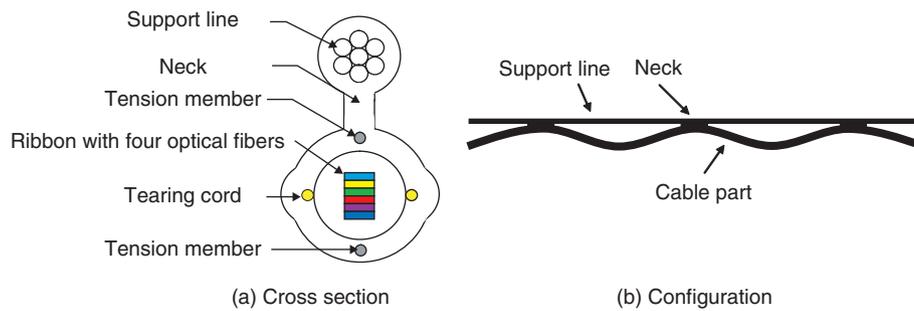
Fig. 8. Configuration of aerial optical fiber cable with 24 fibers.

bulge (Fig. 7), and its shape resembled that of the piece of removed cable described in the previous section. The configuration of this type of aerial optical fiber cable with 24 fibers is shown in Fig. 8.
