Fault Cases in an IP Phone Circuit Accommodating a PBX via a VoIP-GW

This article introduces fault cases in an Internet protocol (IP) phone circuit accommodating a PBX (private branch exchange) via a VoIP-GW (voice over IP gateway). This is the twenty-fourth of a bimonthly series on the theme of practical field information on telecommunication technologies. This month's contribution is from the Network Interface Engineering Group, Technical Assistance and Support Center, Maintenance and Service Operations Department, Network Business Headquarters, NTT EAST.

Keywords: IP phone, PBX, VoIP-GW

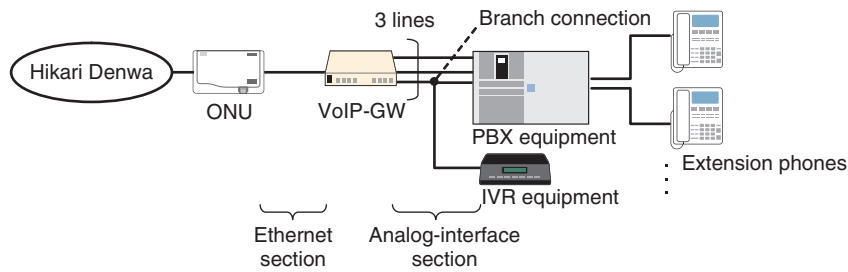
Fig. 1. Equipment configuration.

The equipment configuration of a customer that uses NTT's IP phone service called *Hikari Denwa* is shown in **Fig. 1**. The PBX is connected to the optical network unit (ONU) through the VoIP-GW with three analog lines. One of the lines leads to the interactive voice response (IVR) equipment as a result of branching off the path from the VoIP-GW into the PBX equipment. The VoIP-GW is also connected to an

Ethernet line, and it bidirectionally converts analog signals into IP packets or IP packets into analog signals.

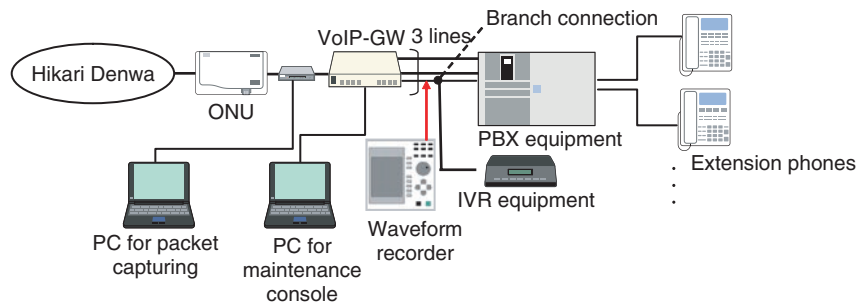
Fig. 2. Inspection setup.

Since we could not confirm the occurrence of a line disconnect before answering in an on-site incoming-call connection test, we decided to conduct long-term monitoring and analyze the collected data. The inspection setup is shown in **Fig. 2** and described below.

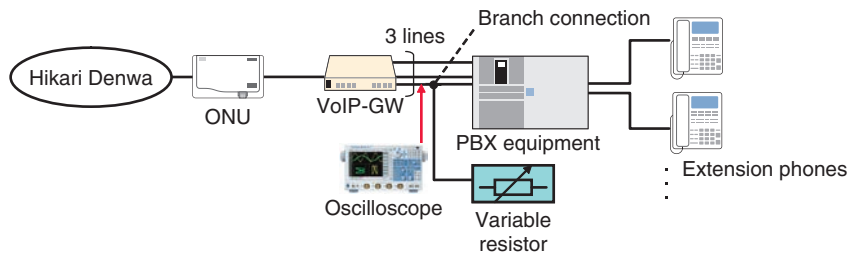
Fig. 6. Configuration of test equipment.

After confirming the occurrence of no incoming-call ringing in an on-site incoming-call connection test, we configured some test equipment and conducted a reproducibility experiment. This configuration is shown in Fig. 6.

- In this reproducibility experiment, we monitored signals in the analog-interface section between the VoIP-GW and PBX equipment using an oscilloscope while varying the resistance using a variable resistor in place of the IVR equipment.
- We examined the conditions under which no ringing occurred when a call came in from the outside.

Specifications of the VoIP-GW installed on the customer’s premises stipulated various electrical conditions with respect to branch connections, so we checked whether the customer’s equipment setup conformed to those conditions. One of the conditions was that the value of DC resistance between L1-L2 was to be 1 MΩ or greater, but we found from measurements that the value was only 0.6 MΩ.

would be unstable and that this fault would occur since the stipulated conditions for branch connections were not being observed.

We surmised that no ringing occurred when receiving calls from the outside since branch-connection conditions stipulated in the specifications of VoIP-GW equipment installed after the change from an analog line to Hikari Denwa were not being observed.
