Case Studies of Failures and Countermeasures in Access Network Facilities

This article describes case studies of failures and countermeasures in access network facilities. This is the thirty-third article in a bimonthly series on practical field information on telecommunication technologies. This month's contribution is from the Access Engineering Group, Technical Assistance and Support Center, Maintenance and Service Operations Department, Network Business Headquarters, NTT EAST.

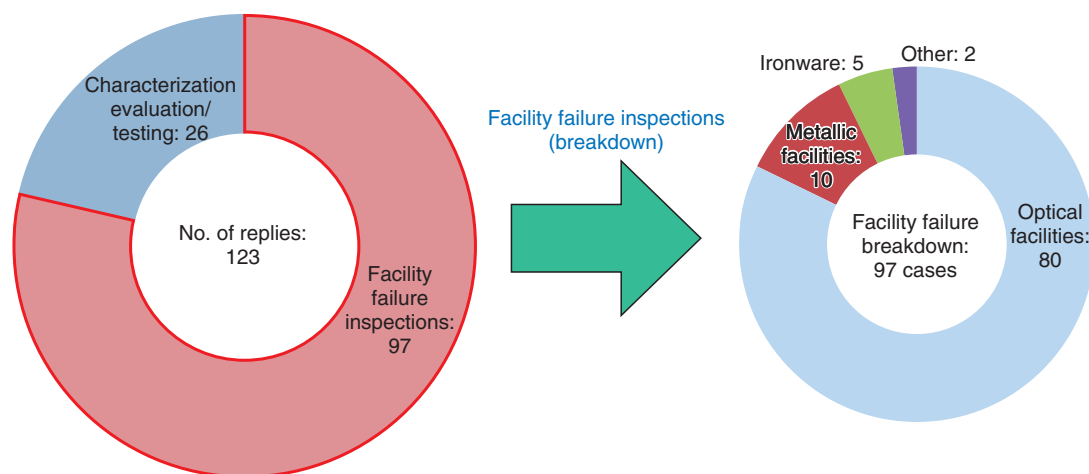
environments containing salt, sulfidizing gas, or other elements; and damage caused by wildlife. In fiscal years 2013 and 2014, the Technical Assistance and Support Center received 97 inspection requests in relation to access network facilities (**Fig. 1**). We introduce three of these cases in this article.

Fig. 1. Number of technical assistance and support requests.
