Recent Case Study of Fault in IP Phone User System

Abstract

This article describes a problem a customer was having with disconnects in inter-office calling using IP-VPN (Internet protocol virtual private network) services and how we rectified it. This is the thirty-sixth article in a series on telecommunication technologies. This month's contribution is from the Network Interface Engineering Group, Technical Assistance and Support Center, Maintenance and Service Operations Department, Network Business Headquarters, NTT EAST.

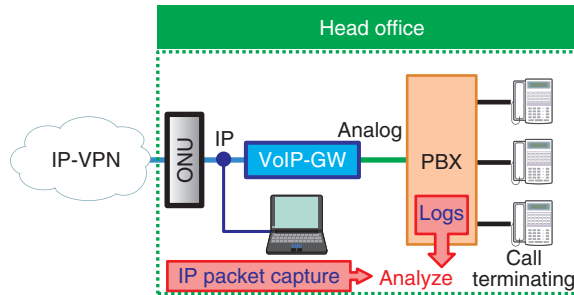
Fig. 2. On-site troubleshooting layout.

Packet capture equipment was installed in the IP interval on the head-office side that had been experiencing a high frequency of disconnects in order to examine the conditions under which the event occurred. This equipment was used to collect and analyze IP packet traffic and PBX logs at the time of the event occurrence (**Fig. 2**).

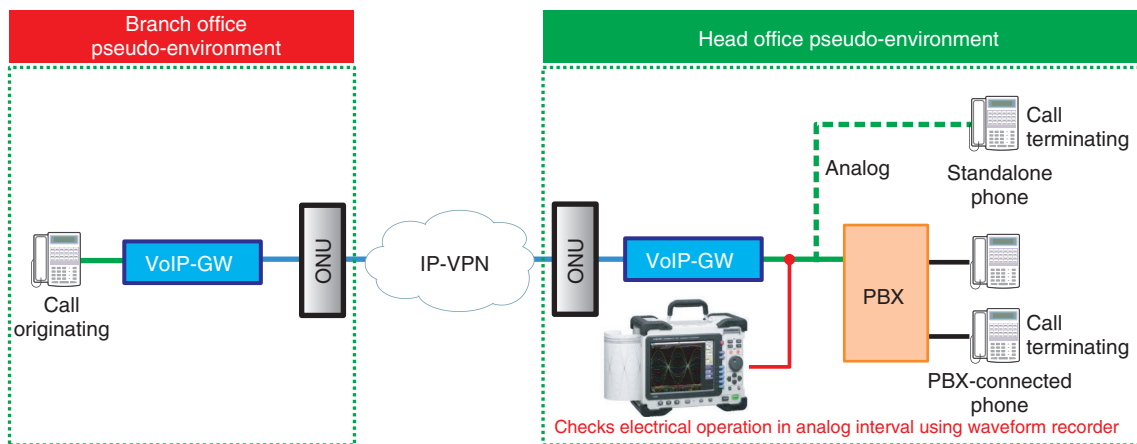
Fig. 4. Schematic of reproducibility test.

To find the cause of this event, the Technical Assistance and Support Center conducted a reproducibility test by preparing VoIP-GW and PBX equipment and IP-VPN services as used by the customer and constructing an environment that emulated the system environment in which the event was occurring. Furthermore, to troubleshoot both the VoIP-GW and PBX at the event occurrence, a standalone phone set was prepared to check whether there were any differences between the call-terminating operation when connecting the standalone phone to the VoIP-GW and the call-terminating operation when connecting the PBX to the VoIP-GW. It was also decided to check for any changes in electrical operation in the analog interval below the VoIP-GW using a waveform recorder and to check the electrical operation between the VoIP-GW and terminals connected below the VoIP-GW when terminating a call (Fig. 4).

The above reproducibility test therefore showed that this event in which an incoming call failed to connect would occur whenever the time from off-hook to depolarization was 606–640 ms. In view of this fact, the settings related to the analog connection between the VoIP-GW and PBX were examined. It was found that the period for detecting the closing of the VoIP-GW TEL port (analog telephone port) circuit due to a terminal off-hook operation was set to 640 ms as a default value in the VoIP-GW. Meanwhile, on the PBX side, the guard time setting turned out to be 600 ms as a default value. This setting serves to prevent an unstable waveform generated at

with the customer and recommended that the setting for the PBX on-hook signal detection method be changed (item (3) above). This effectively eliminated the event in which an incoming IP extension call was disconnected upon answering.
