## Investigation of the Cause of Disconnection of Call Parking on a Business Phone

*Technical Assistance and Support Center, NTT EAST*

*Keywords: call park, business phone, line monitoring system*

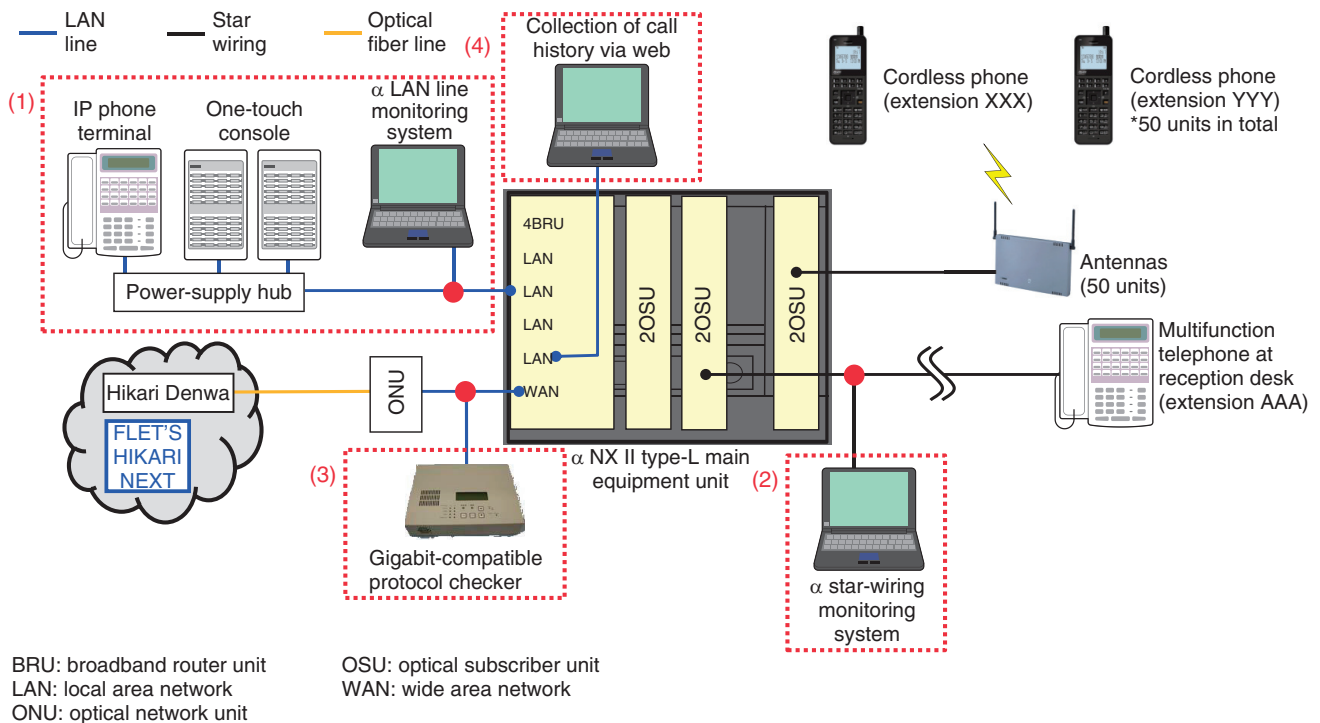
Fig. 1. Configuration of customer's equipment.

The configuration of the customer's equipment is shown in Fig. 1. We considered the possibility of misoperation or failure of the multifunction tele-
