Introduction to Troubleshooting Cases Related to Telephone Systems in Customer Premises

Technical Assistance and Support Center, NTT EAST

In this article, we introduce two cases involving problems that occurred in telephone systems. In the first case, a connection could not be established even when the customer dialed the correct number. In the second case, silence suddenly occurred during the connection. We investigated and solved these problems using various measurement tools and analysis methods. This is the fifty-fourth article in a series on telecommunication technologies.

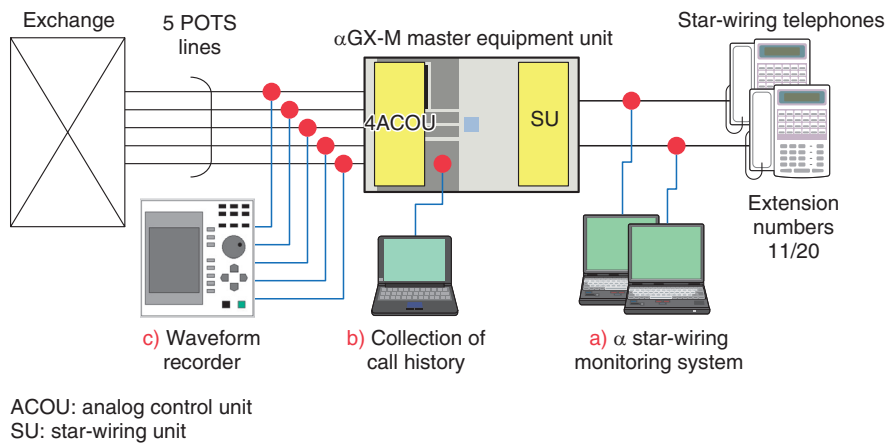
Fig. 1. Configuration of call analysis system and measurement points.

In this case, the customer's key telephone system (α GX-M) was connected to five POTS lines. The customer claimed that a connection could not be established even if the correct number was dialed. On site, the master equipment unit and telephone sets were replaced by service personnel, but the problem persisted.

investigation are shown in **Fig. 1**. The red circles indicate the measurement points. We investigated the following using several measurement tools.

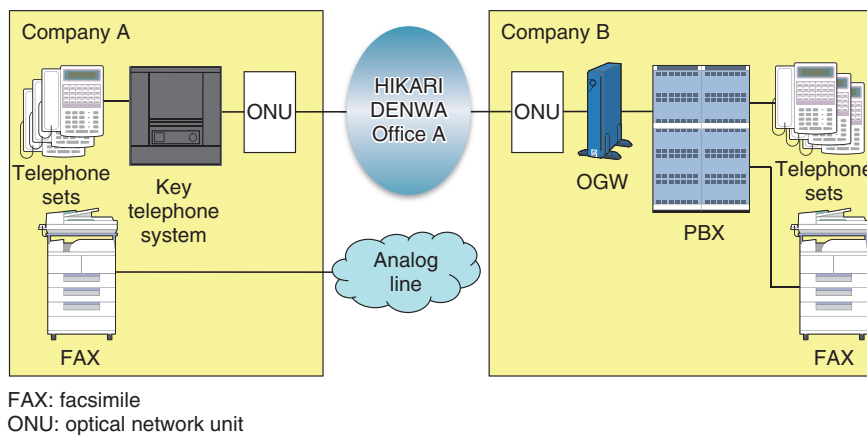
Fig. 5. Equipment configuration.

A customer (Company A) was using the NTT HIKARI DENWA IP phone service in its key telephone system. The customer claimed that a voiceless condition occurred during calls with Company B. Company B, meanwhile, was using the NTT HIKARI DENWA (via OGW (Office Gateway) with Primary Rate Interface) in its private branch exchange (PBX). The equipment configuration at both locations is

shown in **Fig. 5**. We captured IP packets using packet-capturing equipment near the ONU (optical network unit) at both locations. Then the data at the time of the problem occurred were analyzed.

of the FAX CED tone from Company A during the call. Consequently, on checking the surroundings near the telephone set at Company A, we found that the telephone set having extension number 25 was installed about 1 m away from the FAX machine, and the machine was transmitting the sound of FAX communications from the speaker used for monitoring its operation. Thus, the monitor sound during FAX communications was picked up by the microphone of telephone number 25. To avoid unintended pickup of the sound, the volume of the monitor sound during FAX communications was decreased.
