Investigation on Damage to Optical Fiber Cables Caused by Freezing and Thawing of Water in a Lifting Pipe

Technical Assistance and Support Center, NTT EAST

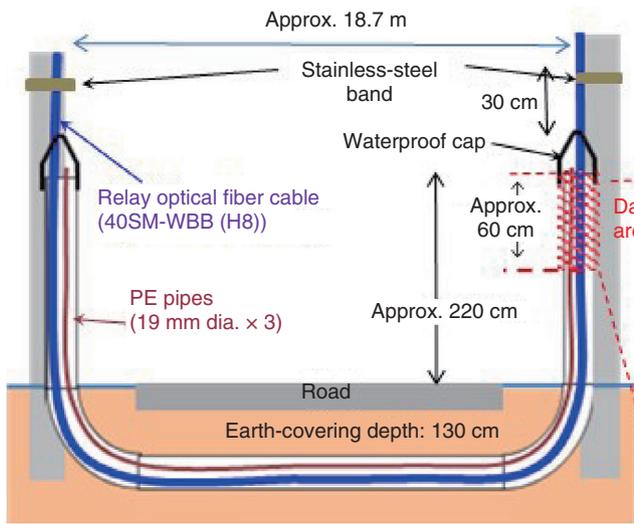
Fig. 1. Overview of equipment.

A lifting pipe is used where an optical fiber cable goes up from underground to the aerial area (**Fig. 1**). In the field, the cable was inserted into a PE pipe, which were both installed in the lifting pipe. First, we inspected the damaged part of the optical fiber cable

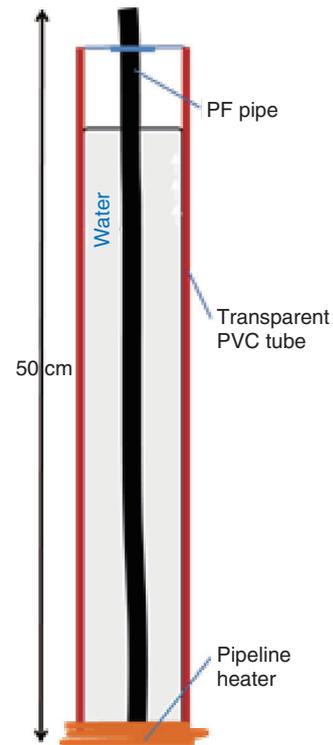
Fig. 4. Lifting pipe simulated with transparent PVC tube.

Considering the results described in verification (1), we observed the changes in the water and their impact on the cable and PE pipe. The results are as follows. We inserted a plastic flexible (PF) pipe (which simulates an optical fiber cable) into a transparent polyvinyl chloride (PVC) tube (which simulates the lifting pipe). The experimental apparatus was filled with water and placed in a thermostatic room. We observed the phenomena inside the pipe, when temperature in the surrounding area repeatedly changed between -15 to 10°C , that is, water in the lifting pipe froze and thawed, repeatedly (**Fig. 4**).
