Case Study of Audible Noise on Analog Leased Lines Caused by Electromagnetic Disturbance

Technical Assistance and Support Center, NTT EAST

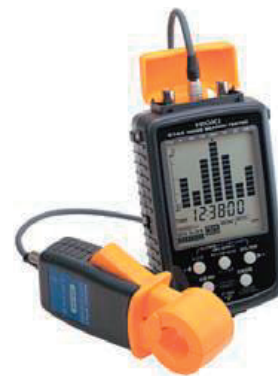
Photo 1. Noise Search Tester 3144 (right) and voltage sensor 9741 (left).

To identify the lines with the highest audible noise, the voltage levels of the audible noise on 17 lines of the 200-pair cable routed into the customer’s main building were measured. The Noise Search Tester (3144) and its probe, i.e., a voltage sensor (9741), both manufactured by Hioki E.E. Corporation (**Photo 1**), were applied to measure the common-mode voltage levels of the audible noise at the MDF of the NTT building. The basic specifications of the Noise Search Tester are listed in **Table 1**. Common-mode voltage levels for seven frequency ranges can be displayed by the tester’s bar indicator.
