Deterioration of Telecommunication Equipment and Facilities in Salt-damage Environments—Case Studies of Corrosion in Guy Wires and Maintenance Holes

Technical Assistance and Support Center, NTT EAST

This article presents examples of equipment and facility deterioration due to corrosion of guy wires and maintenance holes installed in coastal areas as well as examples of countermeasures to protect equipment and facilities from salt damage. This is the seventy-sixth article in a series on telecommunication technologies.

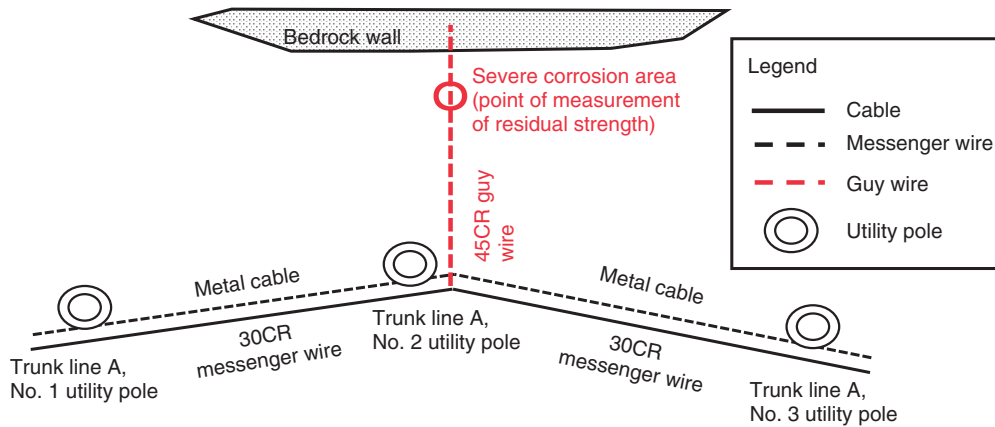
Fig. 2. Facility configuration.

First, we present a case study of guy wire deterioration along the coastline. The middle part of a guy wire of a utility pole had significant corrosion. The guy wire is installed about 30 m from the sea, and the region is designated as a high-salt-damage area on a “salt-damage map” developed and provided by

TASC [1, 2]. The configuration of the facility in this corrosion case is shown in Fig. 2.

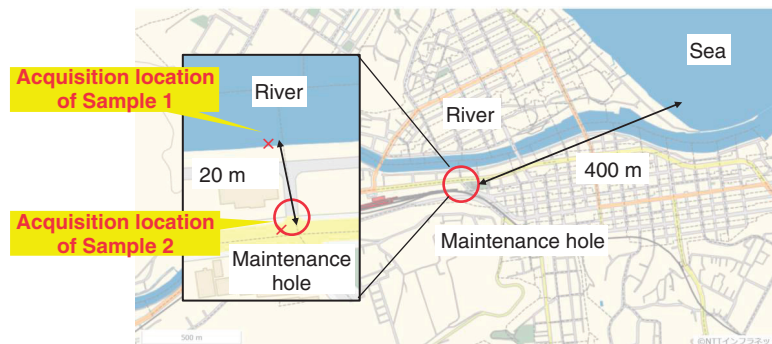
Fig. 8. Location of maintenance hole.

Cases of metal corrosion in a maintenance hole in a section located along a river are shown in Fig. 7. As shown in Fig. 8, the maintenance hole is located about 20 m from the river and about 400 m from the sea. It was previously confirmed that the bottom of the maintenance hole is 0 m above sea level or lower and that the water level inside the maintenance hole rises and falls due to the ebb and flow of the tide, so it was suspected that river water flows into the maintenance hole.
